REPORT ON REPAIR OF FENDERING TO BERTHING PLATFORM

LLANDUDNO PIER

Date 9 November 2009

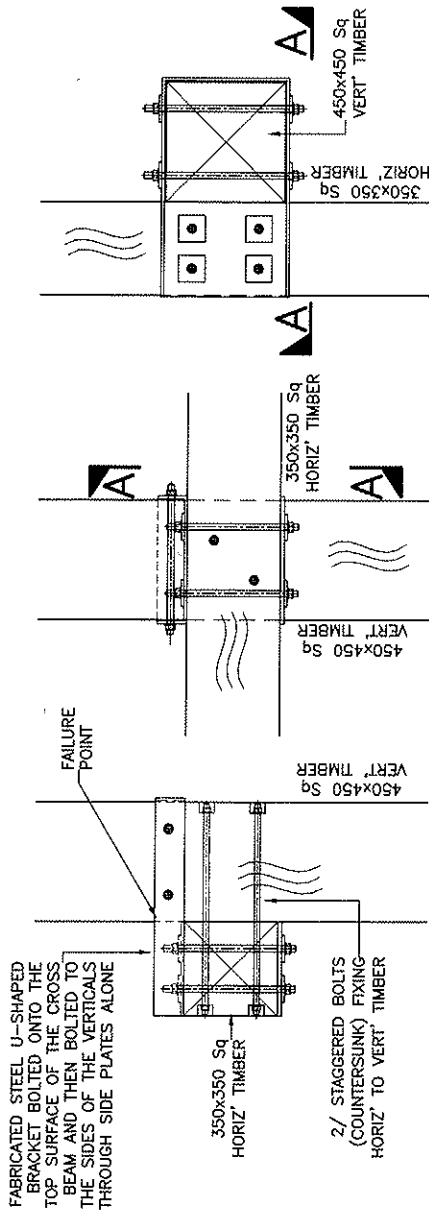
6.4 The steel bracket is considered to be particularly vulnerable to corrosion and overstress. Where the plate connects to the verticals it reduces to a pair of unstiffened steel plates subject to eccentric loading. The remains of these plates show failure of the plate due to buckling under bending.

- 7.3 The timbers that remain show signs of decay and splitting due to overstressing of bolted connections.
- 7.4 The loss of most of the vertical members is as a result of the failure of the steel bracket connecting them to the cross-beams. The detail is considered to be vulnerable to the effects of corrosion and overload.

SECTION A-A ELEVATION PLAN
FAILED PRINCIPAL SUPPORT BETWEEN THE VERTICALS & THE CROSS-BEAMS
