INSPECTION OF THE SUPERSTRUCTURE, VICTORIA PIER, COLWYN BAY

In February 2010 Datrys was commissioned by Conwy County Borough Council (CCBC) to carry out a structural inspection and assessment of Victoria Pier, Colwyn Bay and to provide a report on our findings.

This report relates to the structural inspection that was carried out above deck level on the 27th July 2010. The inspection consisted of a visual assessment all of accessible buildings, structures and areas that were deemed safe to enter. This report follows on from our initial report which concerned the supporting steel and cast iron structure below deck level.

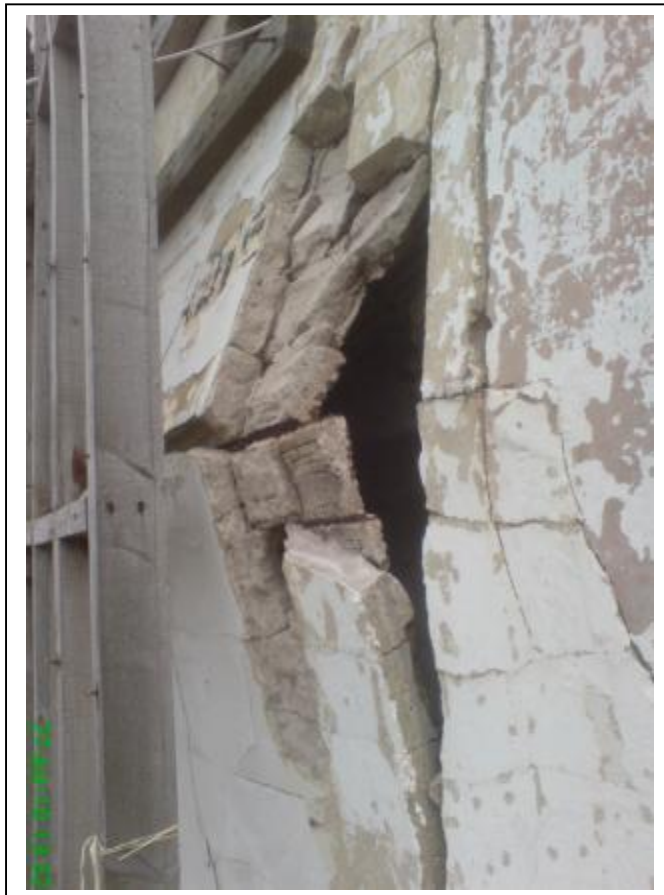
- A substantial proportion of the rendered outer wall leafs are cracked and are collapsing (photo's 12-14, 21-25, 28-29, 58-60).
- Some of the secondary steelwork supporting the fabric walls is corroding (photo's 30, 52, and 60).
- The roof of the toilet block to the north west of the main building is leaking. The floor is wet and seems to be rotten (photo's 35, 36).
- The principal structural members appeared to be in a good condition with little signs of corrosion and no signs of defects.

Most of the external wall panels have failed due to cracking and buckling; in areas they have become detached. This failure pattern is probably due to corrosion of the unrendered inner face of the steel laths as a result of condensation. The expansion of the corroding steel would cause the render to crack allowing exposure to the aggressive external environment. This in turn would lead to accelerated corrosion and expansion resulting in the buckling of the wall panel and its becoming detached from the supporting structure.

Photo 12; Lath & plaster boarding to the pavilion

1. The fabric of the Pavilion is not serviceable and should be replaced in its entirety. It probably contains a large quantity of asbestos and will need to be carefully removed and subject to controlled disposal.

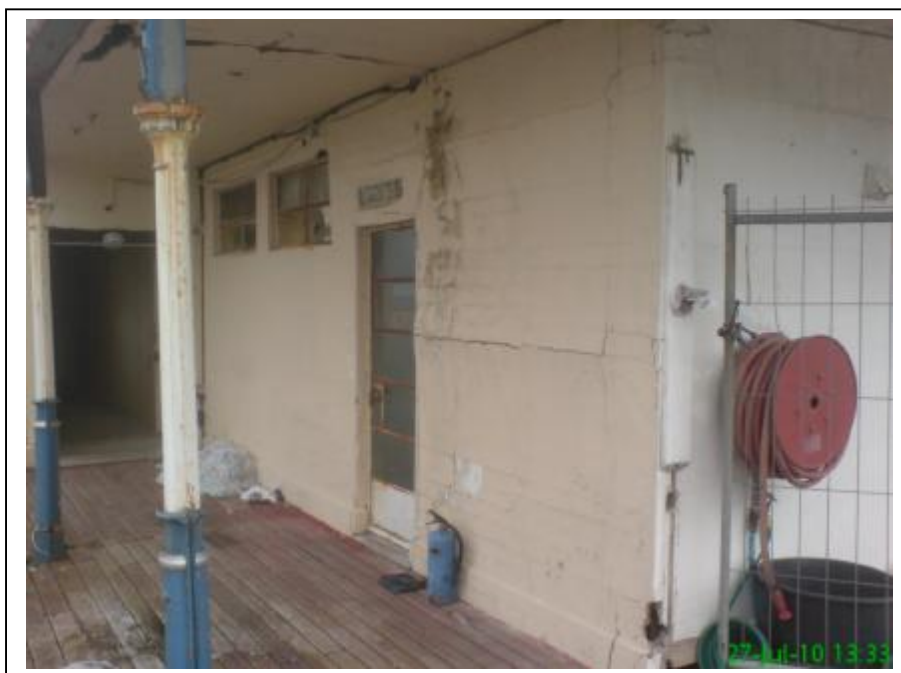
Photo 14: South west corner of pavilion

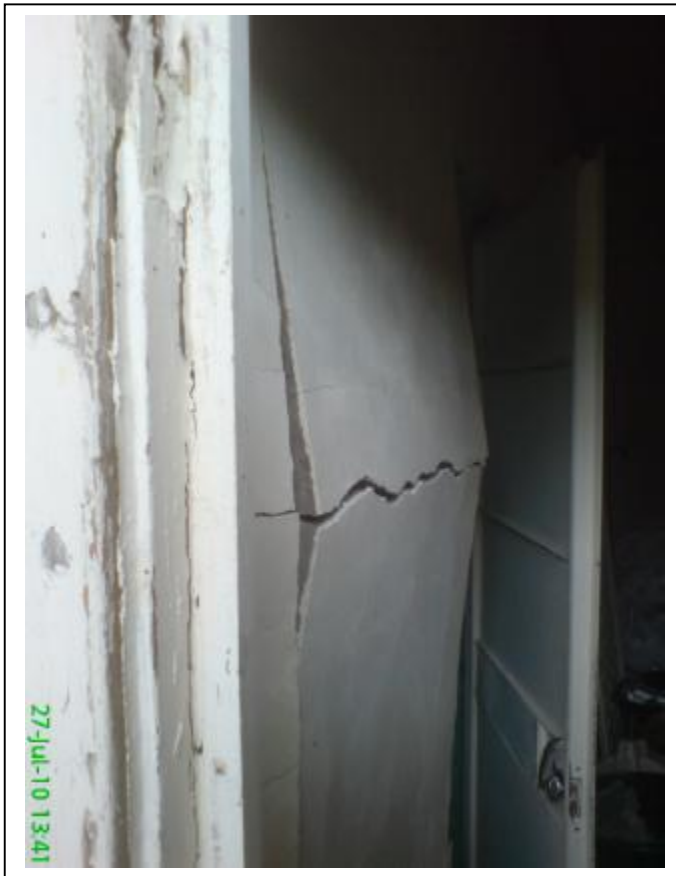
Photo 21: Damaged plaster wall to the south west pavilion corner

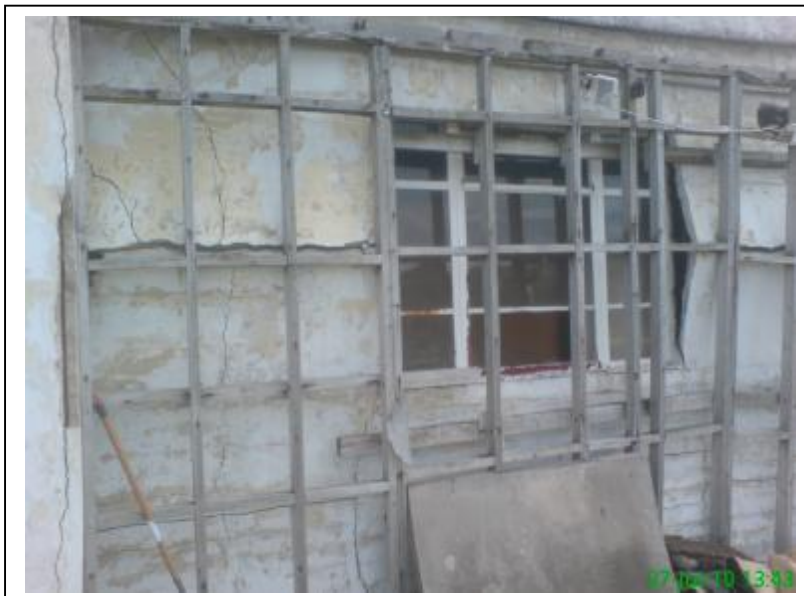
Photo 23: West elevation damage to plaster

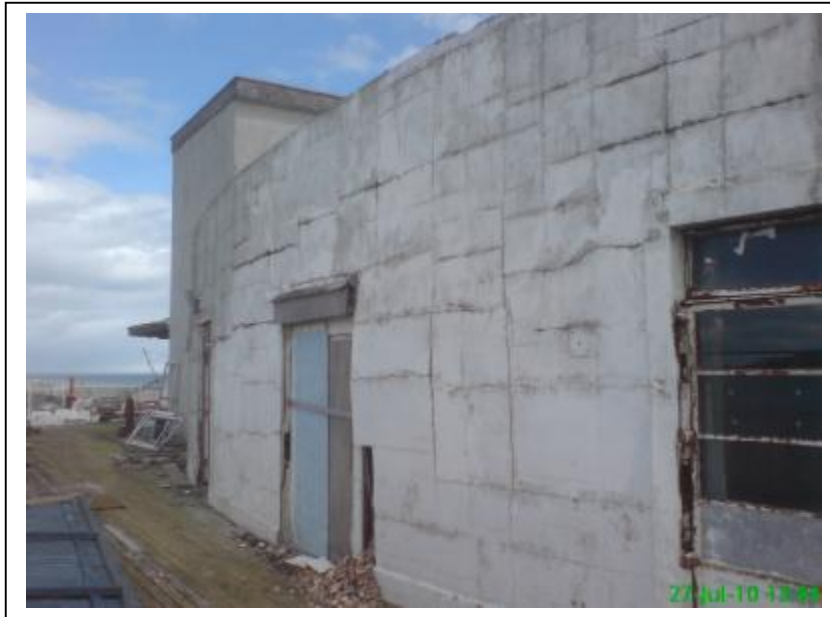
Photo 24: Cracked plaster to the curved structure

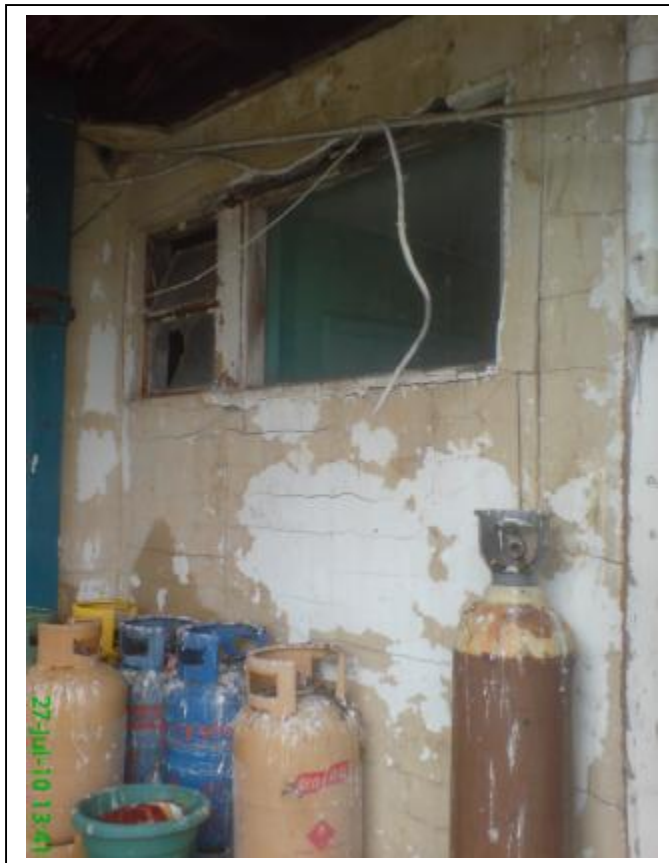
Photo 22; Damaged plaster wall to south east corner of pavilion

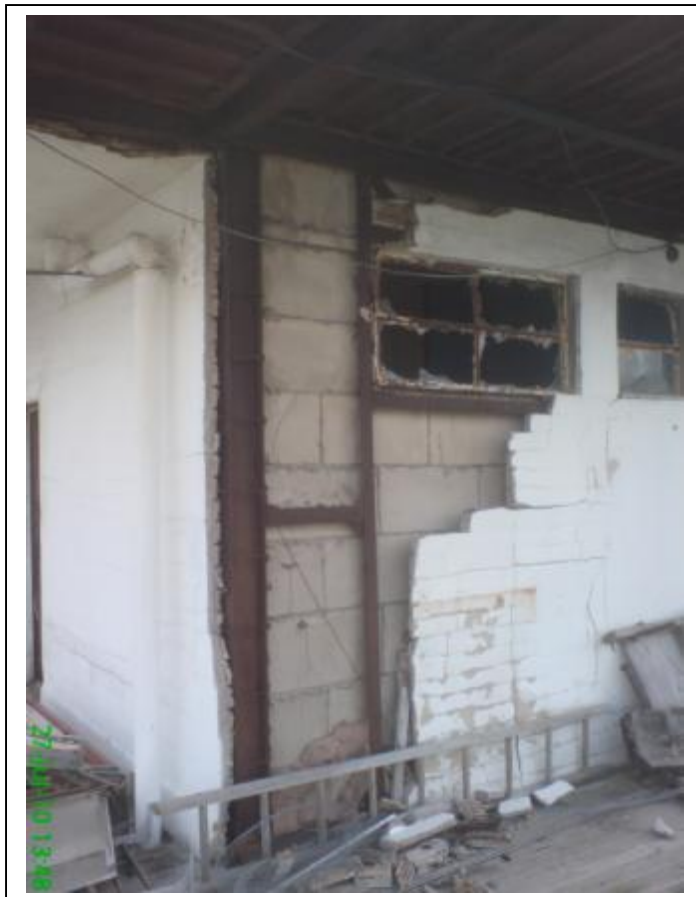
Photo 28: Annex cantilever
roof and wall construction

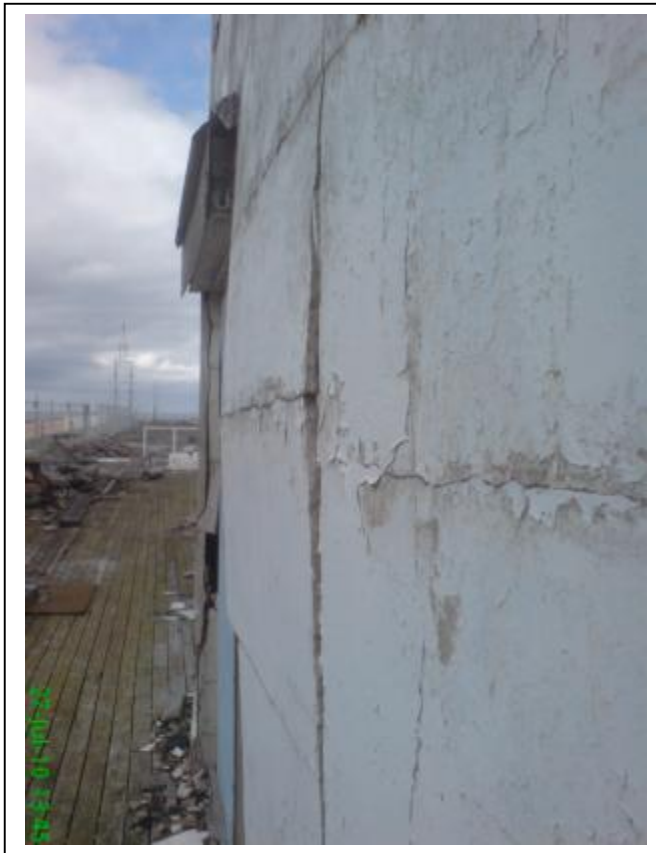
Photo 25: Cracked plaster to the curved structure

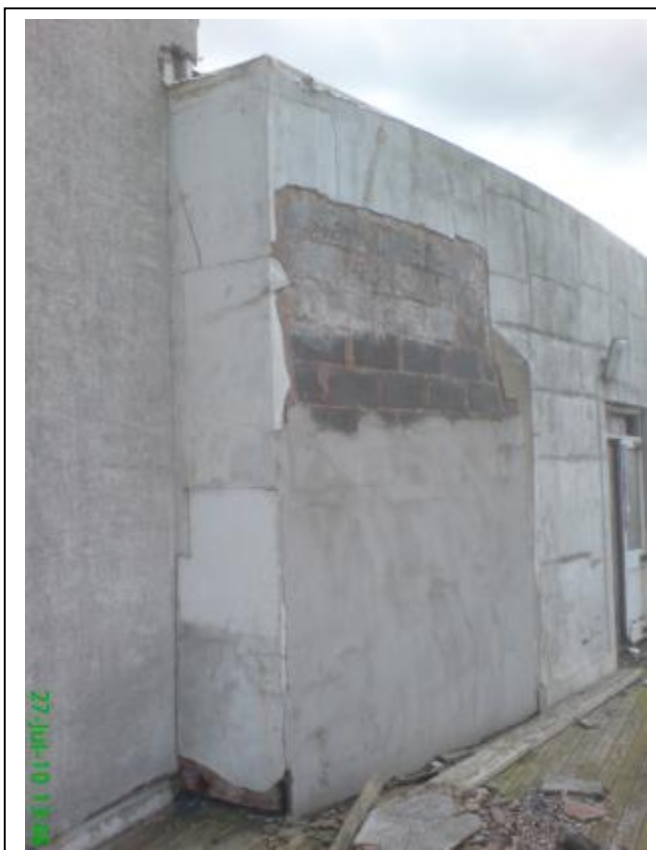
Photo 26: Repaired damage to the curved structure, north end

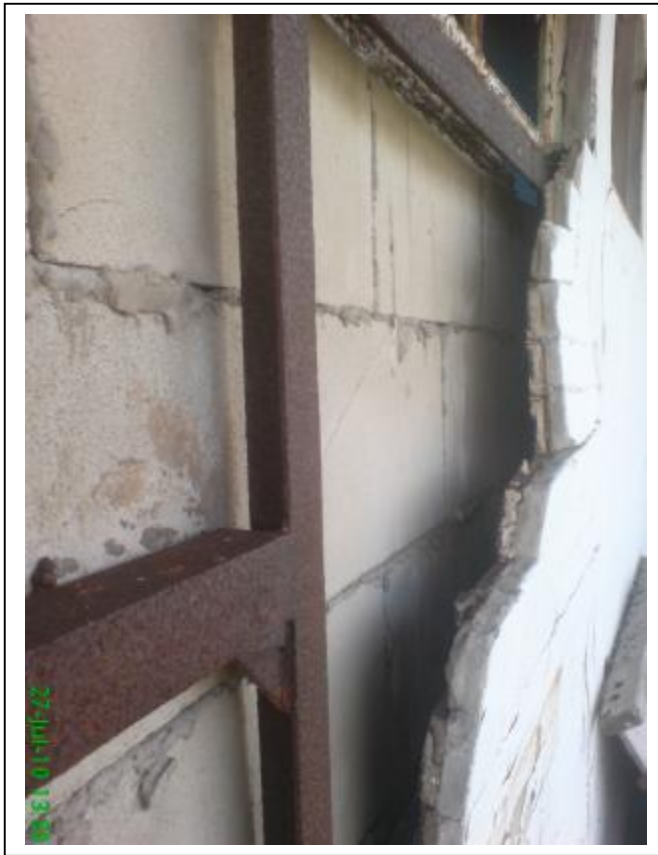
Photo 29; The wall composition

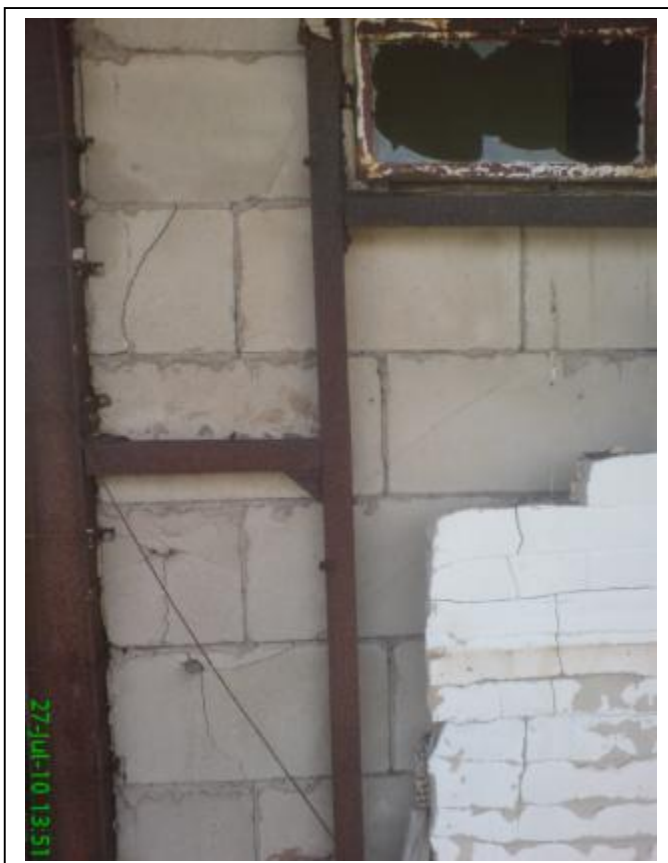
Photo 30: Cracking of internal
blockwork leaf

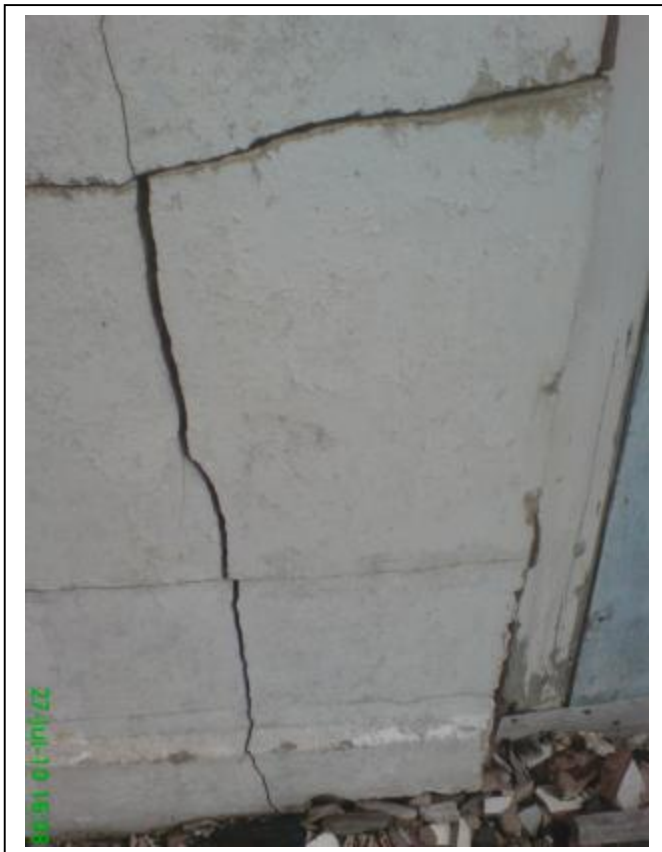
Photo 59: Cracking within the outer leaf plaster of the pavilion

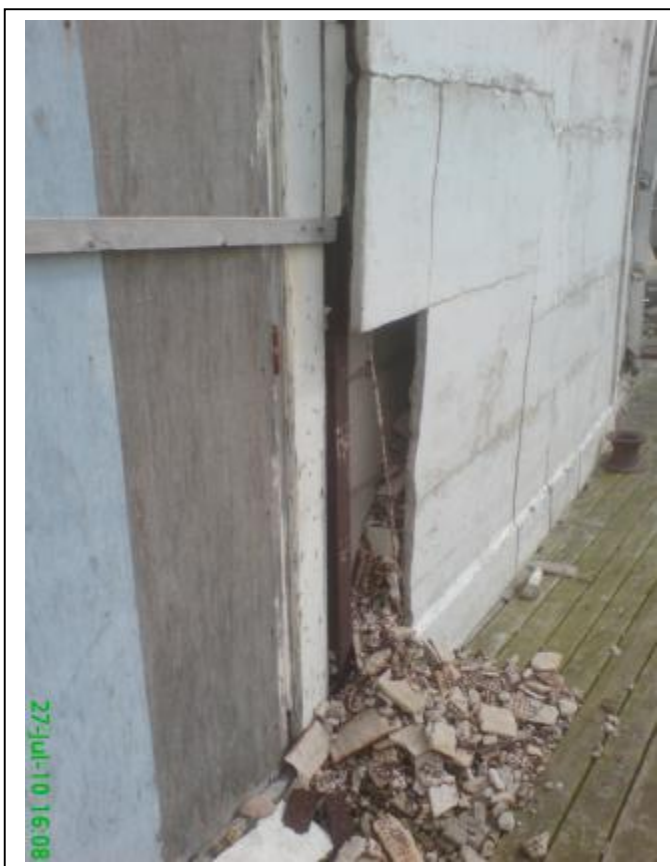
Photo 60: Collapse of outer leaf plaster to the pavilion

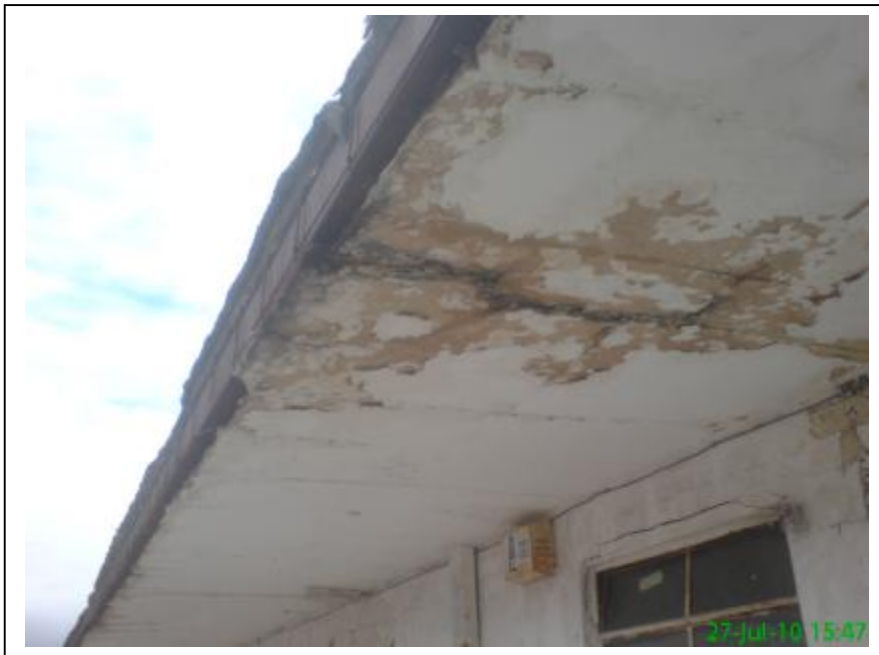
Photo 57: General deterioration of the annex cantilevered roof

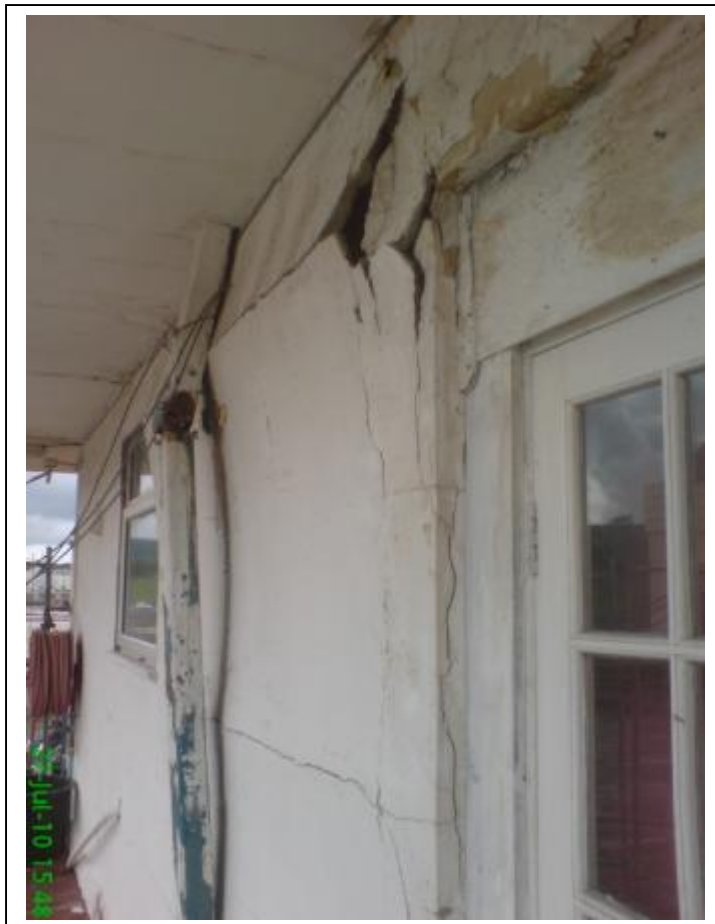
Photo 58: Cracking of the outer leaf plaster to the pavilion

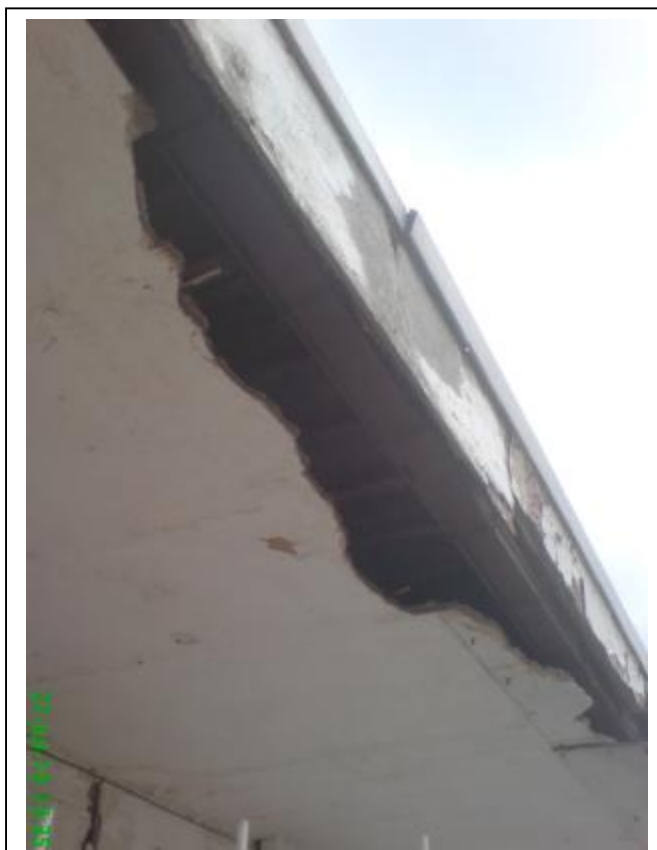
Photo 16: Damaged ceiling under south cantilever of pavilion

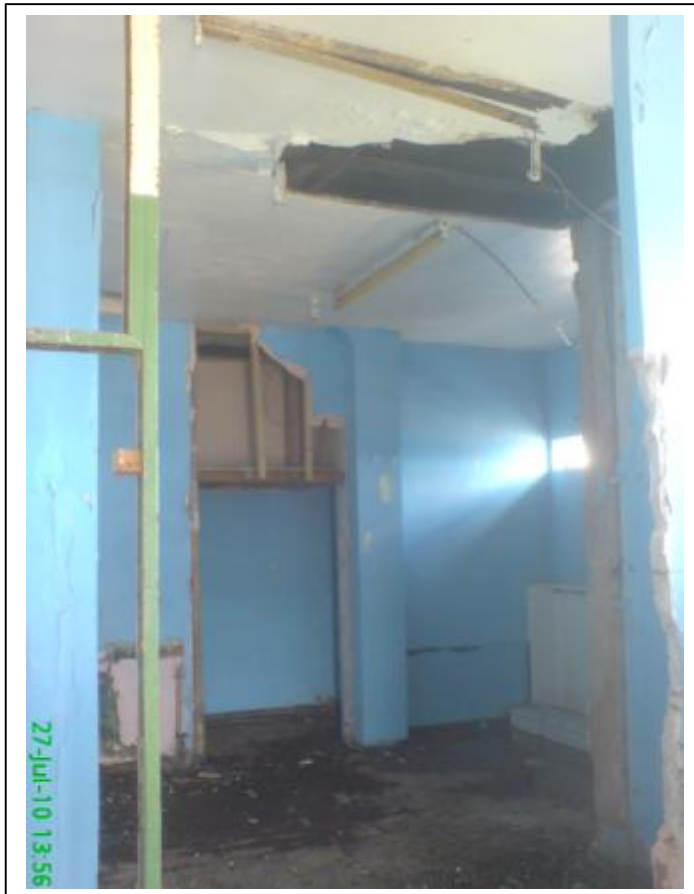
It is clear that there have been problems with the roofs leaking in the past which may be why the majority of the sheeting has been replaced on the lower annexes. The roof to the toilet area continues to leak which will be causing corrosion of the supporting steelwork.

Photo 35: Interior of toilet, north west corner

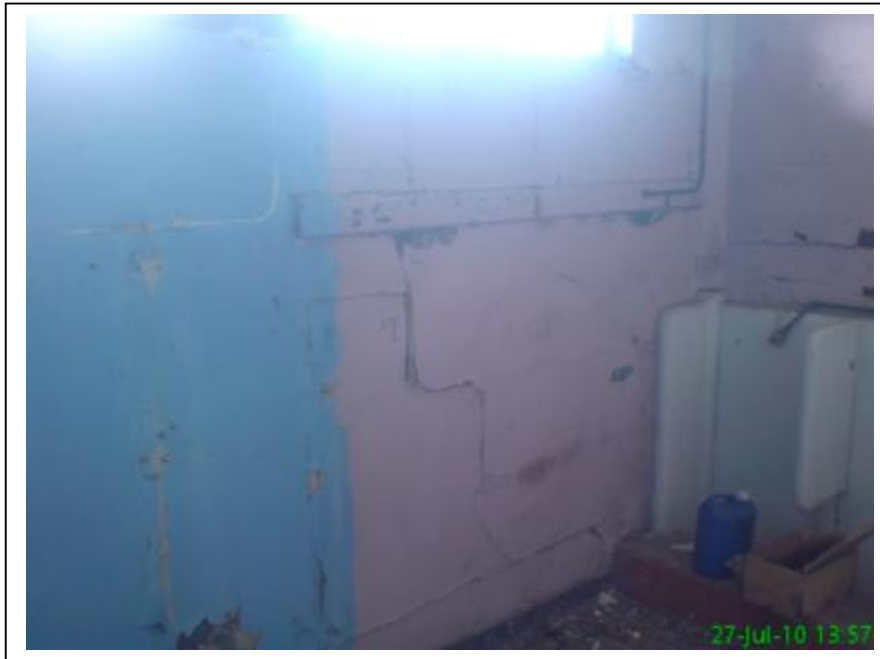
Photo 37: Cracked inner blockwork leaf

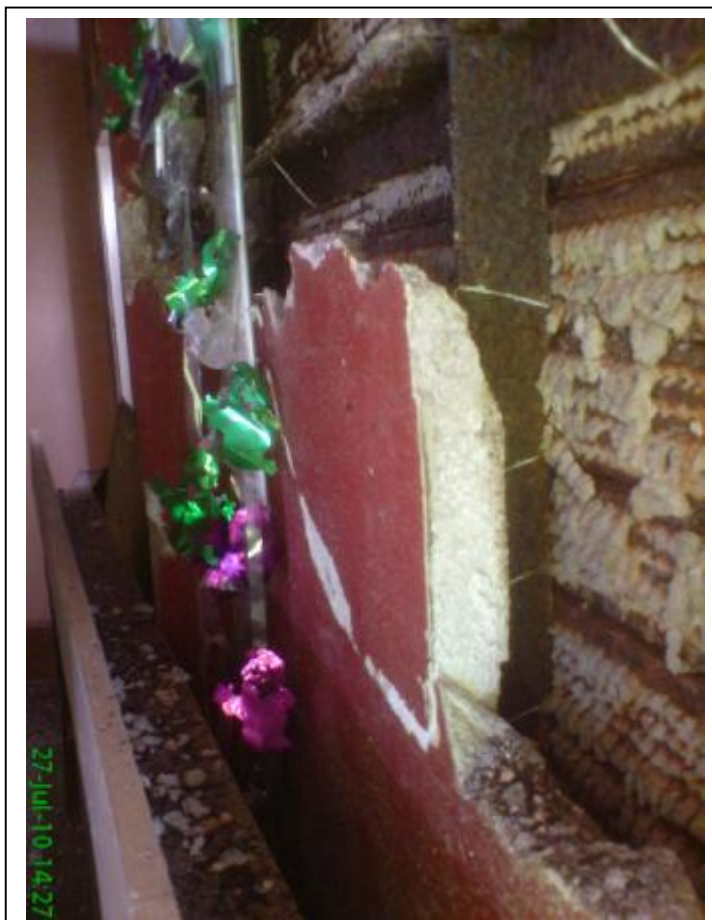
Photo 52: Close up of insulation board to internal wall leaf of pavilion
