STRUCTURAL APPRAISAL

VICTORIA PIER, COLWYN BAY

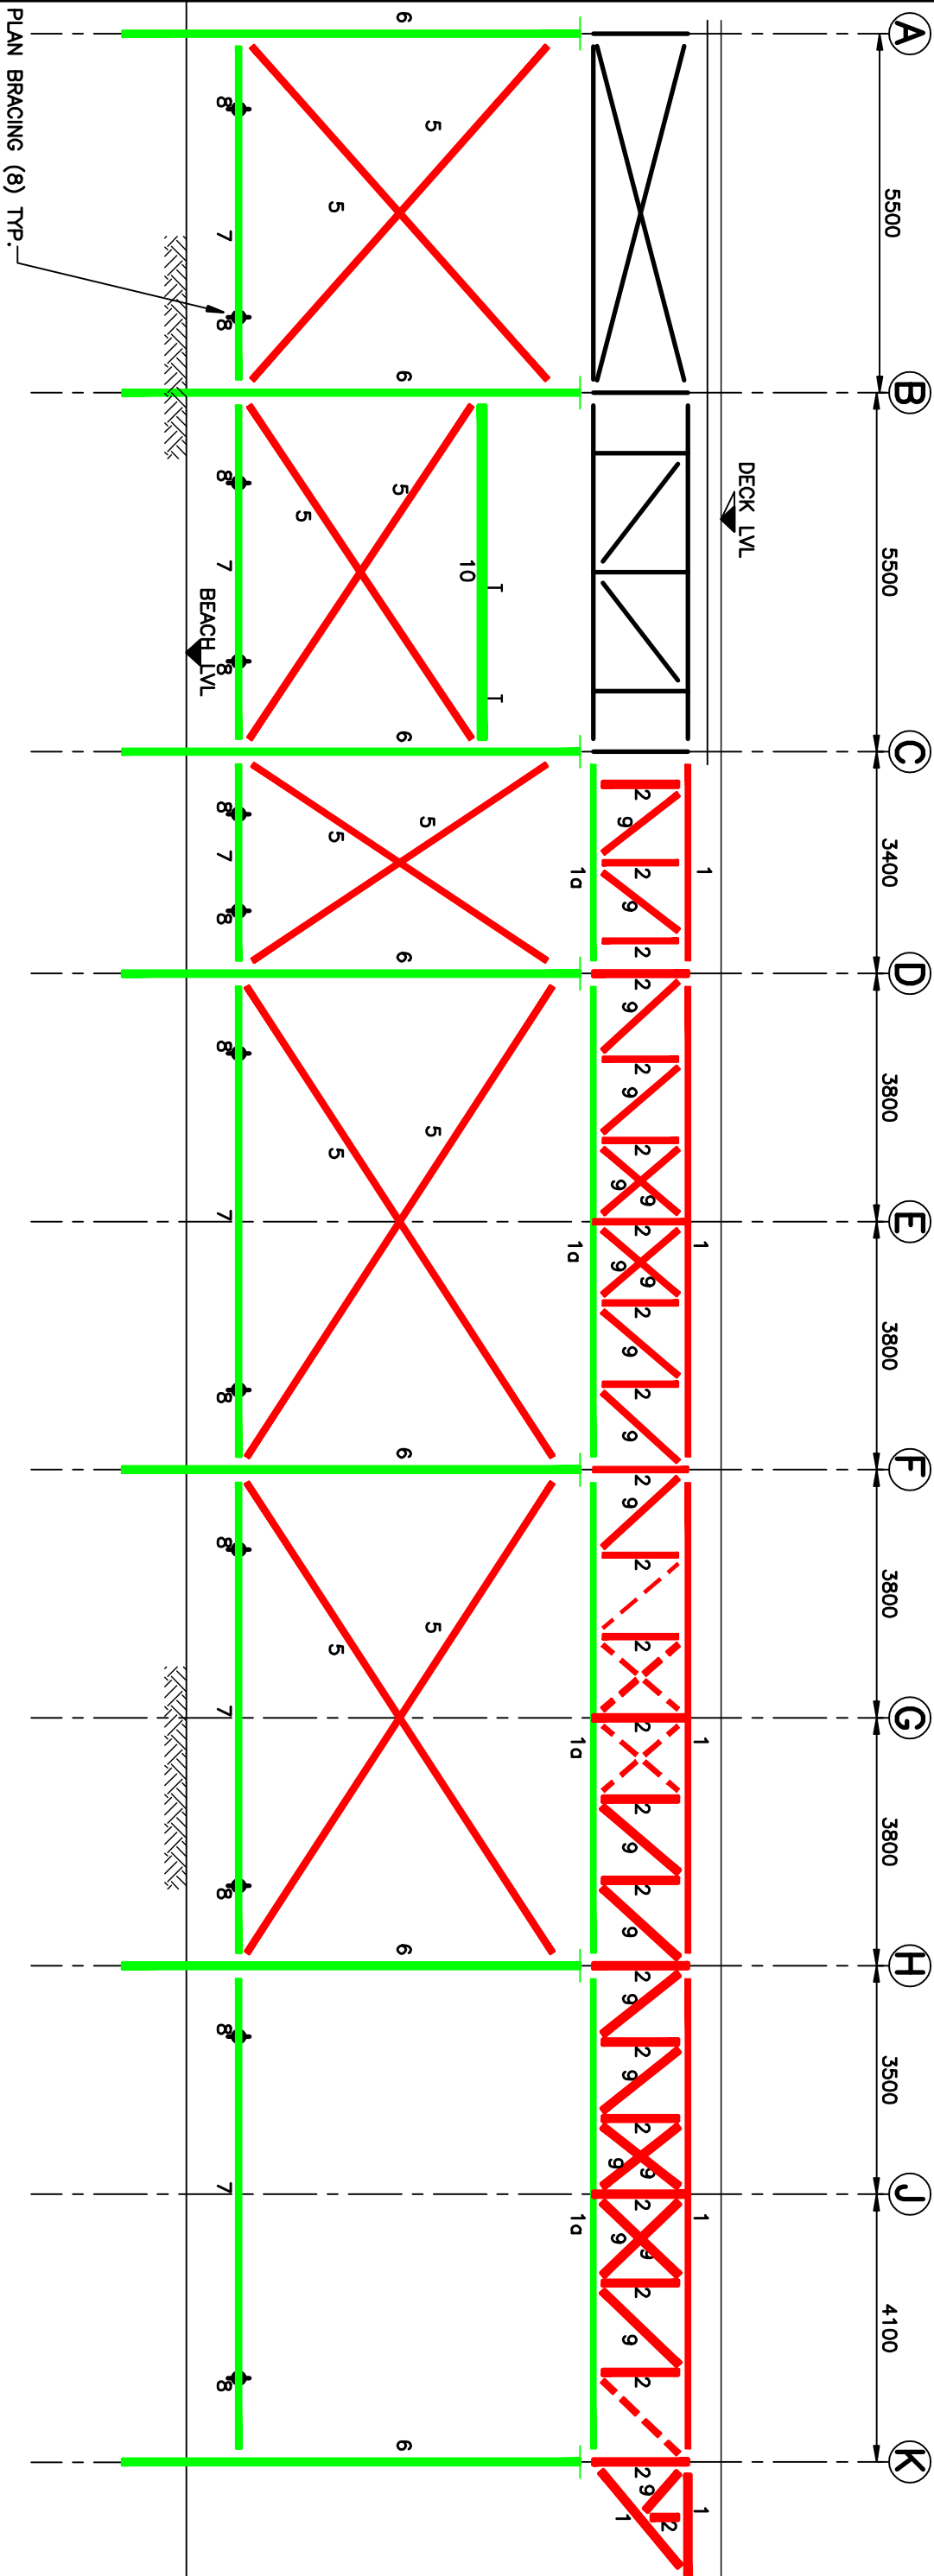
OVERALL VERDICT : REPLACE GIRDER
(FAILURE PREDOMINANTLY OBSERVED DURING VISUAL INSPECTION)
