**ASBESTOS SURVEYING TRAINING & REMOVAL ASSOCIATION**  
**ASTRA HOUSE WHITEHART MEADOW MIDDLETON MANCHESTER M24 2GA**

<b>SURVEY DATE</b>	13.02.12 – 15.02.12
<b>SURVEYOR(S)</b>	Adam Roche
<b>CLIENT</b>	ARTEZ LIMITED
<b>SURVEY REF</b>	Report ref: AR/BROD/AR/1
<b>ADDRESS</b>	Bradford Odeon Cinema, Quebec Street, Bradford, BD1 2ER
<b>SURVEY TYPE</b>	<u>UPDATE TO THE MAJOR REFURBISHMENT/PRE-DEMOLITION SURVEY</u> <u>CARRIED OUT IN MAY 2008 REF:RWB/A1/24162N</u>

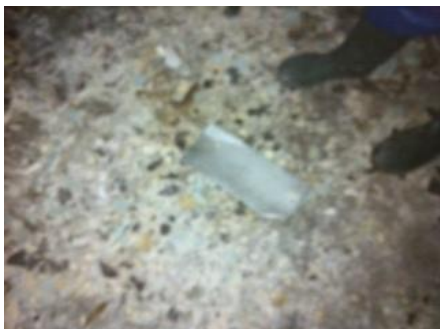
Sample Number	I.D Colour	001	Location	Product Type

First Floor Corridor next to Fridge Room	Board Debris
			Quantity/Extent	Analysis Result
			<1m <sup>2</sup>	Amosite & Chrysotile
Material Assessment Algorithm		Score	Comments	
Product type (1-3)		2	The asbestos insulating board debris is in a poor condition and must be removed along with all the other identified asbestos materials within the previous report by a licensed asbestos removal contractor.	
Damage/Deterioration (0-3)		3		
Surface treatment (0-3)		3		
Asbestos Type (1-3)		2		
Recommendations				
		Licensed Work	X	Action Date
		Non Licensed Work		Reinspection Date
				June 2012
				June 2012

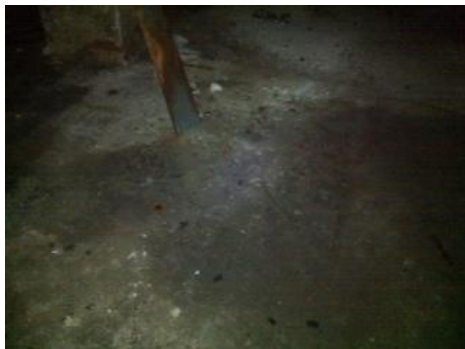
Sample Number	I.D Colour	002	Location	Product Type

Basement Passage Floor Area below Concrete Ceiling Area	Insulation Debris
			Quantity/Extent	Analysis Result
			<1m <sup>2</sup>	NADIS
Material Assessment Algorithm		Score	Comments	
Product type (1-3)		0	No Asbestos Detected In Sample	
Damage/Deterioration (0-3)		0		
Surface treatment (0-3)		0		
Asbestos Type (1-3)		0		
Recommendations				
No Action Required		Licensed Work		Action Date
		Non Licensed Work		Reinspection Date

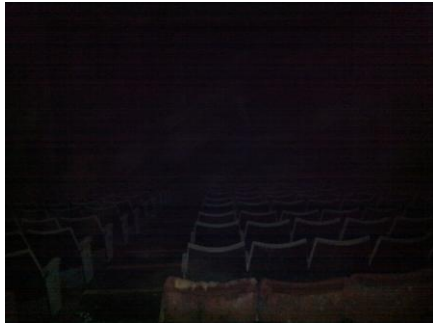
Sample Number	I.D Colour	004	Location	Product Type

First Floor Cinema 1	Sprayed Coating to Ceiling
			Quantity/Extent	Analysis Result
			900m <sup>2</sup>	Chrysotile
Material Assessment Algorithm		Score	Comments	
Product type (1-3)		1	The asbestos spray coating was sampled at 6 points and pooled together into one sample. It was noted that some areas of damage had occurred. The sprayed coating must be removed by a licensed asbestos removal contractor.	
Damage/Deterioration (0-3)		2		
Surface treatment (0-3)		3		
Asbestos Type (1-3)		3		
Recommendations				
	Licensed Work	X	Action Date	June 2012
	Non Licensed Work		Reinspection Date	June 2012

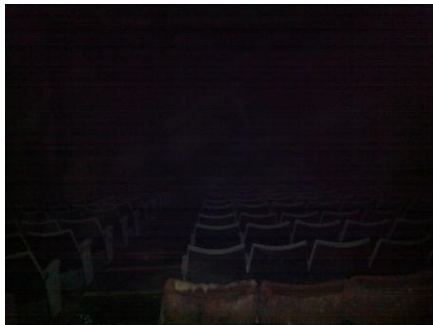
Sample Number	I.D Colour	AWS004	Location	Product Type

First Floor Cinema 1	Sprayed Coating Debris to Chairs and Carpeted Floor
			Quantity/Extent	Analysis Result
			100m <sup>2</sup> over the 900m <sup>2</sup> area	Chrysotile
Material Assessment Algorithm		Score	Comments	
Product type (1-3)		1	The asbestos sprayed coating debris was found on chairs and the floor in various areas over the whole cinema area. The debris has been caused by leaks from the roof above the backing to the sprayed coating has absorbed the moisture and fallen from the ceiling. The sprayed coating debris must be removed by a licensed asbestos removal contractor.	
Damage/Deterioration (0-3)		2		
Surface treatment (0-3)		3		
Asbestos Type (1-3)		3		
Recommendations				
	Licensed Work	X	Action Date	June 2012
	Non Licensed Work		Reinspection Date	June 2012

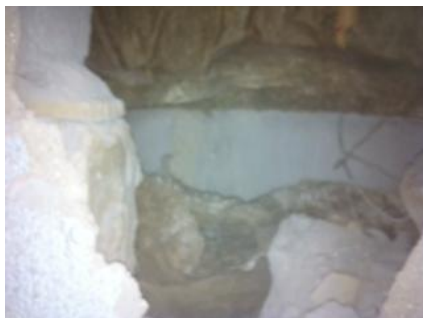
Sample Number	I.D Colour	006	Location	Product Type

First Floor Cinema 1		Paper Lining to Pipe Work Insulation	
	Quantity/Extent		Analysis Result	
	30lm		NADIS	
Material Assessment Algorithm		Score	Comments	
Product type (1-3)		0	No Asbestos Detected In Sample	
Damage/Deterioration (0-3)		0		
Surface treatment (0-3)		0		
Asbestos Type (1-3)		0		
Recommendations				
No Action Required	Licensed Work		Action Date	
	Non Licensed Work		Reinspection Date

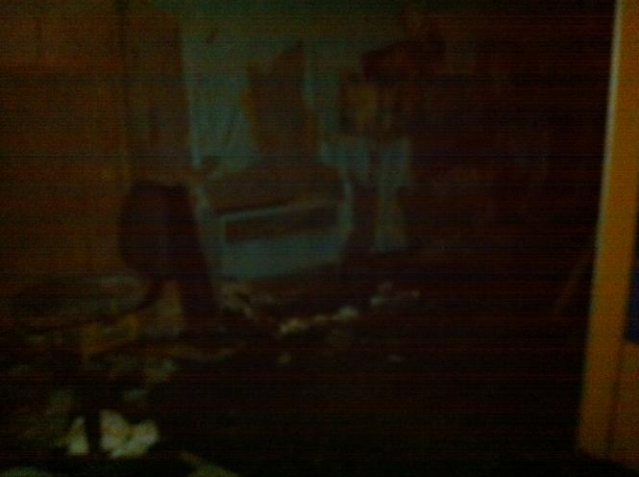
<p><b>AIB Debris from damaged area of ceiling in Basement Plenum Chamber</b></p>	<p><b>Woven pipe work insulation above non asbestos pipe work insulation in Basement Plant Room</b></p>

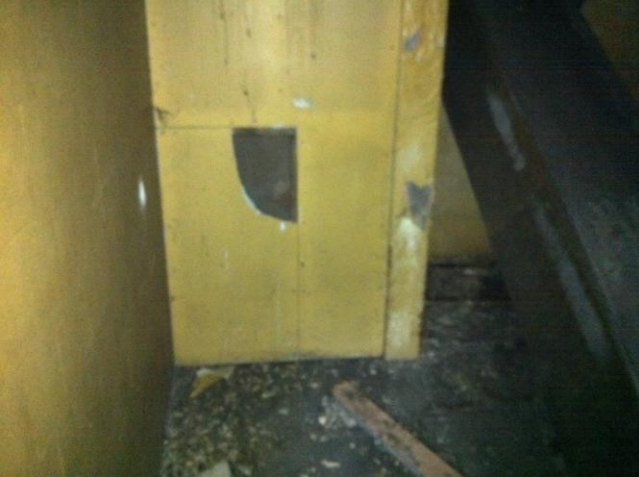
<p><b>The internal AIB linings to the heater within the Ground Floor Foyer</b></p>	<p><b>The highly damaged internal AIB linings to the heater within the Ground Floor Foyer</b></p>

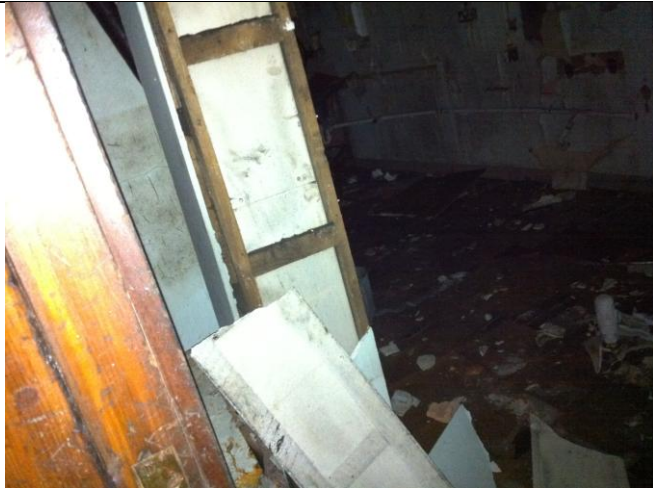
The ground floor level the asbestos insulation board ceiling panelling to the switch room 0/004/02 has been damaged due to vandalism. As you carry on through the sprayed coating to the ceiling 0/010/01 within the bingo hall has been penetrated in various areas to access above this was re-sampled and proven to be negative for asbestos content.

<p><b>The Ground Floor Bar Area. AIB debris and loft hatches above.</b></p>	<p><b>AIB ceiling to Floor Switch Room. Vandal damaged.</b></p>

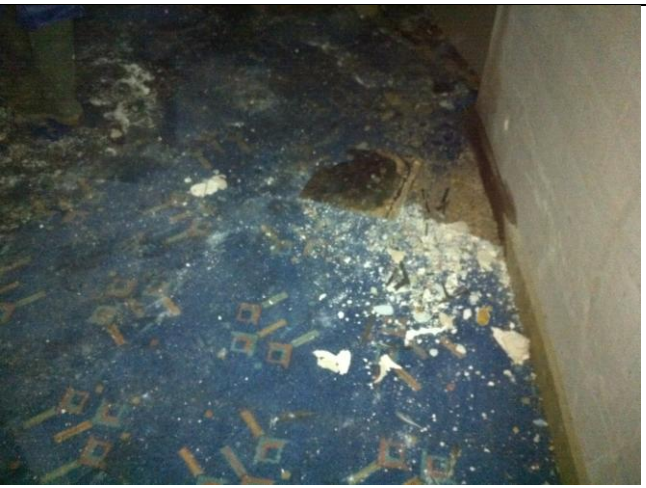
<p><b>First Floor Upper Foyer damaged heater lining</b></p>	<p><b>First Floor Store Room AIB panelling to column highly damaged</b></p>
