STAGE 1 ROAD SAFETY AUDIT REPORT FOR 111644: FOOTBALL STADIUM AND TRAINING FACILITIES AT KINGSFORD, ABERDEEN

Report Ref 40817(1) Rev C

111644: Football Stadium & Training Facilities, Kingsford, Aberdeen.
Road Safety Audit Stage 1

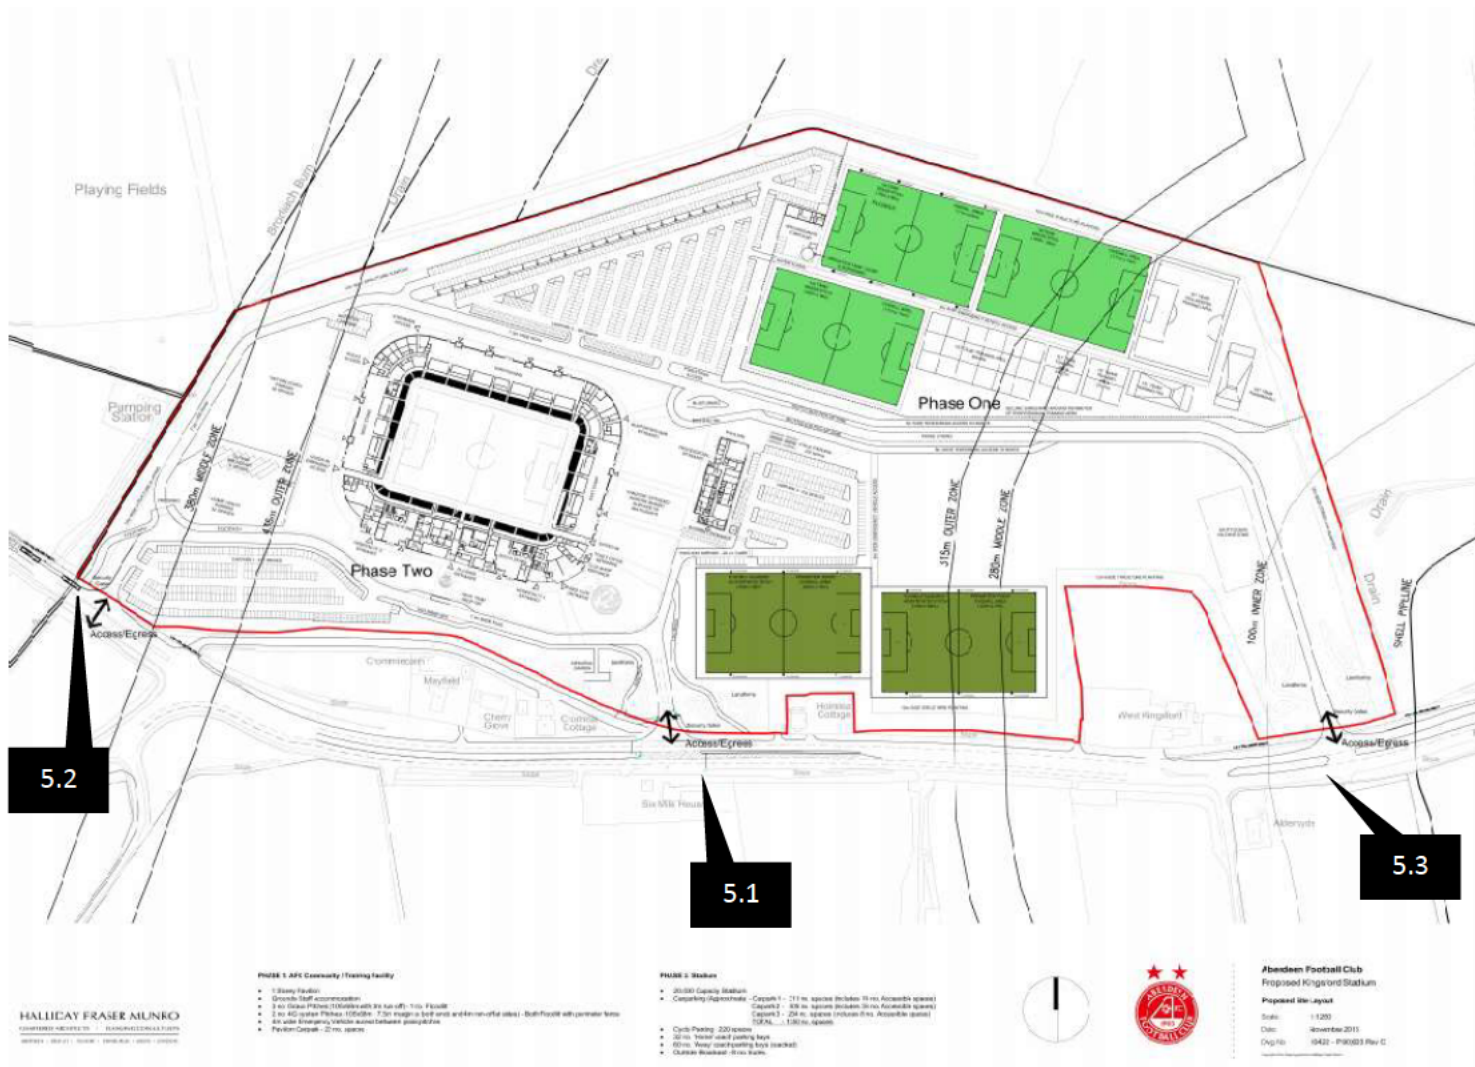
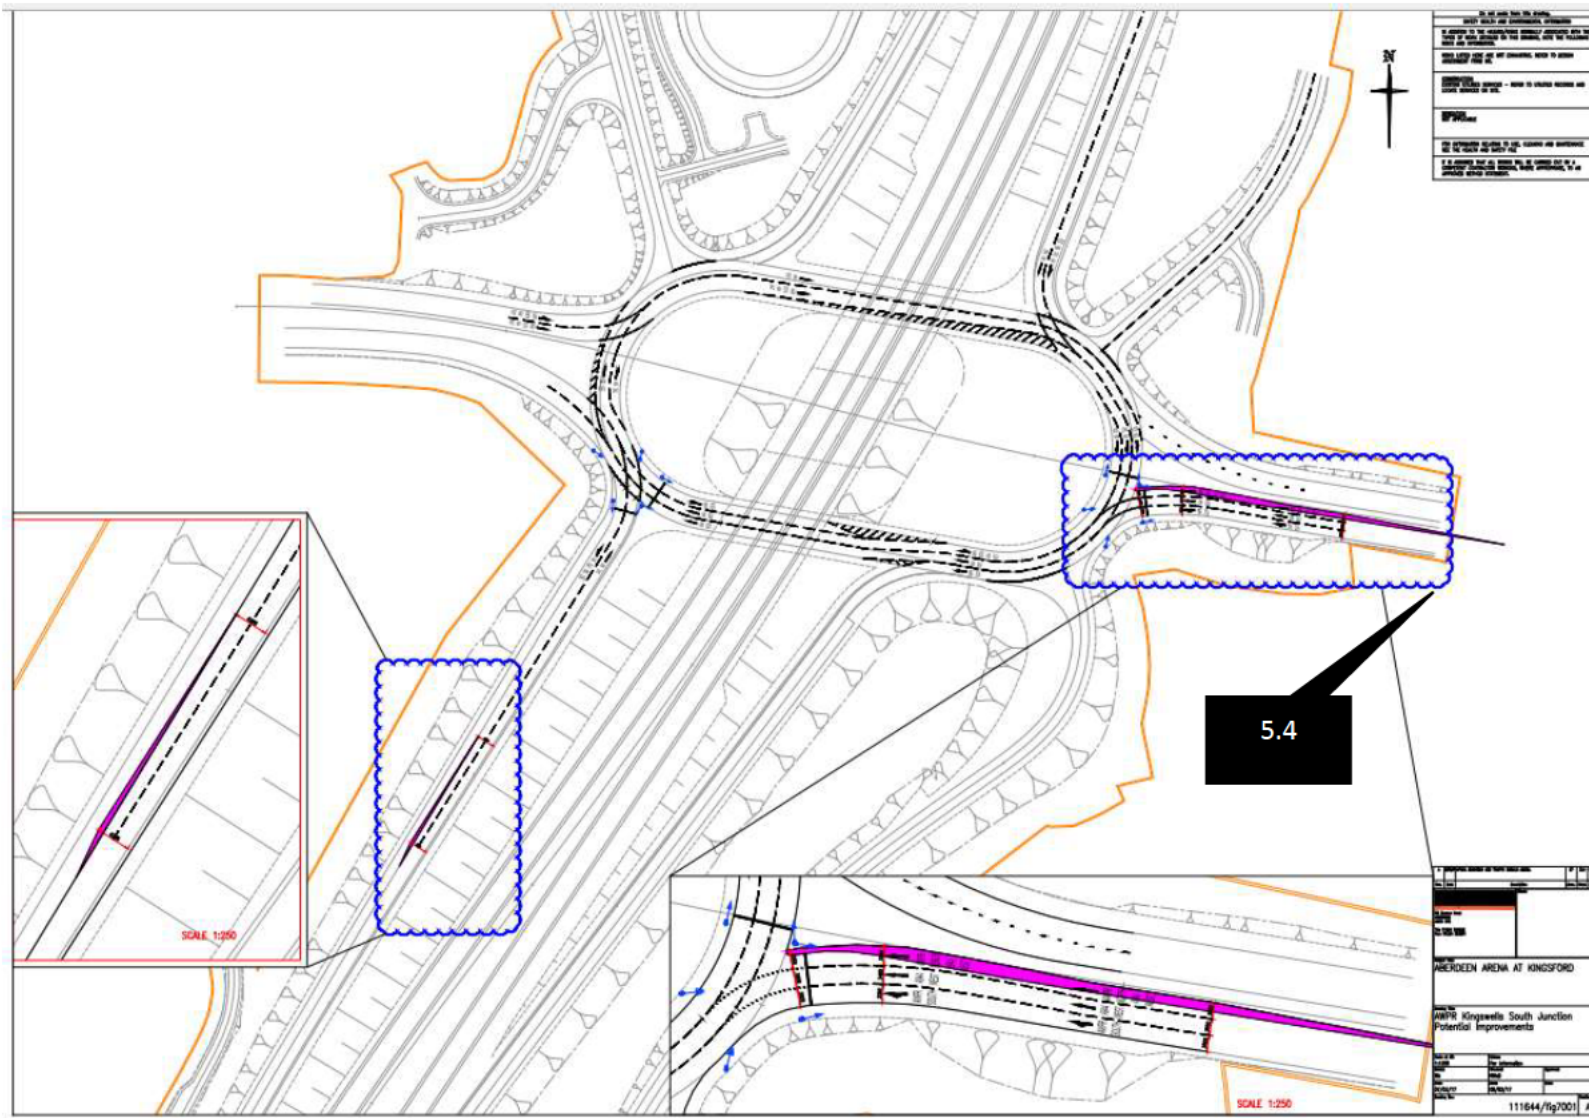
Appendix A. Location Plan of Problems

5.1 PROBLEM

Location A944 Main Entrance and approaches.

Summary Risk of serious side impact collision.

The activation of the part-time traffic signals at the stadium and the deployment of temporary traffic management measures on match days will require bollards to be removed from the central reservation, and signs altered in the central reservation and verges on both A944 approaches.

Manually carrying out these tasks requires workers to cross the A944 and work within the central reservation. This exposes them to the risks of being struck by a vehicle.

The continual installation and removal of temporary bollards will no doubt lead to excessive wear of the bollards and likely loss or misplacement of them. Through time it should be anticipated that some bollards will get broken or lost and the gap in the central reservation will not be securely closed during non-match days. The recommended route for westbound traffic to enter the site on non-match days is to drive past the site, through the signalised A944/B9119 junction and carry out a U-turn at the Arnhall roundabout, then back through the signalised junction before turning left into the site. An opened central reservation gap at the main entrance will tempt some drivers to avoid the recommended route and turn right through the gap and across the eastbound traffic flow. This will increase the possibility of a serious side impact collision with eastbound traffic who will not be expecting traffic to turn across their path.

5.2 PROBLEM

Location A944 and west entrance.

Summary Risk of pedestrian injury collisions.

Arnhall Business Park can provide car parking spaces during match days as well as bus stops for public bus services. Drawing 111644/sk8013 also shows a length of Venture Drive being used for as a Taxi drop-off and pick-up area. This has the potential to generate over 1800 pedestrians walking eastwards from the business park to the stadium, and returning after the game. Pedestrians will want to take the most direct path, which is likely to be from Venture Road and along the A944 dual carriageway to a crossing point near the stadium. Guardrail will contain the pedestrians to the footway. Drawing No 111644/sk8013 shows a demountable length of pedestrian guardrail opposite the entrance to the stadium. Further east there is a controlled Toucan crossing facility within the signalised A944 / B9119 junction.

It is proposed that when pedestrian flows are highest during match days the demountable barrier is removed to allow pedestrians to cross the A944 towards the stadium. This will create an uncontrolled crossing of a 40mph dual carriageway.

The uncontrolled crossing of the A944 dual carriageway by large numbers of pedestrians will present a risk of pedestrian and vehicle collisions. Pedestrians stepping out into the path of approaching vehicle will lead to sudden braking and shunt type collisions which may result in pedestrian injuries.

5.3 PROBLEM

Location A944 near east access.

Summary Risk of vehicle strike with redundant roadside furniture.

Near the east access there are existing signs that warn of cattle crossing. As the field to the north of these signs is to be developed there may no longer be a need for cattle to cross the A944. Redundant signs are an unnecessary distraction to drivers as well as being a roadside hazard that any errant vehicle could hit.

5.4 PROBLEM

Location A944 eastbound approach to AWPR Kingswell South junction.

Summary Risk of side swipe collisions due to late lane changing.

During periods of traffic queuing the road markings will be obscured by queuing vehicles and drivers will have inadequate advance notification of the lane destinations. This will result in late or sudden lane changing manoeuvres which can contribute to low speed side impact or shunt type collisions.

1. The bollards or barriers that close the central reservation gap are of a type that can be activated by a remote electronic switch, thereby removing the risk associated with having workers and vehicles in the central reservation.
2. That the advance signs that warn of when the traffic signals are operating and of the temporary lane destination are of an electronic type that can be operated remotely.

1. The preferred pedestrian route from Arnhall Business Park to the stadium is from Venture Road, along the south footway of the A944 to the controlled Toucan crossing at the signalised junction of the A944 and B9119.
2. Only when pedestrian flows are likely to exceed the capacity of the Toucan crossing should the demountable barriers be removed and the uncontrolled crossing activated. The operation of the uncontrolled crossing will require the assistance of the match day Police who will have powers to stop traffic. A

operational procedures plan must to be put in place which includes a risk assessment and training of stewards.

It is recommended that all redundant signs are removed.

It is recommended that the advance direction signs are altered to reflect the 3 lane approach and their destinations.
