Part 1/2					
Report J462720/FA03	Date: 01 Sep 2018	3			
Client Name					
Address			1		
	ation for contract				
Name, address and contact informa	ation for contractor				
Site address for clearance				nool, Kedward Avenue, Middlesbrough, Clevelan	
Detail scope of works in method sta and brief description of works i.e. A			e Clearance fol Area 03.	lowing Environmental clean under fully controlled	conditions
insulation/cement	spray coating	to Loit	Alea 05.		
STAGE 1 OF 4 - PRELIMINARY S	SITE ASSESSMENT				
Plan of work defines entire working		Yes	Hygiene faciliti	es operating and clean	Yes
Removal of specified asbestos com				nd area surround enclosure clean	Yes
Enclosure and air locks intact and d		Yes	Waste route/sl	kip area clean	Yes
Air extraction unit operating		Yes	Are viewing pa	nels present	
ewing panels present			<u> </u>		
					Yes
STAGE 1 RESULTS			T		
PASSED			Date & time of	inspection: 01 Sep 2018 09:24

SITE: Brambles Primary School Kedward Avenue	CONTRACTOR:	DATE: 01 Sep 2018		
Middlesbrough Cleveland TS3 9DB		ANALYSIS LOCATION: Site

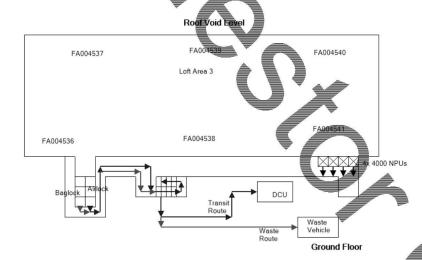
Enclosure Width: 7m Enclosure Length: 25m Enclosure Height: 3.5m
