CERTIFICATE OF REOCCUPATION

Report	J462720/FA01	Date: 23 Aug 2018	Time arrived on site: 13:30
Client Name			
Address			
Name, address and contact information for contractor			
Site address for clearance	Brambles Primary School, Kedward Avenue, Middlesbrough, Cleveland, TS3 9DB		
Detail scope of works in method statement areas to be assessed and brief description of works i.e. AIB/ spray coating insulation/cement	4 Stage Clearance to loft Area 2A following environmental clean of Area

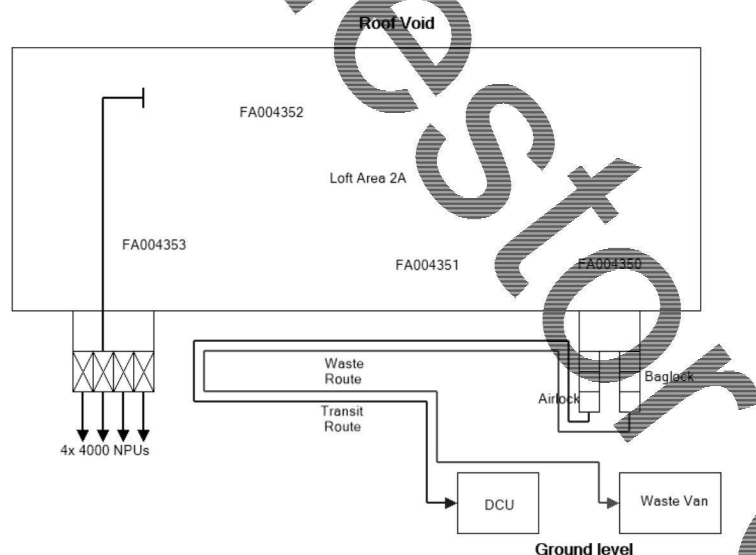
Enclosure Width: 12m Enclosure Length: 25m Enclosure Height: 2m
