**From:** [REDACTED]  
**Sent:** 04 January 2019 16:17  
**To:** [REDACTED]@uuplc.co.uk; [REDACTED]@uuplc.co.uk  
**Cc:**  
**Subject:** Fernilee Reservoir route specification  
**Attachments:** Notes from site visit to Fernilee Reservoir with Rob Meetham.docx  
**Importance:** High

**Notes from site visit to Fernilee Reservoir, SWPLP Scheme Manager and PDNPA Landscape Architect, on 3 January 2019**

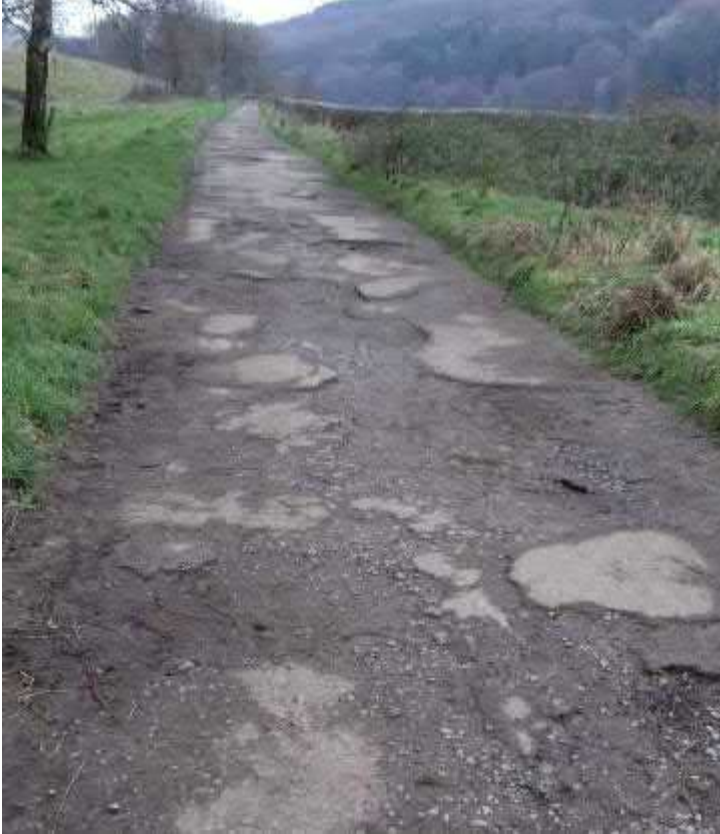
Car park at northern end of the route is well surfaced, leading to the start of a tarmac road (this is a private road which does have vehicular access for reservoir maintenance), the first 35.5m is fine, but it then starts to break up into significant potholes.

Potholed section of road = 297.5m in length, width = 3.2m with kerb stone edging, which is mostly grown over, this needs scraping back to expose the edging.

Potholes need filling and whole section needs re-surfacing suitable for vehicular use, using materials appropriate to the site (e.g. tarmacadam).

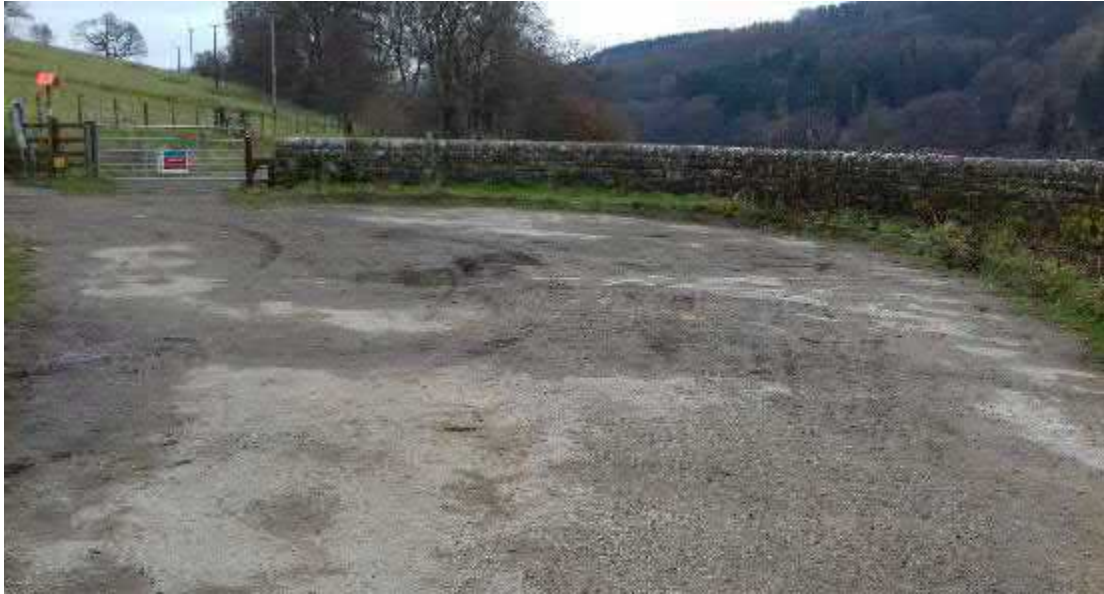
The road widens out to large 'turning area' at the end of this section.

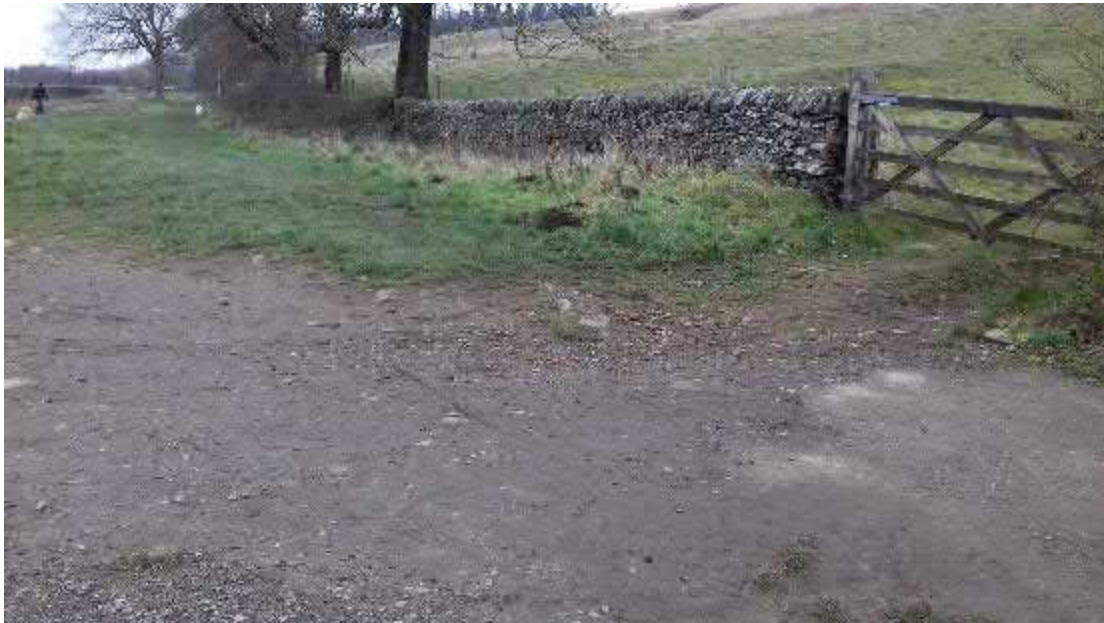
Turning area leads to a farm track (not a public right of way) need to ensure suitable edging between re-surfaced road and this track.

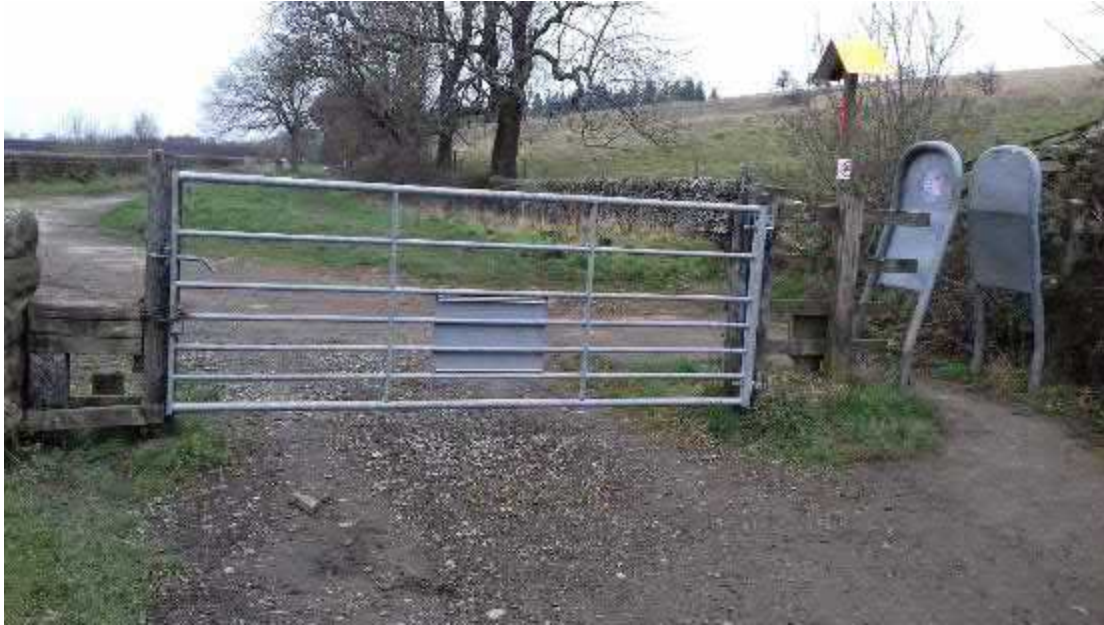
Gated barrier shown below currently comprises: dry stone wall from reservoir side, next to a small wooden stile (redundant), next to a metal vehicle gate with chain and 3 separate padlocks for different users, attached to wooden posts at either end, with a section of post and rail fencing, gas pipeline marker, adjacent to A-shaped 'squeeze barrier' to prevent trail bike usage.

**This barrier would benefit from: remove wooden stile, move vehicle gate along to abut wall, remove wooden post and rail fencing and squeeze barrier and replace with an accessible gate with radar key access for wheelchairs and pushchairs. Suggested product:**  
<https://centrewire.com/products/woodstock-large/>

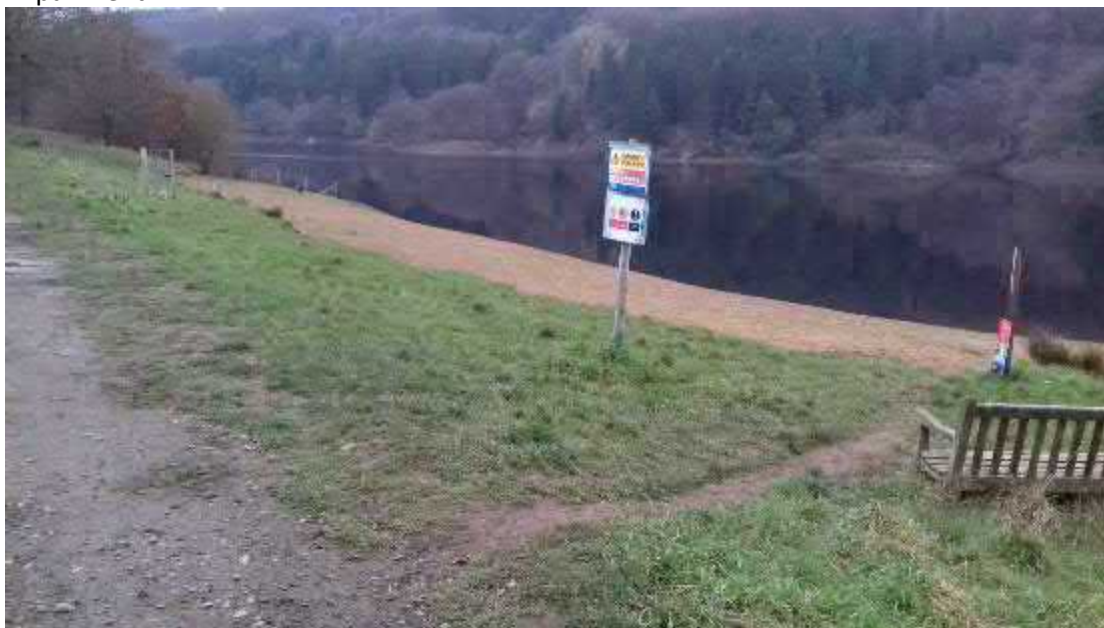
Existing benches here are off the trail and not easily accessed by people with mobility or visual impairment

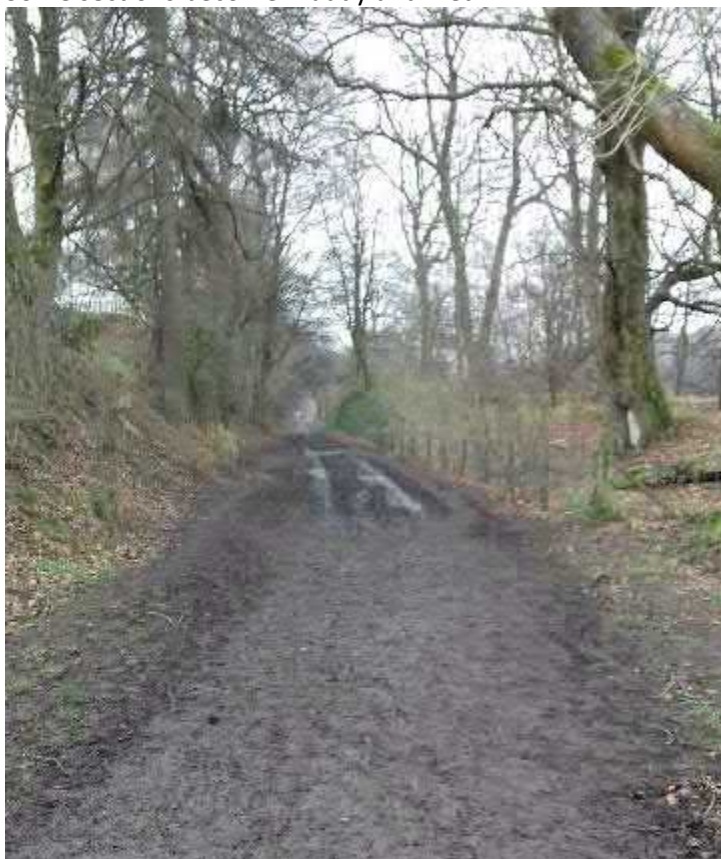
Some sections become muddy and wet

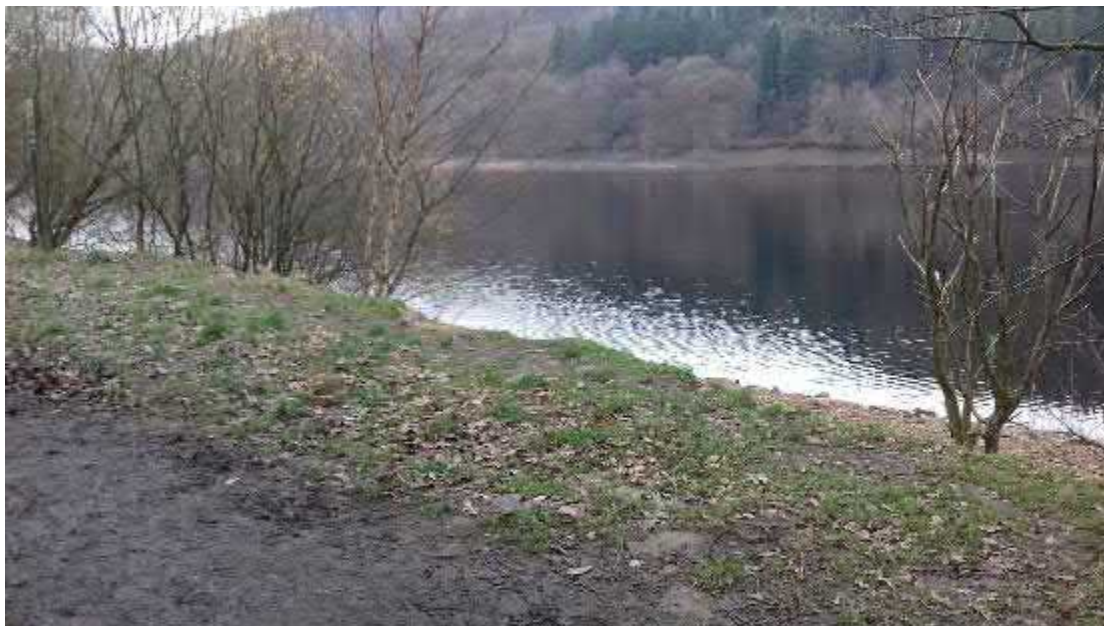
Potential to install new bench at 273m.

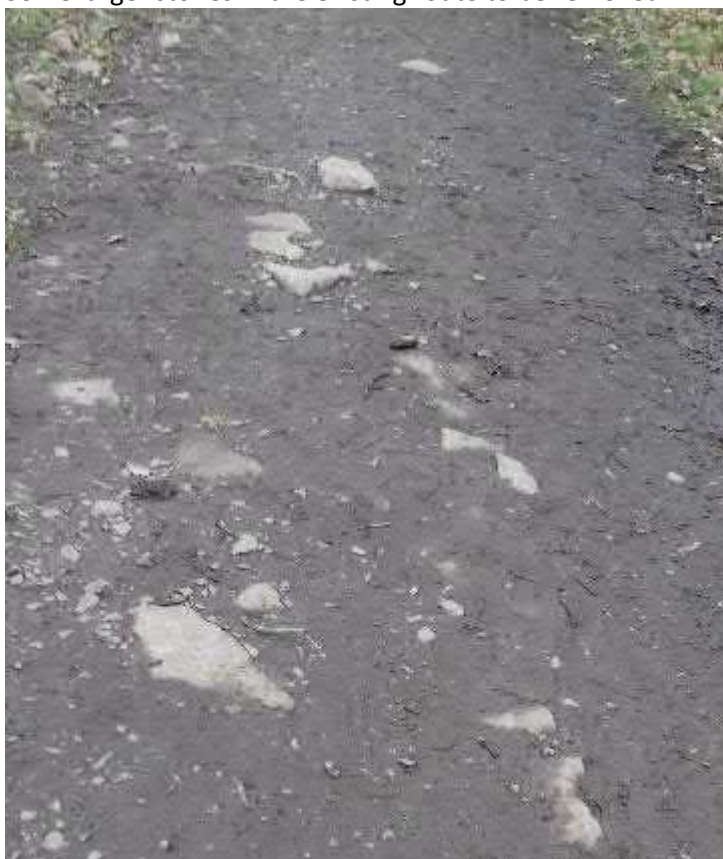
Some larger stones in the existing route to be removed

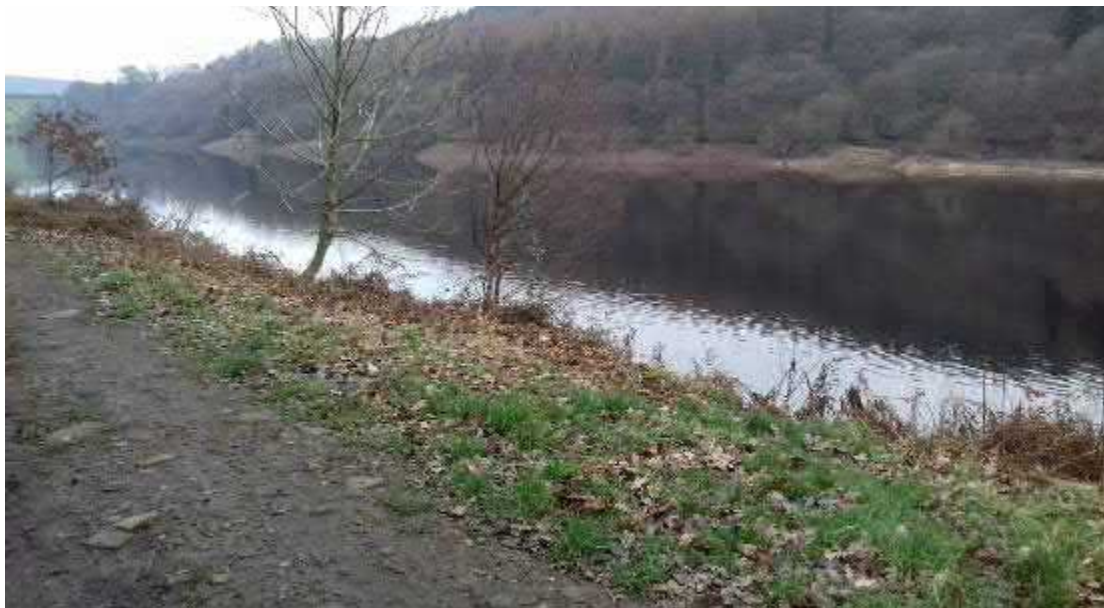
Potential to install a new bench at 402m.

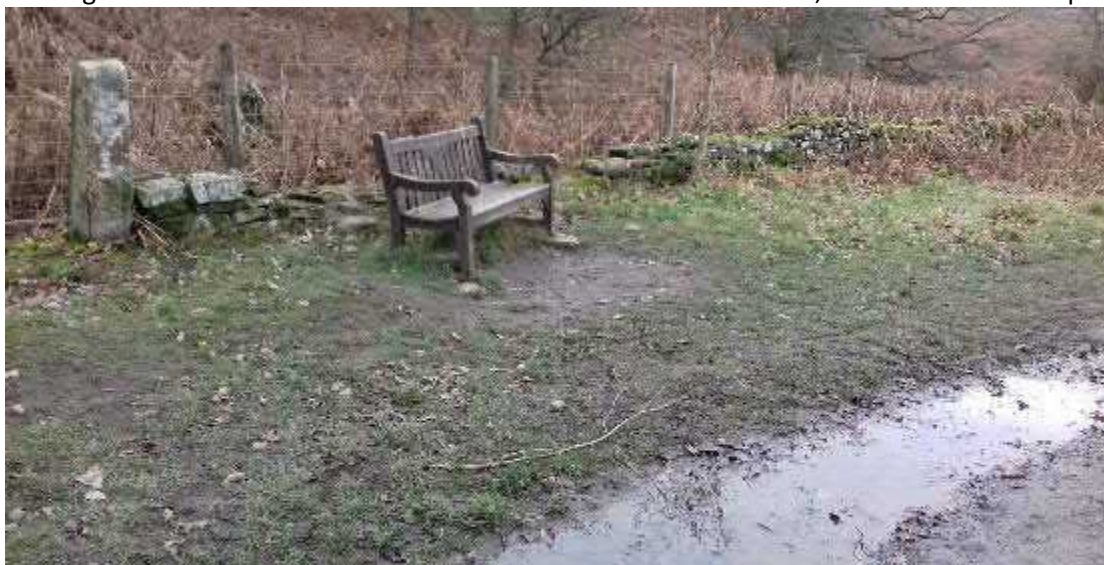
Existing bench at 493m is a memorial bench in reasonable condition, but access needs improving.

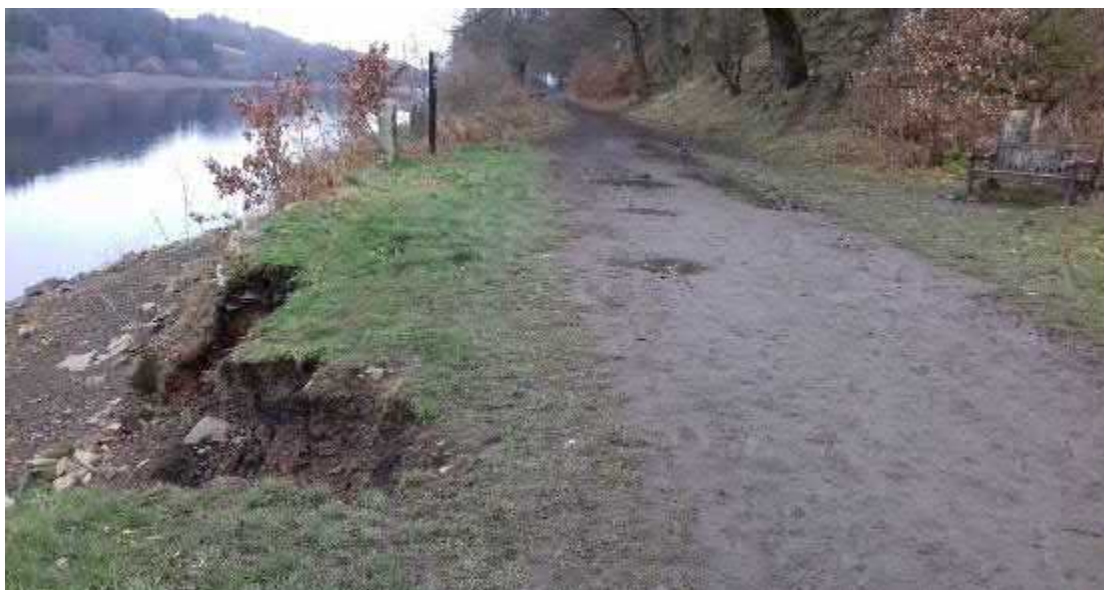
Some sections at the edge of the trail (reservoir side) are suffering erosion and should be reinforced before the re surfacing works

- Can UU do some preparatory work before the re surfacing – notably, reinforcing approx 5 areas where the edge of the trail has noticeably eroded and it seems people are using these as access points to the reservoir 'beaches' – see some examples on the attached site notes

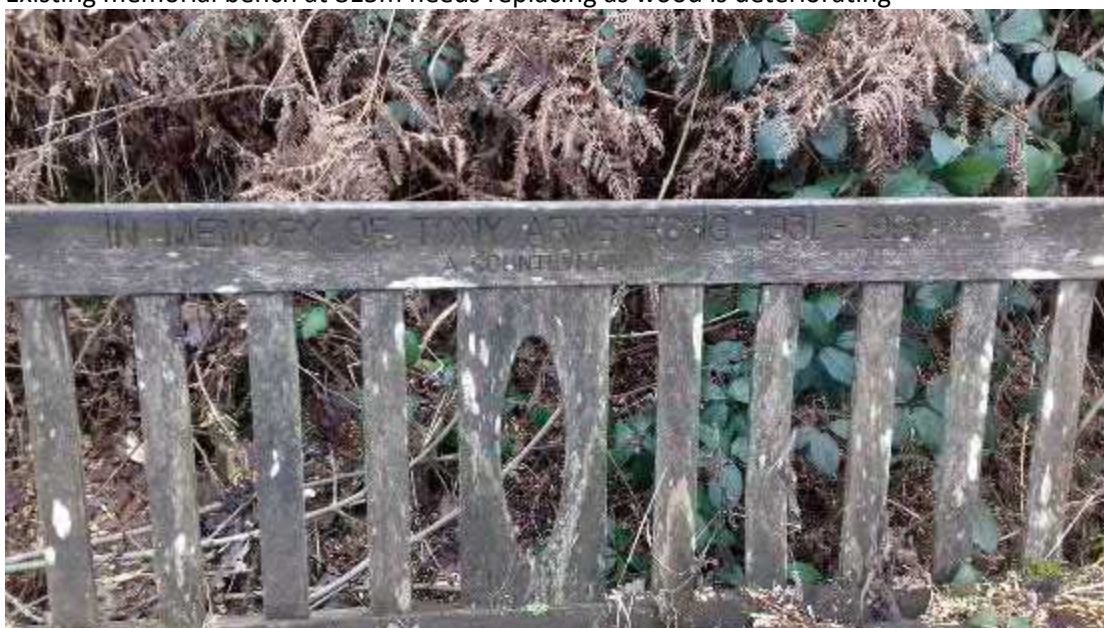
Existing memorial bench at 815m needs replacing as wood is deteriorating

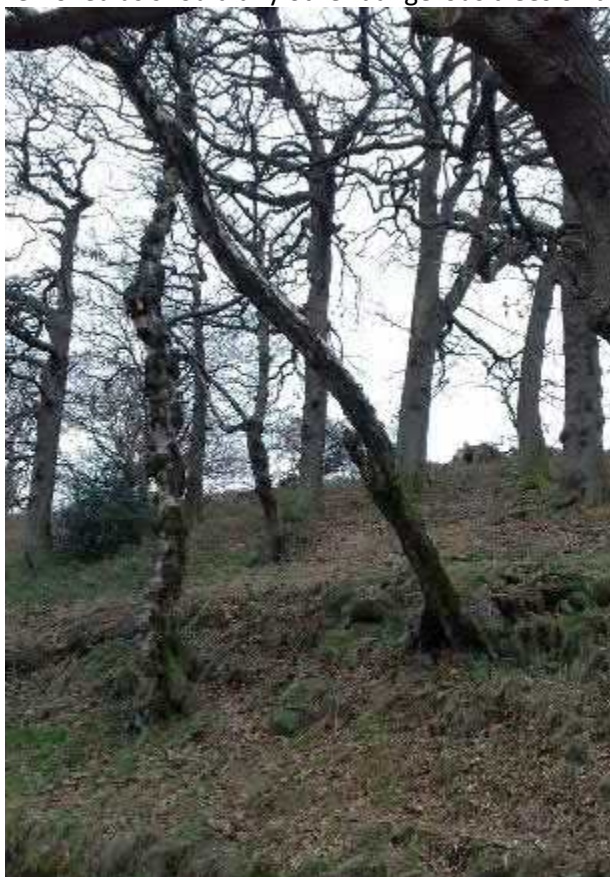
A dead birch is hung up against a branch on the eastern side of the trail at 851m. This should be removed as should any other dangerous trees or branches before re surfacing works commence

- Can UU also do some preparatory work to make safe any dangerous trees/branches on the opposite side of the trail to the reservoir – I noticed one dead birch hanging against another tree, and some rather loose looking root plates. The removal of some overhanging branches in the two areas where the trail gets very muddy would also be beneficial.

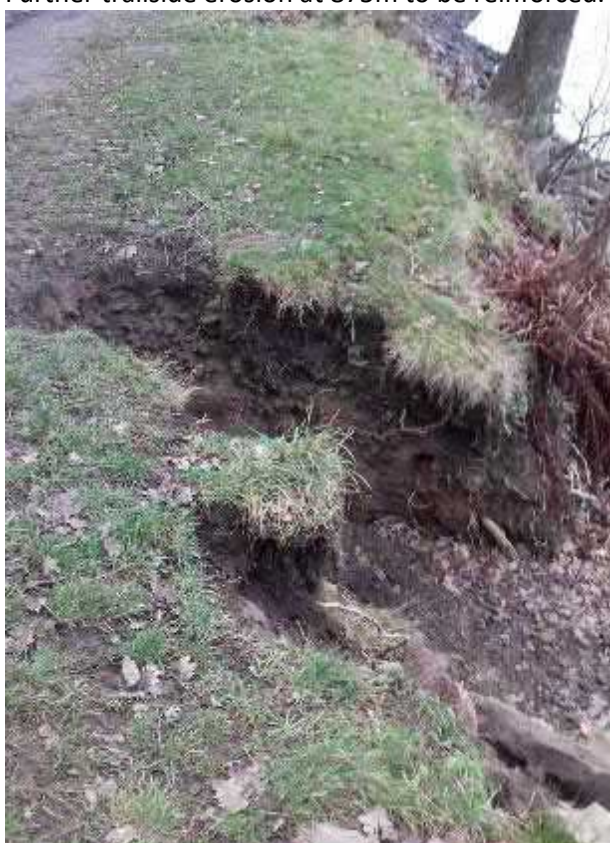
Further trailside erosion at 875m to be reinforced.

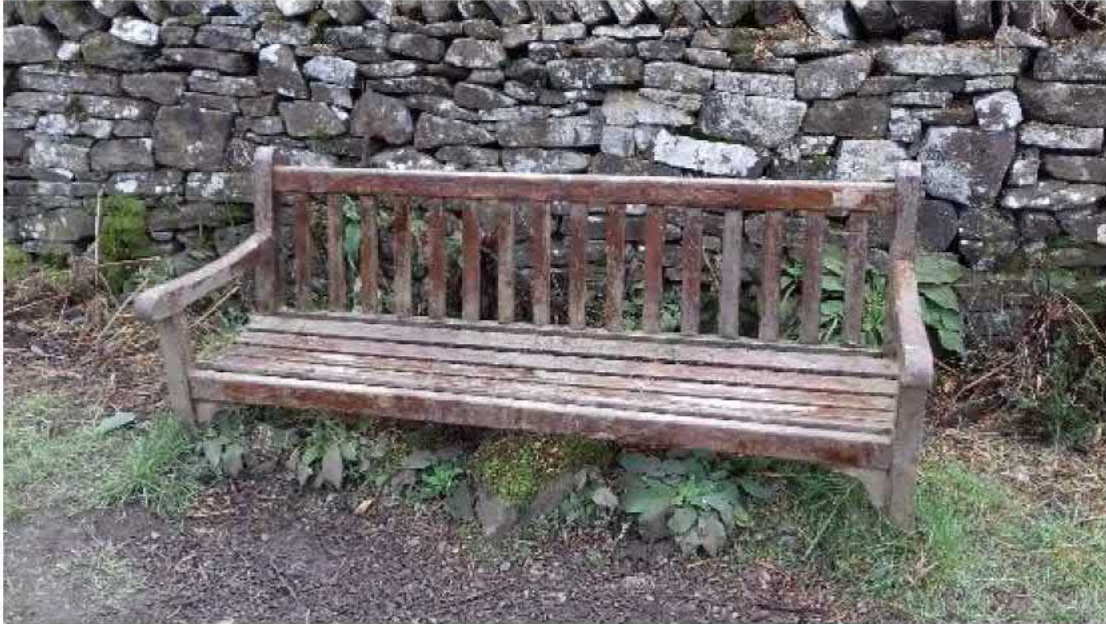
Existing memorial bench at 1024m would benefit from sanding down and re-treating to prolong its life.

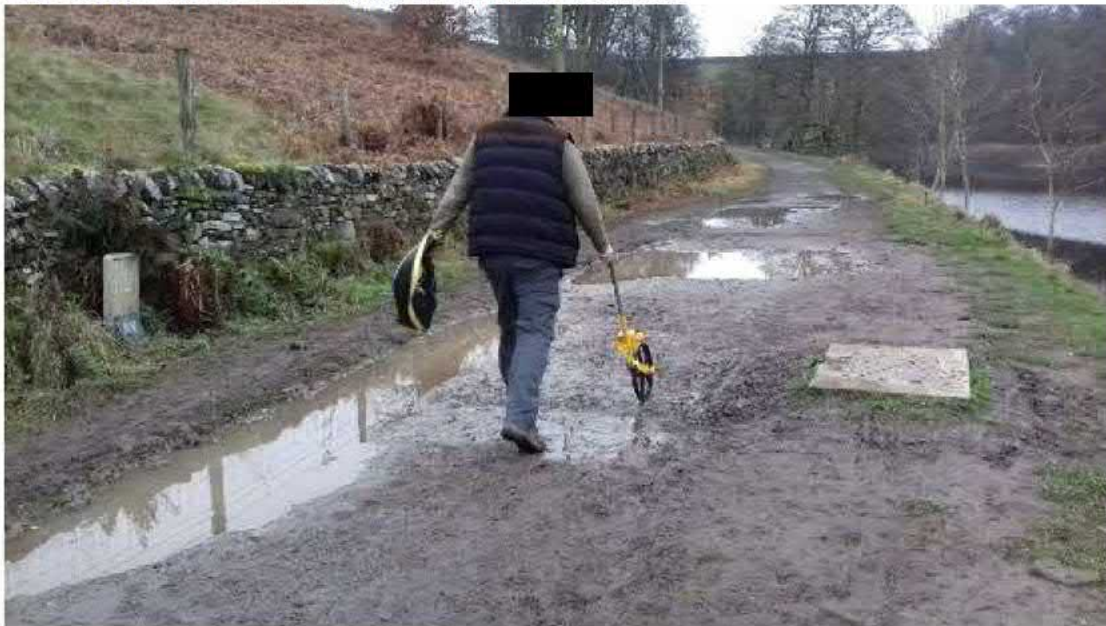
Service cover at 1124m is elevated from the trail surface.

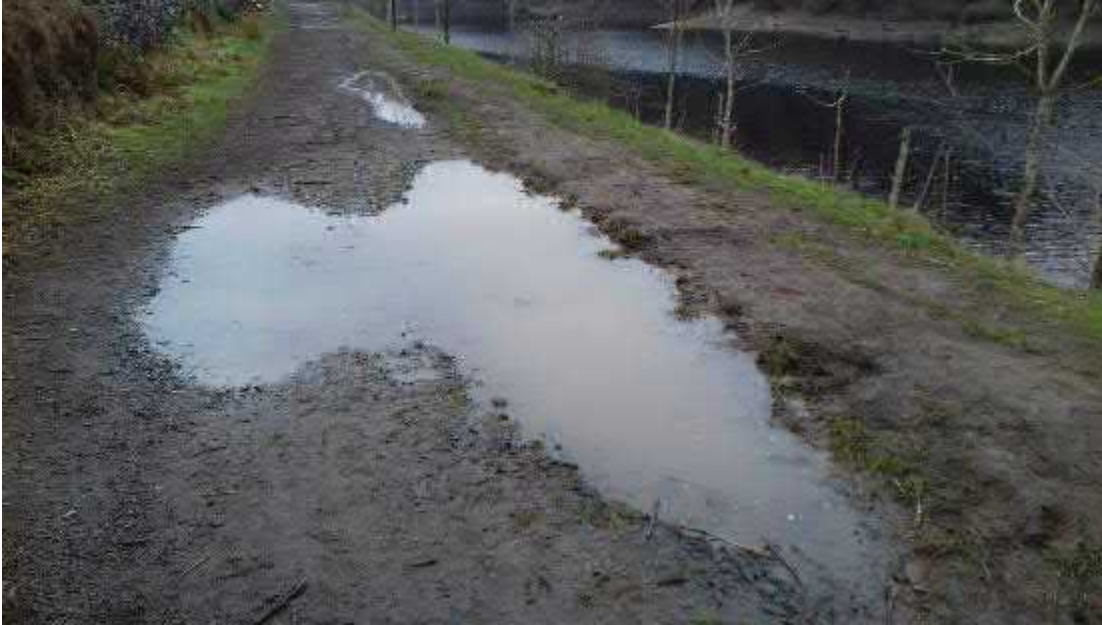
Potholes and puddles are substantial in places.

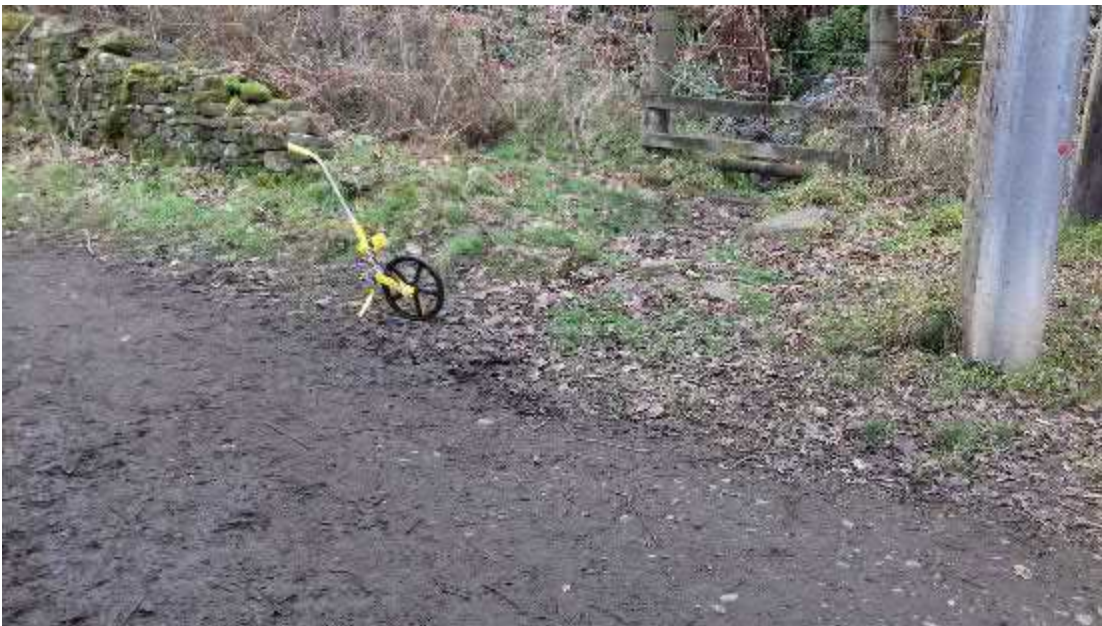
A piped culvert at 1295m is quite high beneath the current trail surface and risks overflowing, the culvert should be cleared out and the trail surface could be raised here to help prevent overspill

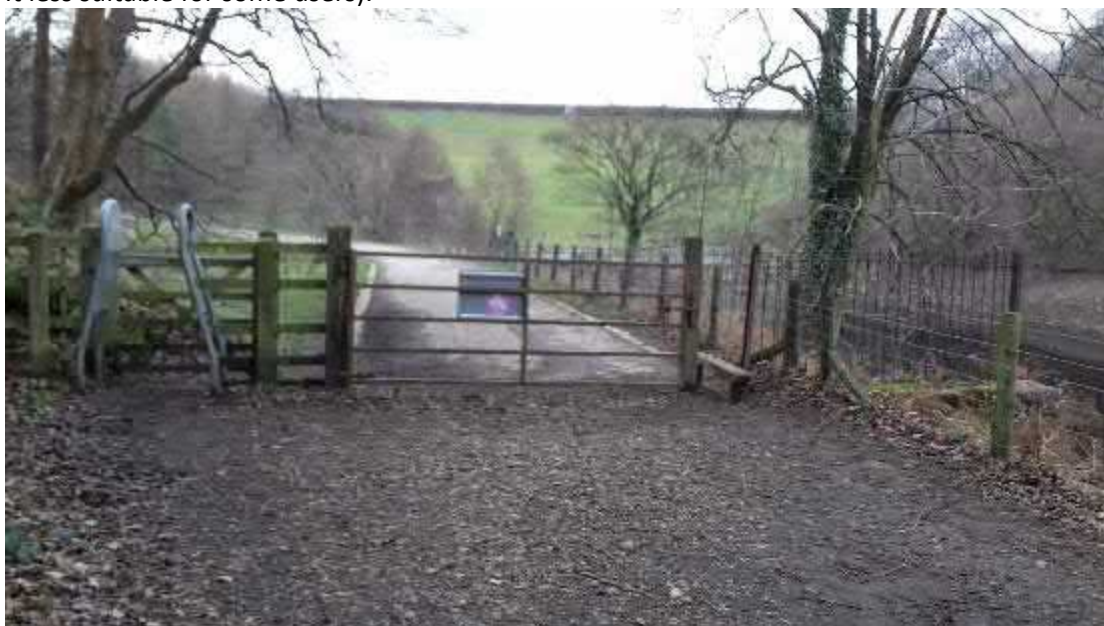
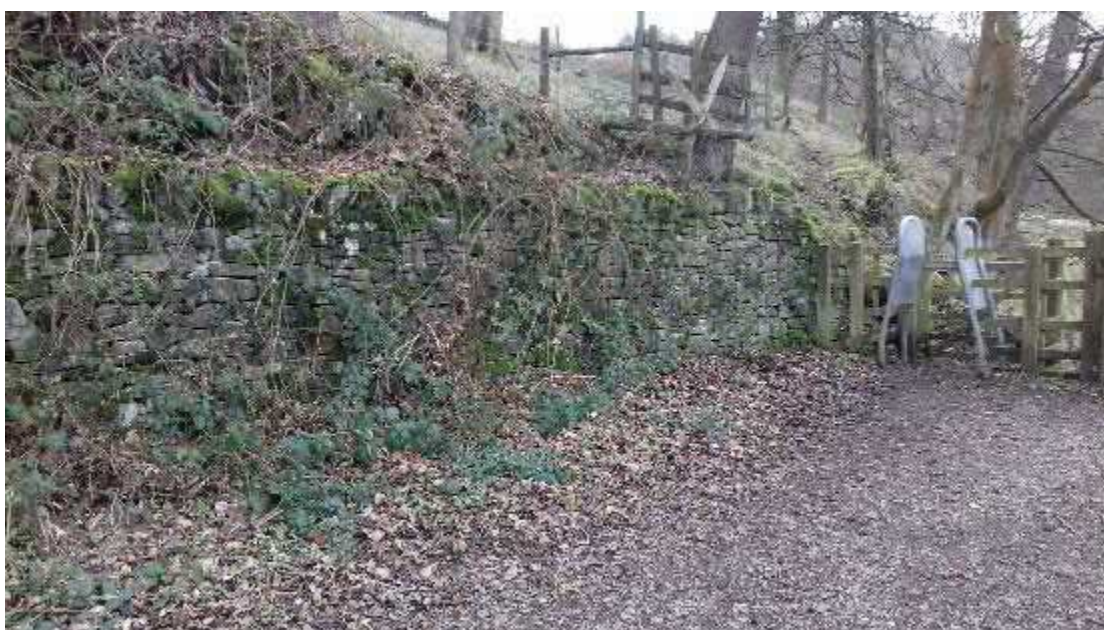
At the end of the trail, at 1343m, is a gated barrier. This is the point at which the re-surfacing will stop (the remainder of the route is adequately surfaced but also has a steep incline which will make it less suitable for some users).

**The existing barrier is very unattractive and would benefit from replacement as at the other end of the trail. A bench and some interpretation and/or artwork at this location would make this a destination point rather than a barrier to further progress for some users.**
