DU Penetrator Recovered from the Solway Firth

Recovered Depleted Uranium Penetrator

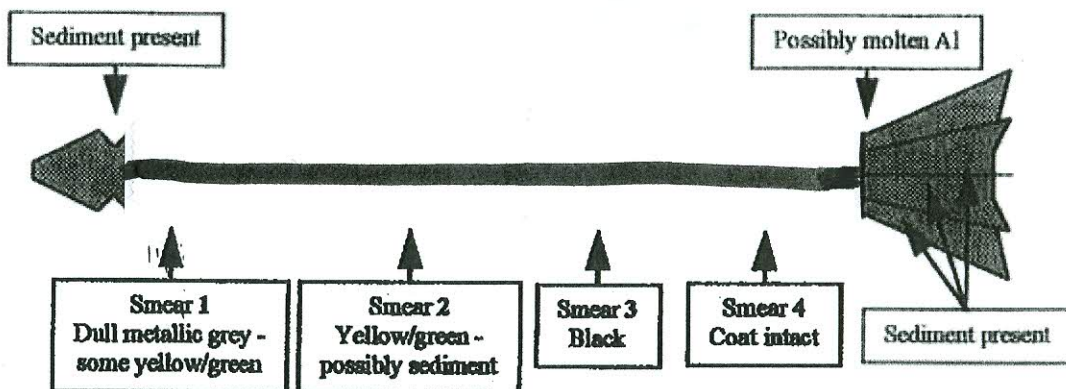
1. Please find enclosed the smears and a small sample of oxide taken from the penetrator which was recovered from the Solway over the weekend. The schematic below indicates the locations from which the smears were taken.

12. Before being sent to DRPS, the smears taken were initially screened using a Harwell solid-state alpha drawer assembly operating at 43% efficiency. All smears were taken over an area of approximately 40cm² and the results as shown below are in counts per 300 seconds net of background:

Smear 1	90 counts
Smear 2	58 counts
Smear 3	68 counts
Smear 4	37 counts
Smear 5	Nil

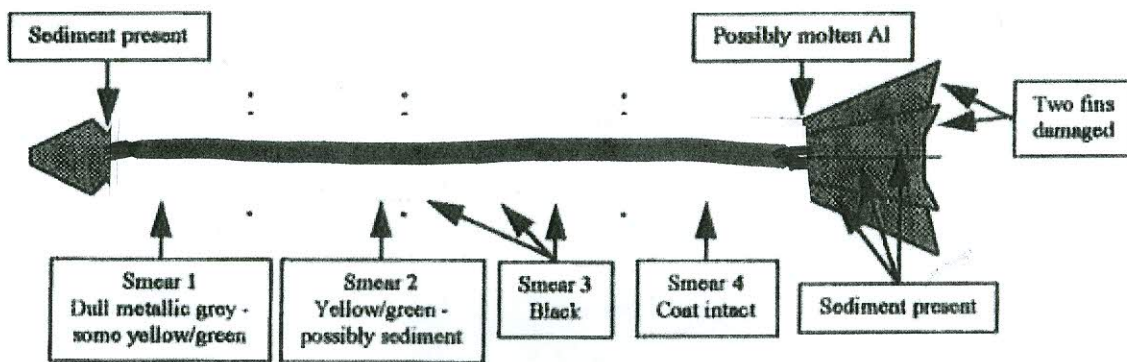
5. Overnight storage in the laboratory had allowed the penetrator to thoroughly dry out. As a result there was a noticeable but unquantifiable increase in the amount of blooming and the black oxide had lost its cohesiveness and was markedly more friable.
6. The penetrator was in remarkably good condition for something that has been fired out of a gun and into the sea where it had remained for an (as yet) undetermined period. The corrosion present is relatively light and the penetrator can be considered in five distinct regions:
7. At the front the metal is dull grey, the aluminium coating has gone and slight yellow/green oxide 'blooms' have formed. Some silt is compacted into the shoulder.

8. In front of the [redacted] area more extensive yellow/green oxide has formed and there is some silt trapped in the [redacted]
9. To the rear of the [redacted] area but in front of the [redacted] area there is more extensive oxidation. This is black and friable and there is some erosion of the DU.
10. The back end of the penetrator is still coated with aluminium - this is bright and apparently unaffected by the seawater. Between the [redacted] area and the fins there are what appear to be globules of aluminium mixed with oxidised DU, possibly caused by heating.
11. The fins are largely intact except for two which have slight damage. Silt and sea shell fragments are impacted between the fins.

The schematic below should help to identify the various areas referred to above.
