Report of the Public Inquiry into the causes
and circumstances of the accident to
Canadair C.4 G - ALHG
which occurred at Stockport, Cheshire
on 4th June 1967

**Report of the Public Inquiry
into the causes and circumstances of
the Accident to Canadair C.4 G-ALHG
which occurred at Stockport, Cheshire
on 4th June, 1967**

1968

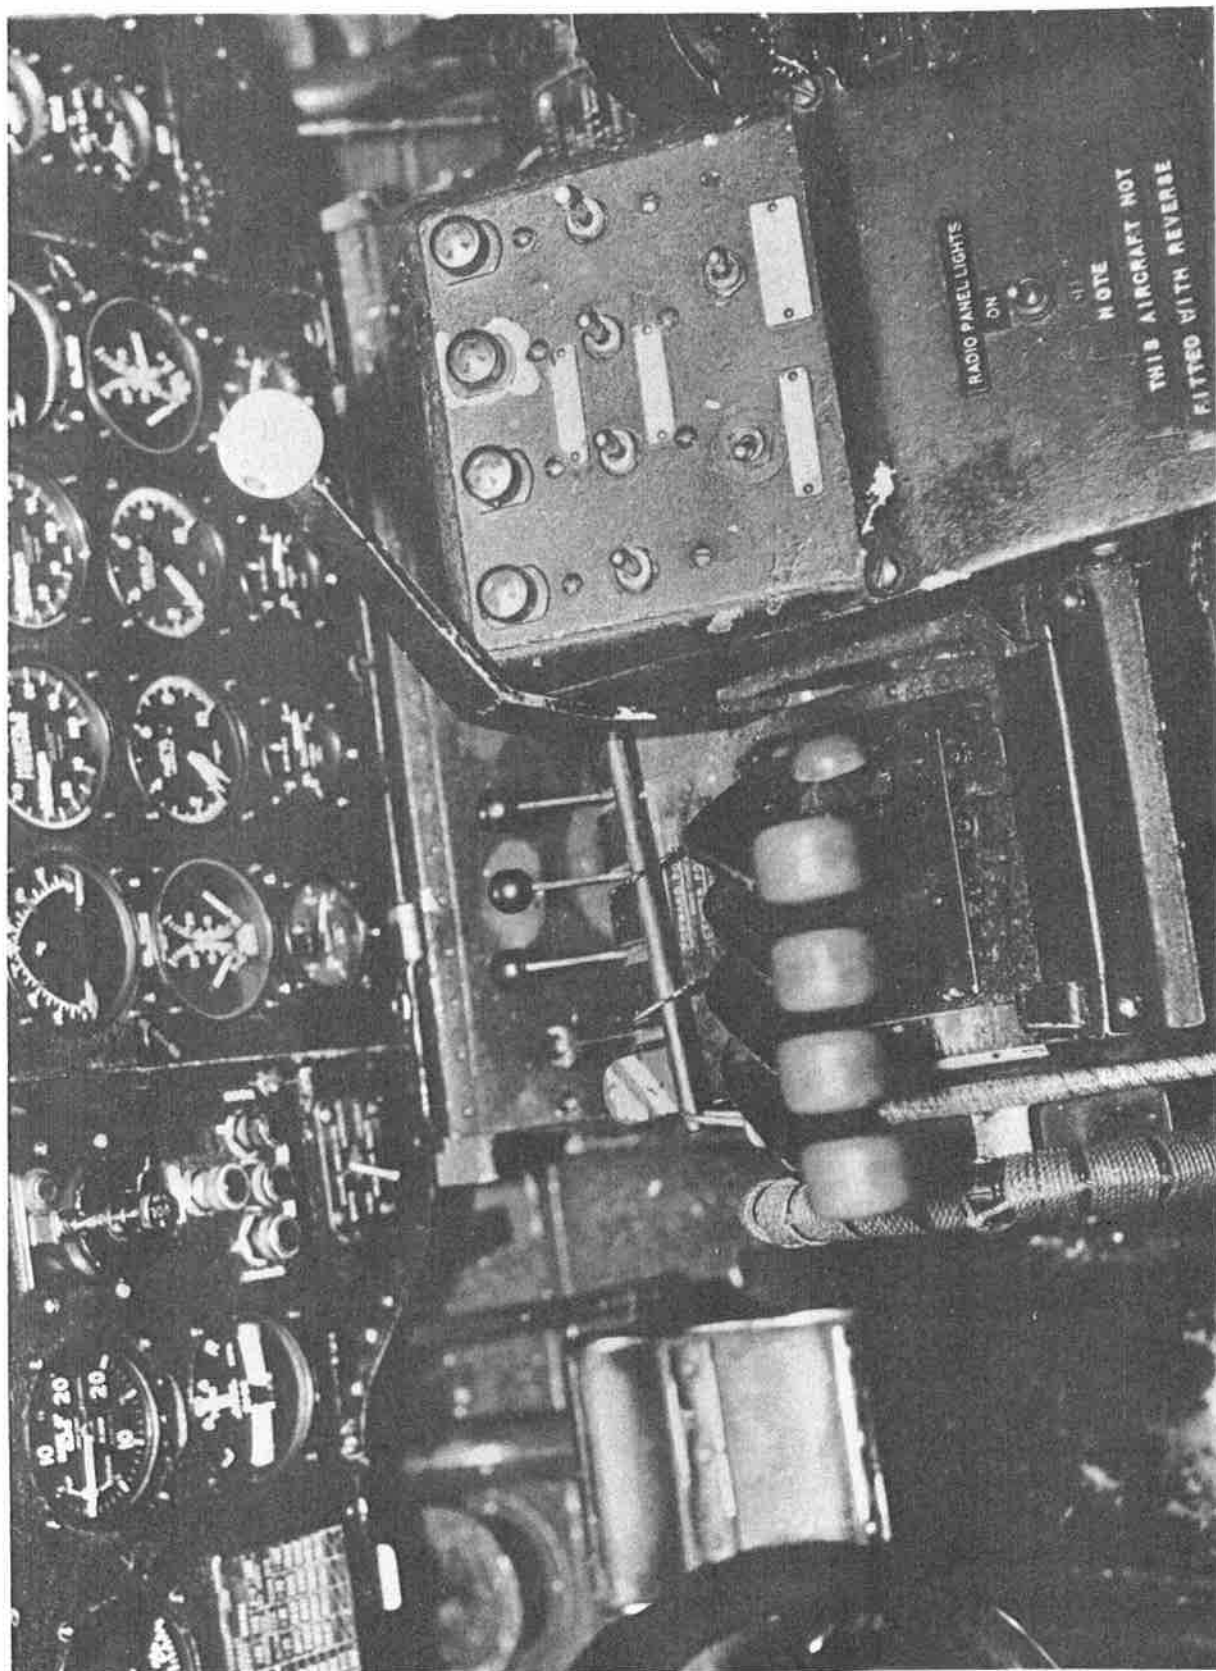
FIGURE 2. FUEL TANK SELECTOR COCKS

(b) no. 3 main tank on, no. 3 auxiliary tank off, no. 4 main tank on, no. 4 auxiliary tank off, the starboard cross feed valve closed in the 'no cross feed' position, no. 3 engine being supplied by no. 3 main tank (the green lines) and no. 4 engine by no. 4 main tank (the ~~brown~~ ^{blue} lines).

If both cross feed valves were turned to the 'cross ship cross feed' position and nos. 3 and 4 selector valves were turned to the off position, all four engines would be being supplied from no. 1 auxiliary tank. Owing to the wing dihedral, if the aircraft was laterally level and the main tank selector valves and cross feed valves were open either in the 'inter engine' or 'cross ship cross feed' position fuel would run by gravity from nos. 1 and 4 tanks inwards towards nos. 2 and 3 tanks.
