## **ORLIT HOMES TUNNEL GARDENS 1-29 & BLAKE ROAD 73/75/77/79 N11**

# **STRUCTURAL ASSESSMENT SURVEY REPORT**

**31st July 2015**

**Project No :** BCC/T12

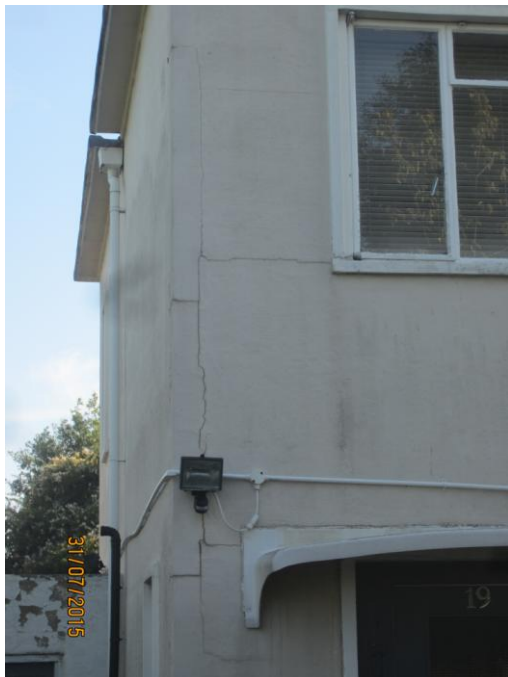
Photo 1 : Typical front corner damage.

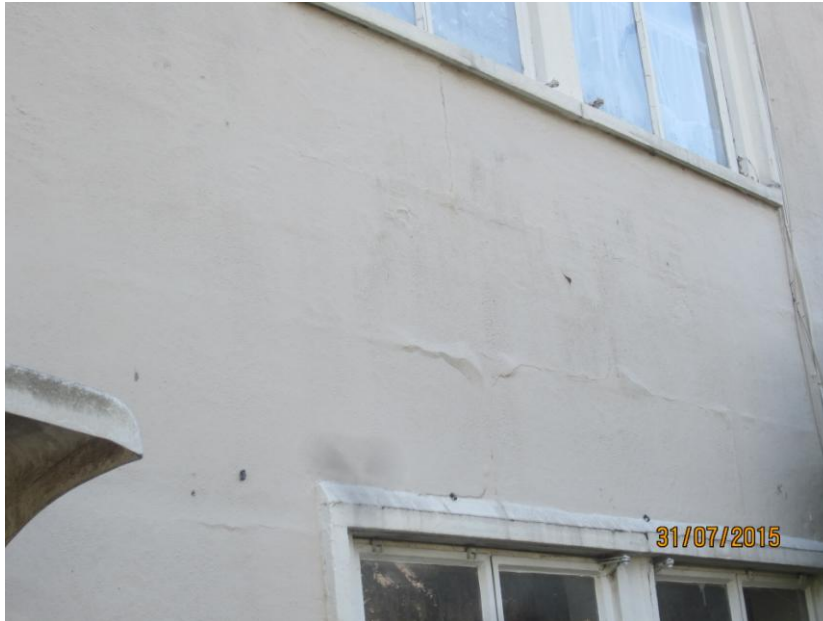
Photo 2: Paint Blistering uneven joints

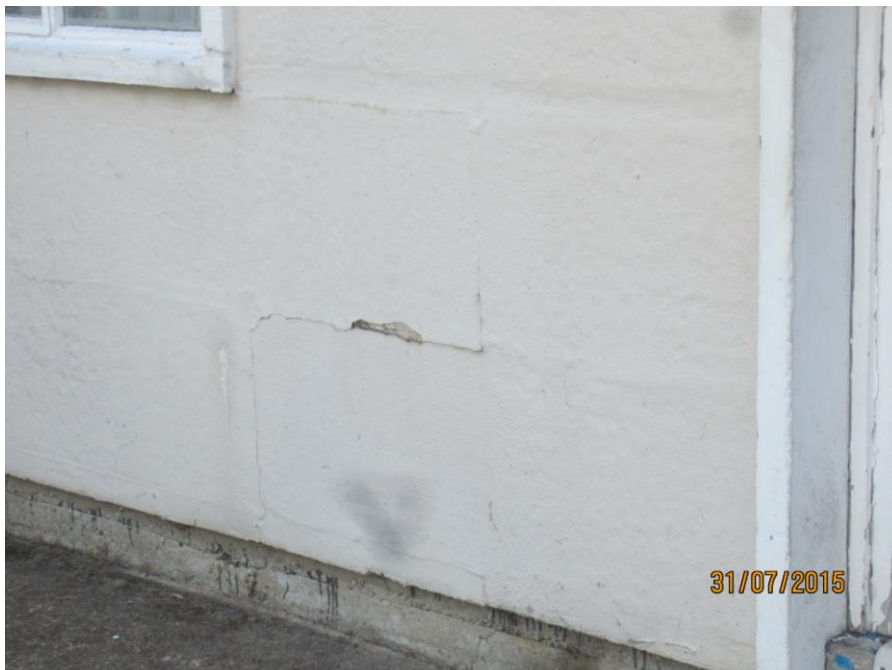
Photo 3: Damaged arises.

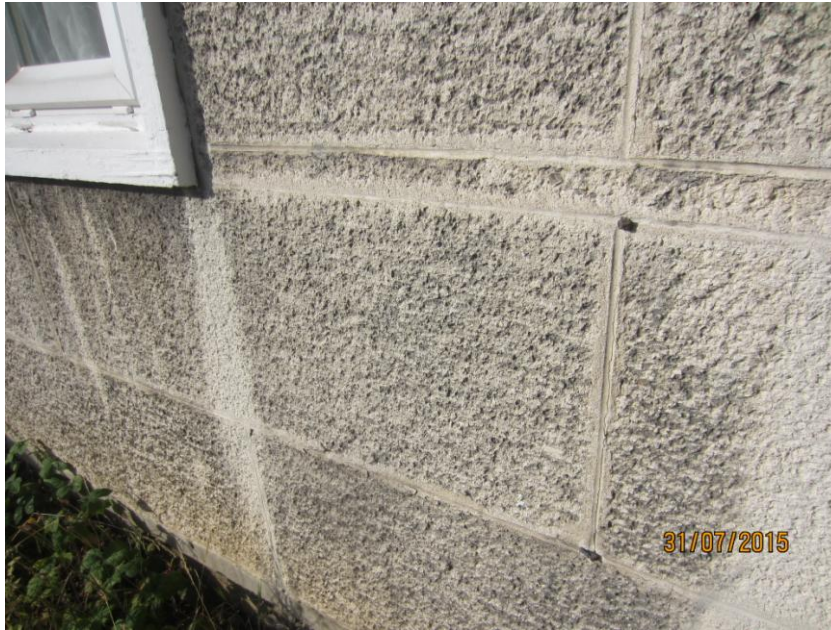
Photo 4: Typical face-work house 12.

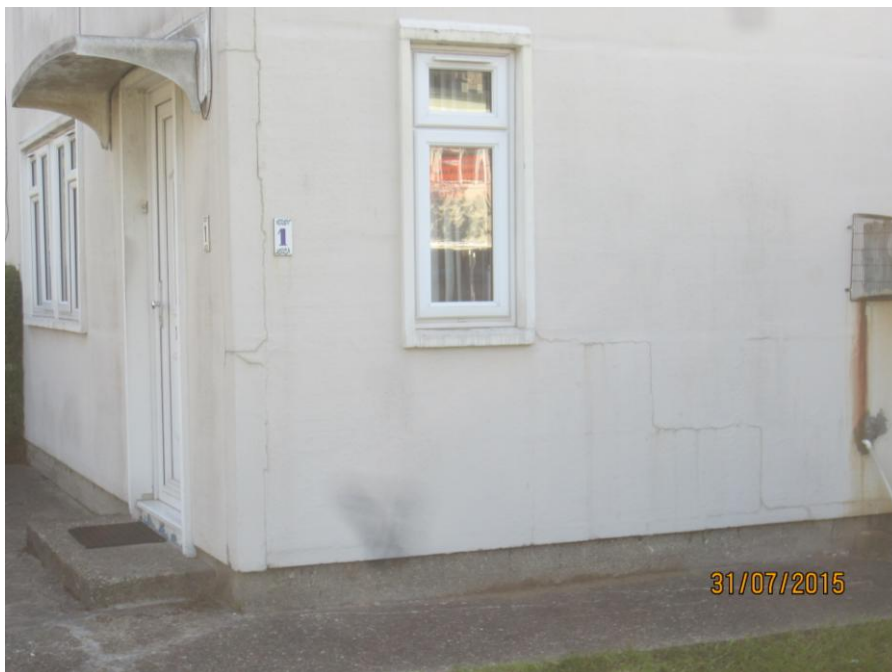
Generally the properties appear in a fairly good condition externally and the condition is equivalent to conventional brick cavity houses. There are some fine cracks up-to 2mm wide between separate units and movement particularly at corner units. There were occasional cracked units but not many.

Photo 5: Typical corner damage.

- 1) Externally cracked joints particularly around corners.
- 2) Cracked units require resin injection and making good.
- 3) Exposed reinforcement to No 12 soffit requires repair as does the damaged unit to the front of No 11.
- 4) The units need external air bricks front and rear to give under ground floor ventilation. (there are no known problems though)
- 5) Internally the issues are re-plastering around window /door frames and better inter panel connections.

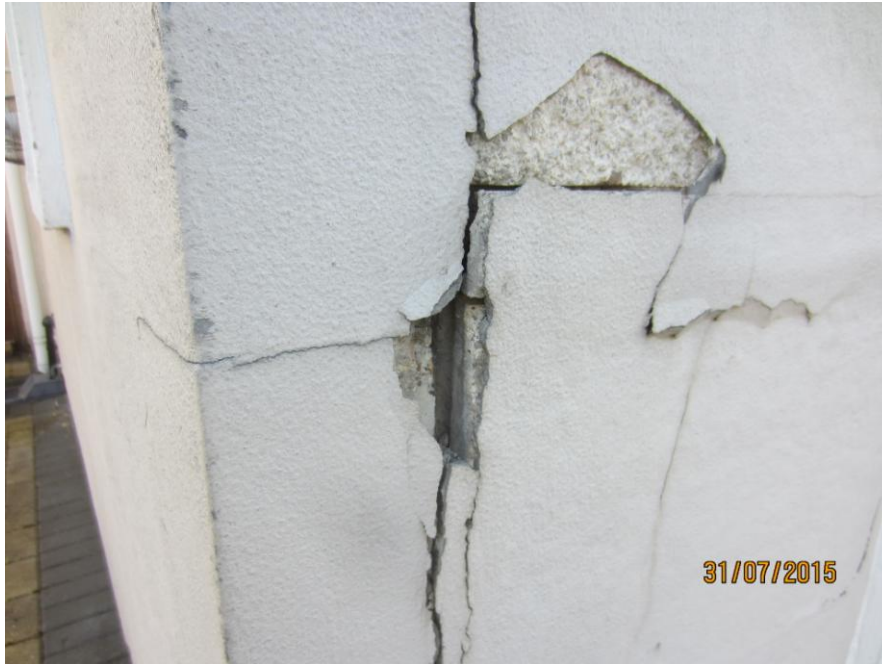
No 11 has a car impact damage which has fractured a unit by the front door. Other units have some diagonal cracks but none appear to be causing issues. One unit is ivy covered No 21.

Photo6: Unit 11 car damage.

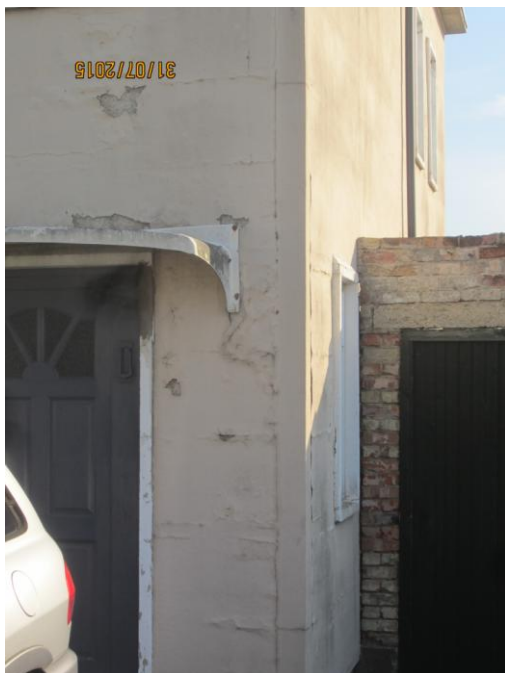
Photo 7: Blistered paint.

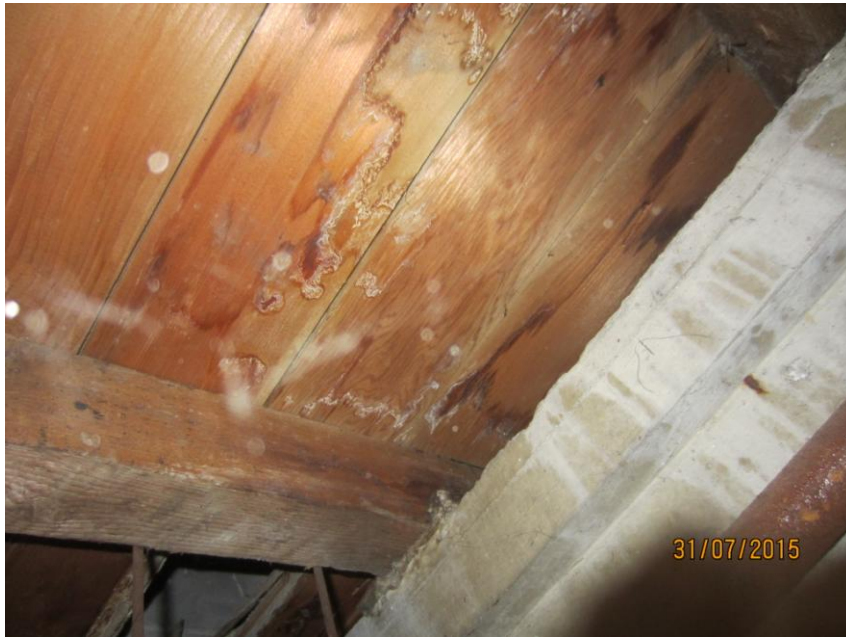
Photo 8: Under floor timberwork

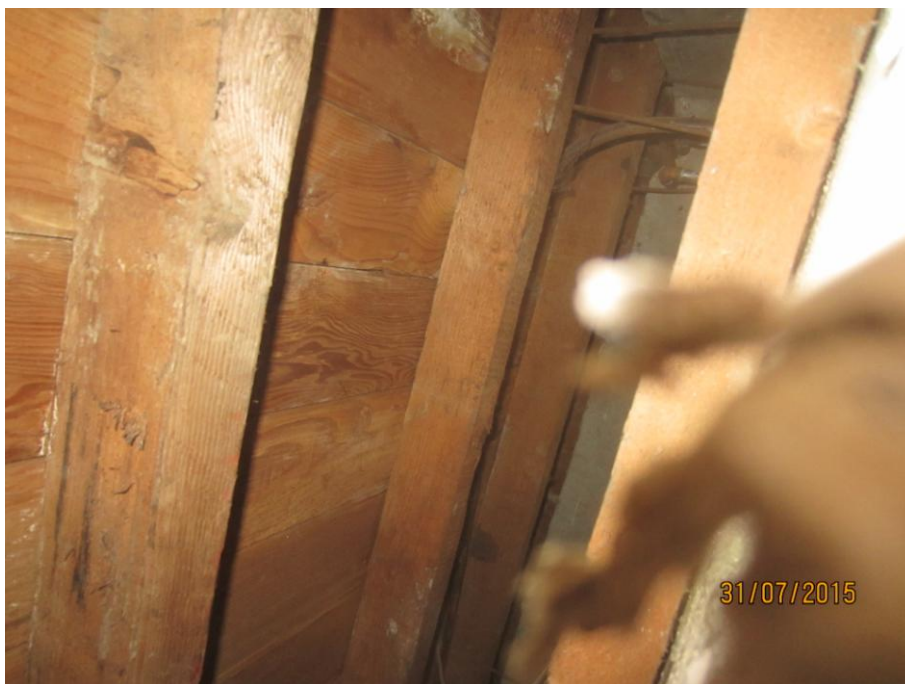
Photo9: As above

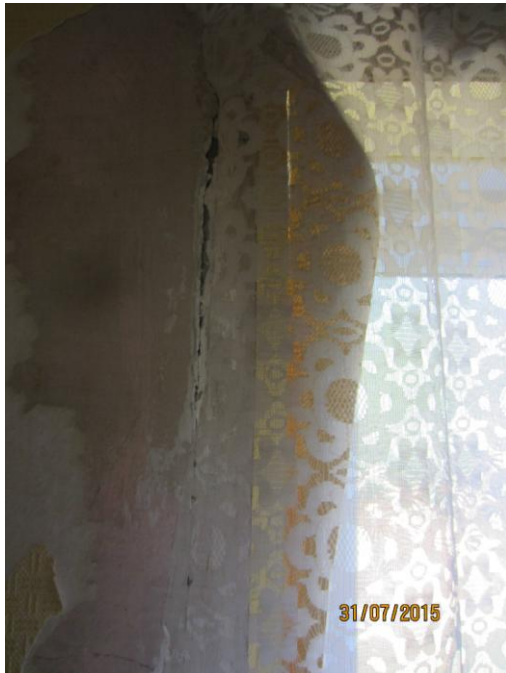
The floors appear well supported and No 12 has a plasterboard defect in the stair area. The entrance door edges crack where the plaster adjoins from the wall panels. Other windows have a similar defect but this is a minor issue. The units have steel power conduits in the concrete but these are embedded at 30mm plus and no problems exist.

Photo 10: damage at window wall junction.
