FACTUAL REPORT

Duty Holder Details: Merlin Attractions Operations Ltd			
Name of Duty Holder	Merlin Attractions Operations Ltd. Trading as: Alton Towers Resort	Role	Theme / Amusement Park
Address	Farley Ln, Alton, Staffordshire, ST10 4DB.	Registered Office	3 Market Close, Poole, Dorset, BH15 1NQ.
Duty Holder Status	Private limited company	Companies House No.	06272935

Introduction / accident summary

The accident happened at around 13:51 on 02/06/15.

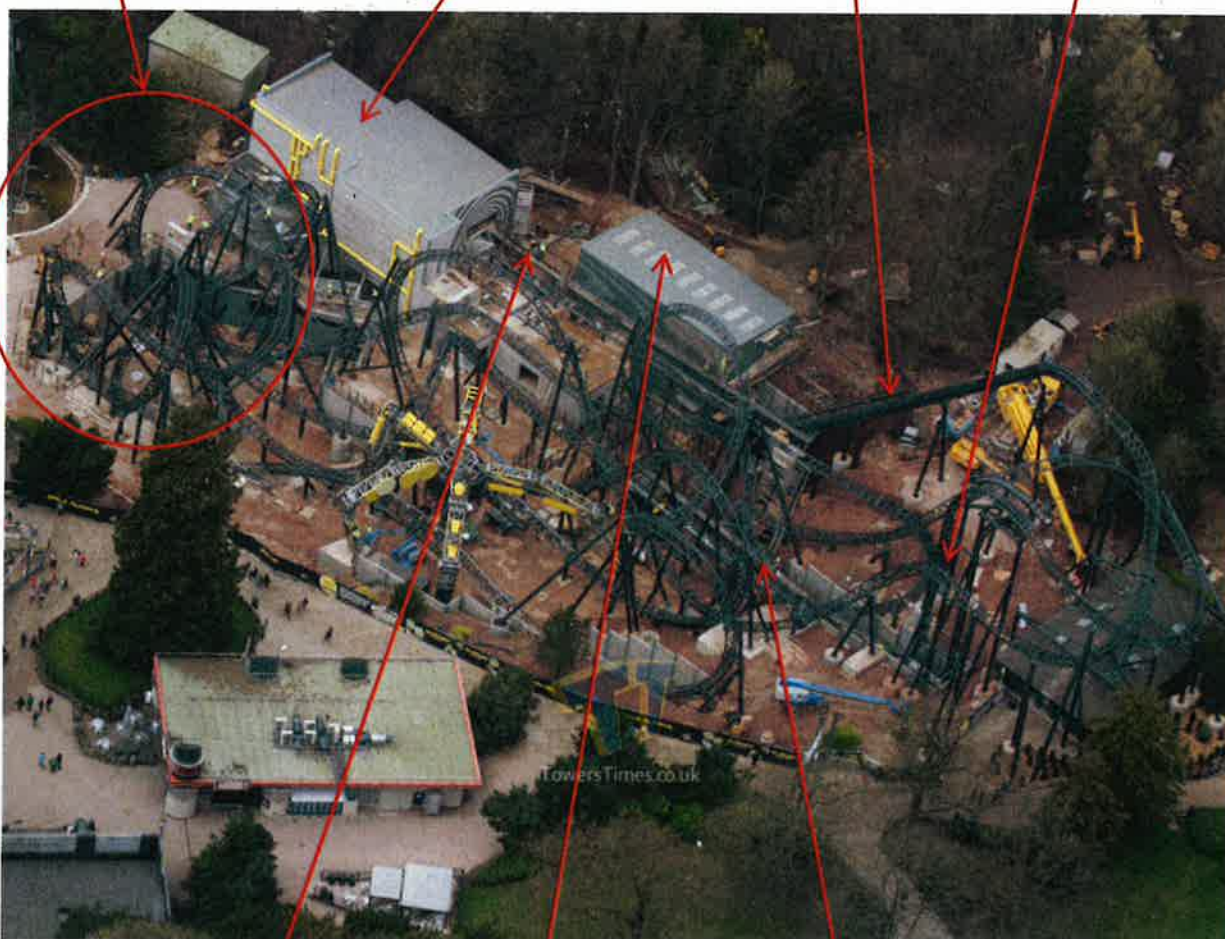
'Cobra Roll' loop,
i.e. location of crash

Station building
(containing ride control room/cabin)

Lift No.1

Lift No.2 (vertical)

Transfer section of track
(i.e. trains added or removed here)

Location of block No. 3's track-side reset button
(i.e. Control Panel OPB3)

Work shop & Maintenance Building
(spare trains stored here)

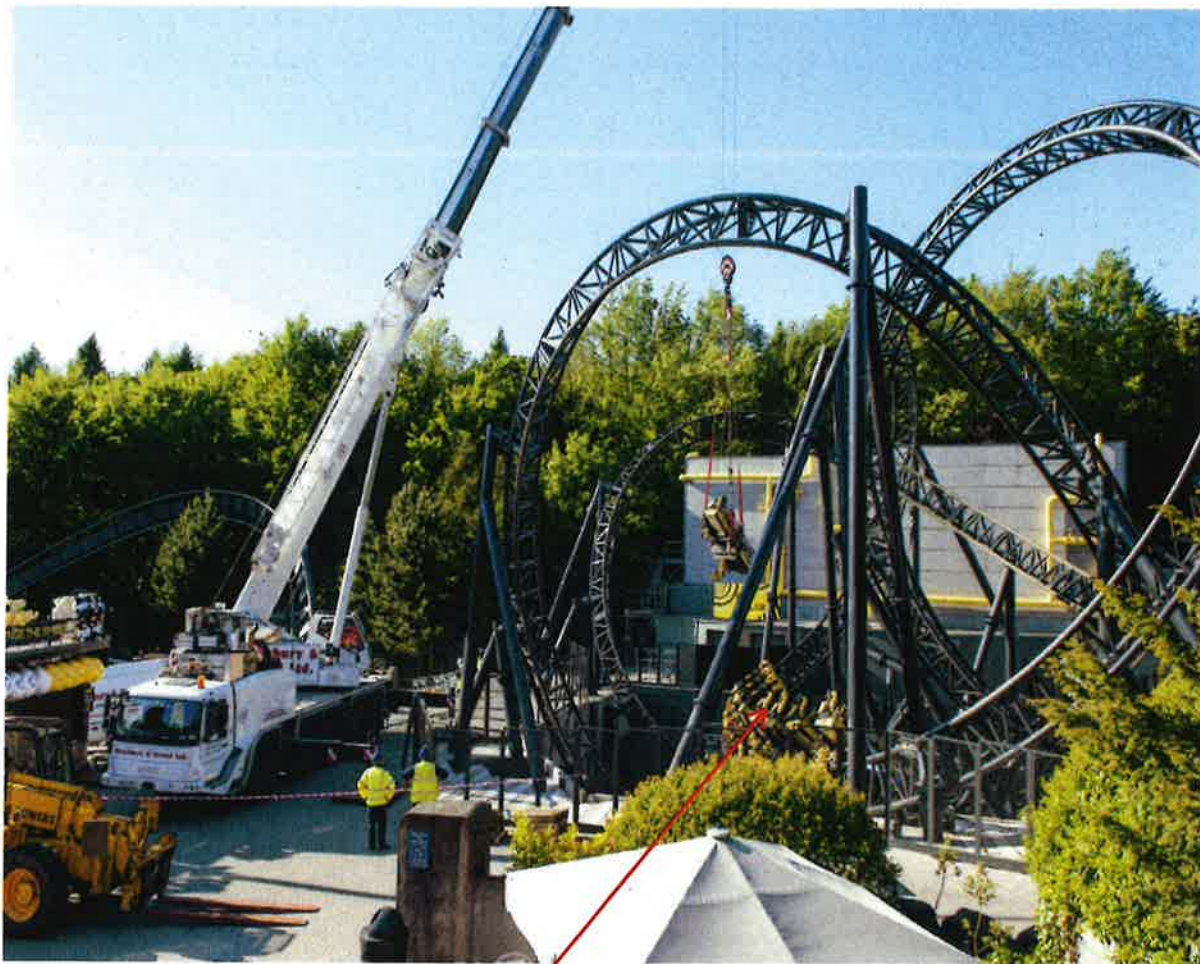
[HSL Image ref: 1506011_074 – exhibit ref LM/69]

3. Figure 2. Photo, below, taken by HSL during 1st day of train removal on 5/6/15 (post-accident).

Stranded incident trains - part of the track goes below ground level at this location

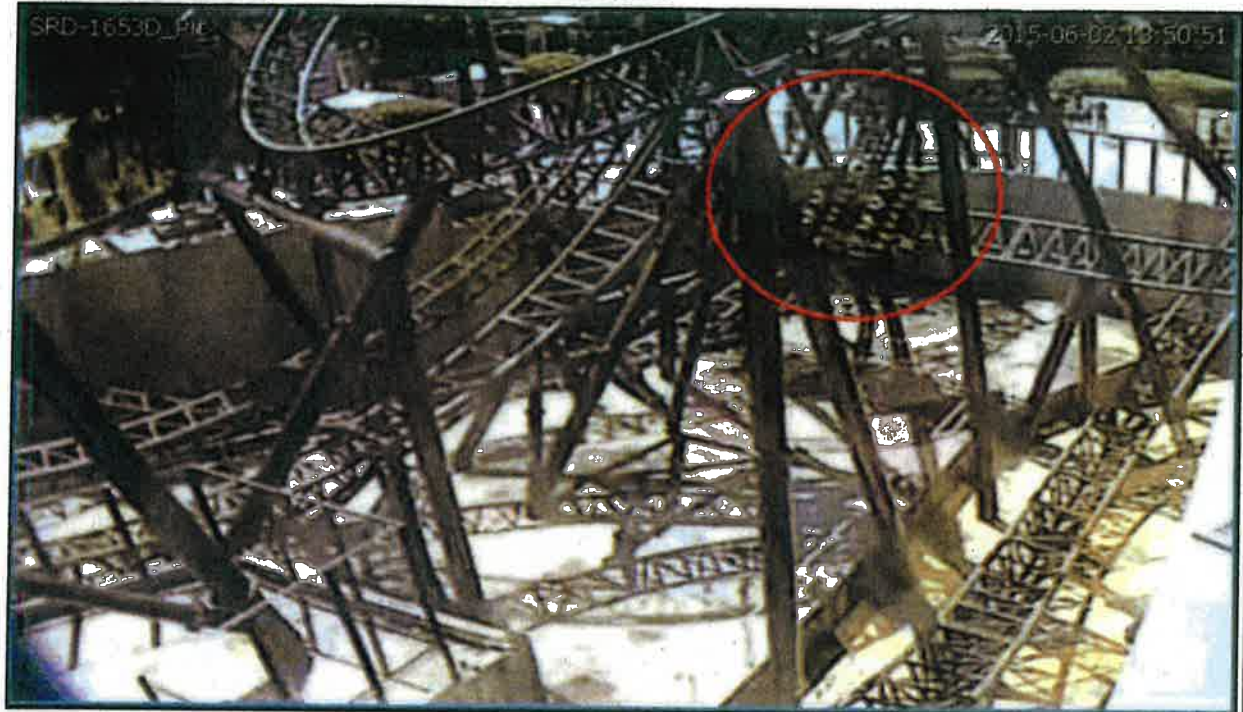
24. The key CCTV camera is CAM09, the "Pit Camera". [REDACTED] comments, in his report, that only the last two rows of the stationary stranded train were visible on the CCTV image, on camera CAM09, as other parts of the track were largely blocking the view [REDACTED] See Figure 8, below.

Figure 8 – photograph taken from [REDACTED] – this shows the view from the CCTV "pit camera". The rear of the stationary, valleyed train (Train 3), from the day of the incident is partially in view. This is prior to the crash.
