Material Assessment Record

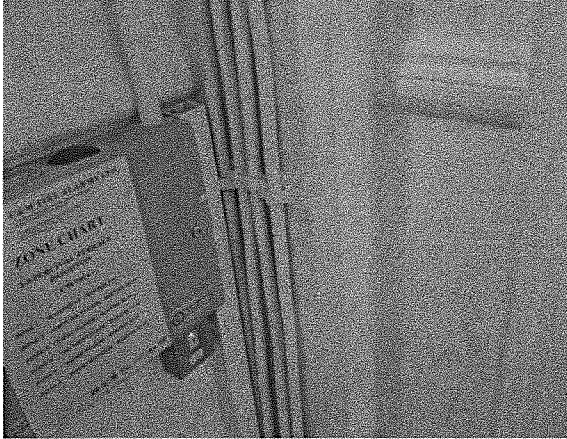
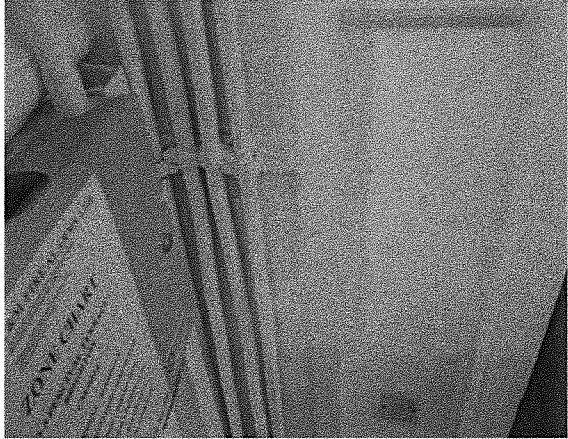
Item	Building	Level	Location / Room number	Survey Type	Quantity	Sample Reference
1	Domestic	Ground Floor	G.001 - Hall	Management Survey (with MA only)	4lm	QR000216

Material Description				Material Risk		
Boxing adjacent to alarm box – Cement Asbestos Cement				Product Type	1	Surface Treatment
				Extent of Damage	0	Asbestos Type
Asbestos Type				Score - Material Risk		
Chrysotile				3		Very Low
Additional Information				Accessibility		
N/A				Easily disturbed		
Recommendations				Review Date		
Label & Manage				May 2019

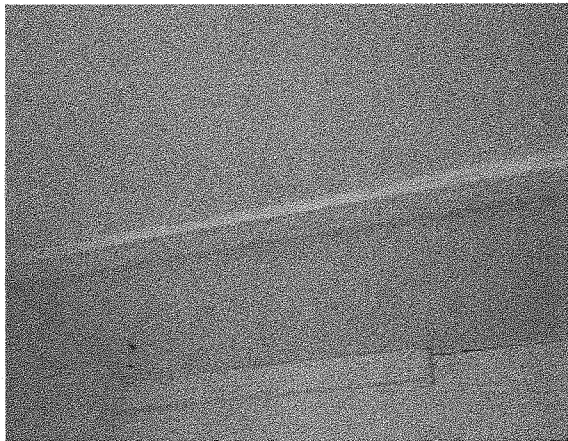
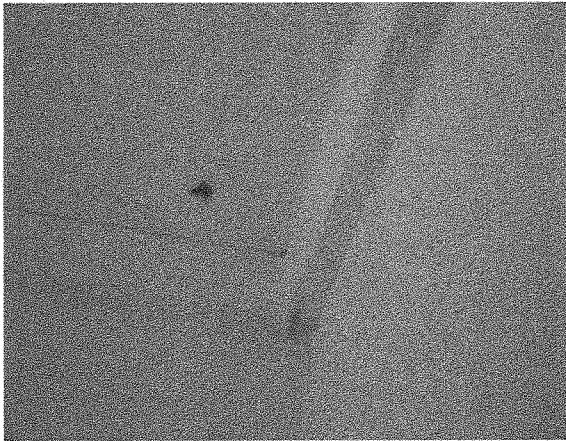
Item	Building	Level	Location / Room number	Survey Type	Quantity	Sample Reference	
5	Domestic	Ground Floor	G.005 - Hall adjacent to 15	Management Survey (with MA only)	4m²	QR000217

Material Description				Material Risk			
Ceiling – Insulation board Asbestos Insulating Board				Product Type	2	Surface Treatment	1
				Extent of Damage	0	Asbestos Type	3
Asbestos Type				Score - Material Risk			
Chrysotile + Crocidolite				6		Low	
Additional Information				Accessibility			
Part plasterboard ceiling				Usually inaccessible or unlikely to be disturbed			
Recommendations				Review Date			
Label & Manage				May 2019

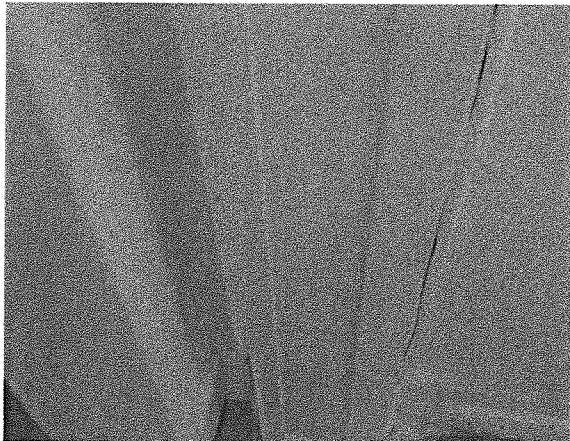
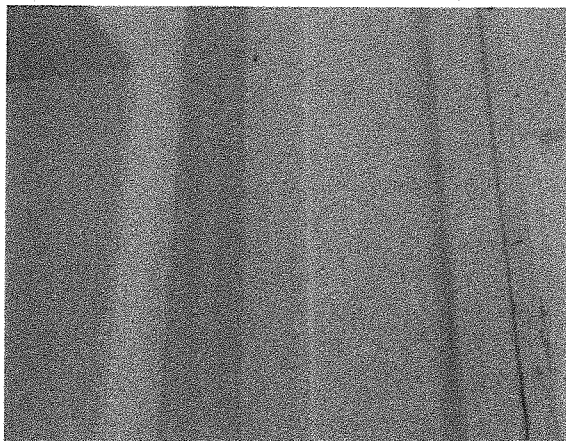
Item	Building	Level	Location / Room number	Survey Type	Quantity	Sample Reference	
10	Domestic	4th Floor	4.003 - Hall 55-60	Management Survey (with MA only)	2lm	QR000220

Material Description				Material Risk			
Riser panel – Cement Asbestos Cement				Product Type	1	Surface Treatment	1
				Extent of Damage	0	Asbestos Type	1
Asbestos Type				Score - Material Risk			
Chrysotile				3		Very Low	
Additional Information				Accessibility			
N/A				Easily disturbed			
Recommendations				Review Date			
Label & Manage				May 2019
