QMUL  
**Francis Bancroft Building**  
Engineering Review

02/2017

Issue | 2 November 2017

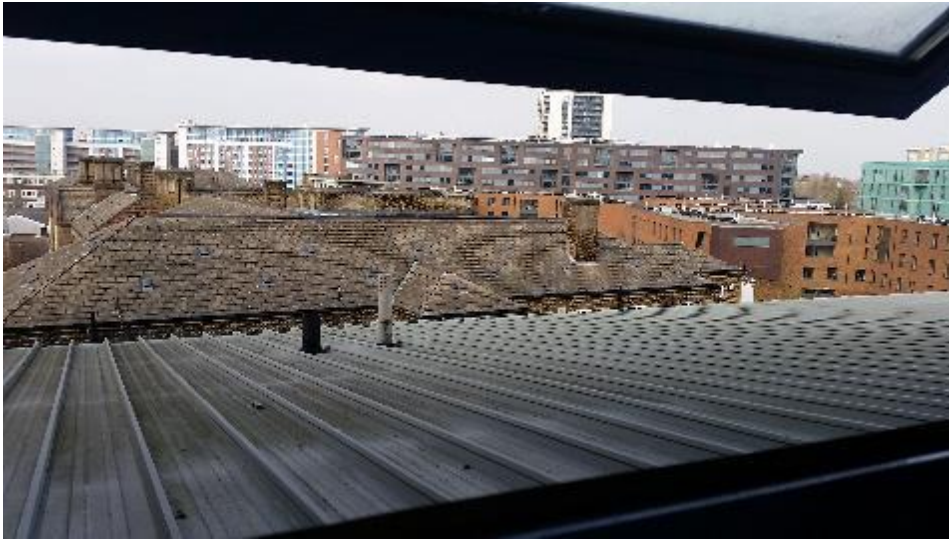
Figure 3.7 Soil Vent Pipes Adjacent to Room 4.23 Openable Windows (pre modification)

An open letter from FBB building users highlighted the problems in room 4.23<sup>1</sup> where reports of ill health have been reported for several years. They reported “a strong smell formaldehyde or ammonia and manure”. This room was vacated earlier in 2017 whilst works were carried out on the soil vent pipes immediately outside the openable windows, see Figure 3.7.

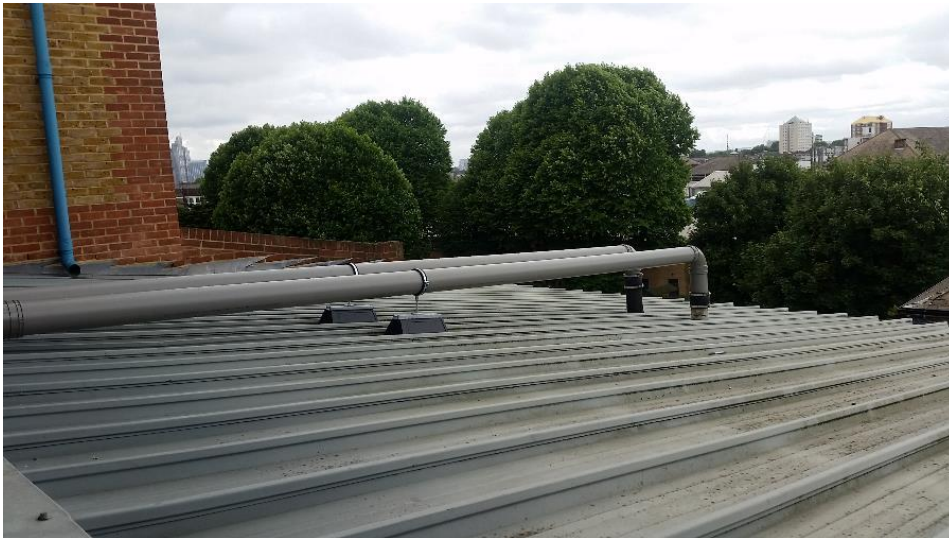
Figure 3.8 Soil Vent pipes Extended above roof line (Spring2017)

These soil vent pipes have now been extended above the roof-line and the room now has been re-occupied with reported improved air quality, see Figure 3.8.

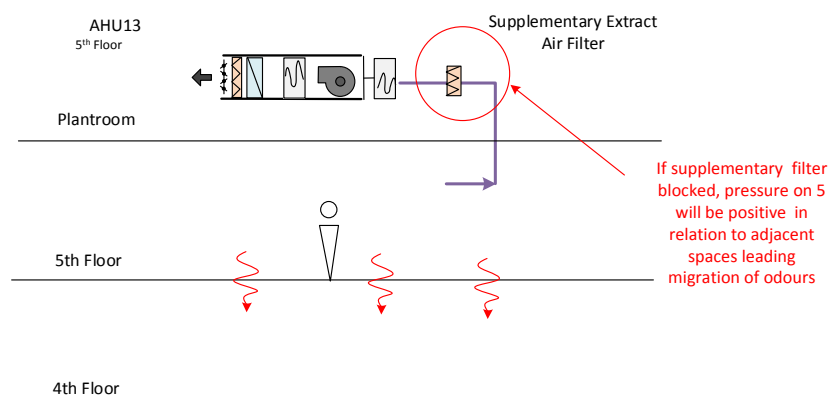
Figure 3.9 Possible Route of Air Migration from 5th to 4th Floor

The supply air produces dust staining at the supply outlets suggesting that the central filters are clogged or by-passing. The extract from the 5th floor has an inline supplementary filter in the roof top plantroom that when left in a ‘dirty’ condition results in a significant reduction in air flow and a disruption to the pressure regimes leading to migration of smells into other parts of the building, see Figure

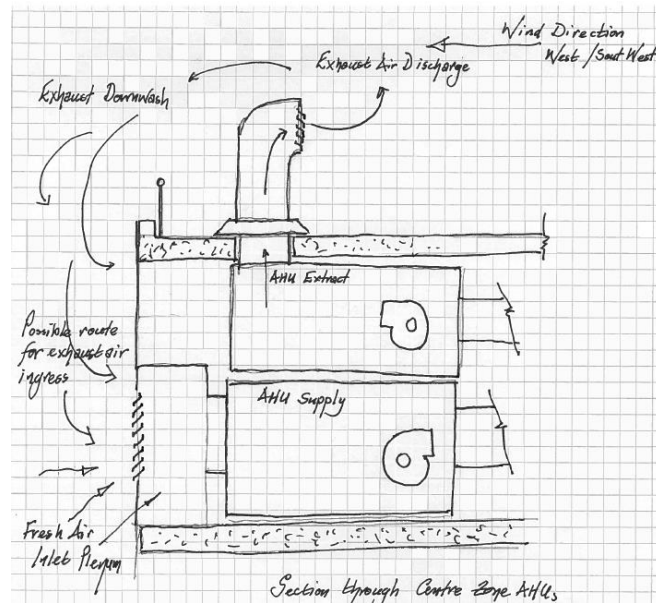
Figure 6.10 Section through Centre Zone Exhaust Discharges and Fresh Air Intake

Figure 6.10 is a section through the fresh air intake and exhaust air discharge and indicates how the discharge may possibly short circuit into the fresh air inlet plenum. The discharges from AHU13 & 14, located in the centre of the bank of three will have exhaust air from the 5th floor.

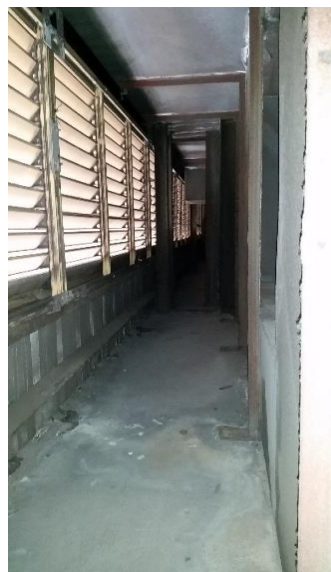
Figure 6.11 View along the Centre Zone fresh air plenum

The fresh air plenum extends over the full width of the bank of 5 AHUs, see Figure 6.11. A measure to reduce the effect of short circuit would be to baffle the centre sections where discharge air from AHU13 & 14 may be at its most concentrated

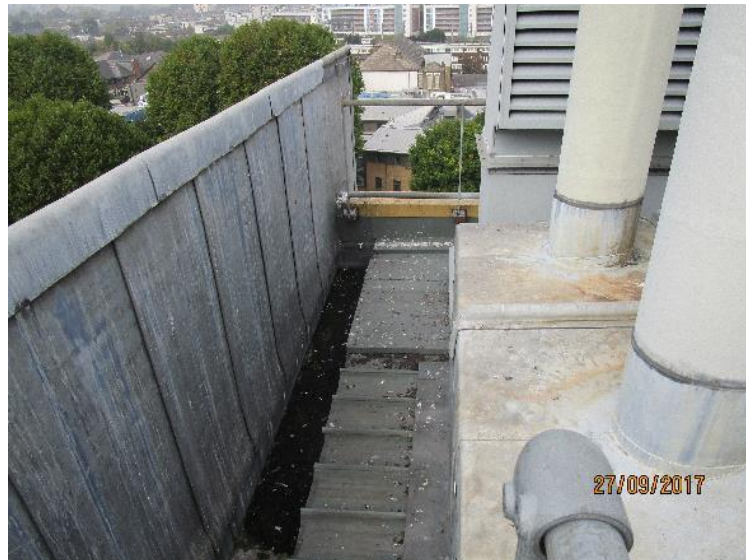
Figure 6.12 Evidence of bird fouling of the roof areas and roof mounted equipment

There is evidence of bird fouling at roof level that may also be finding its way into the air intakes, see Figure 6.12. The fresh air centre intake plenum, although dirty was free from this type of material, see Figure 6.11.

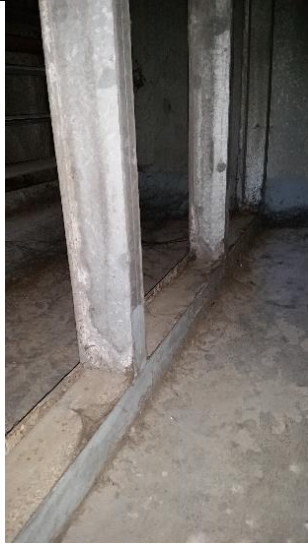
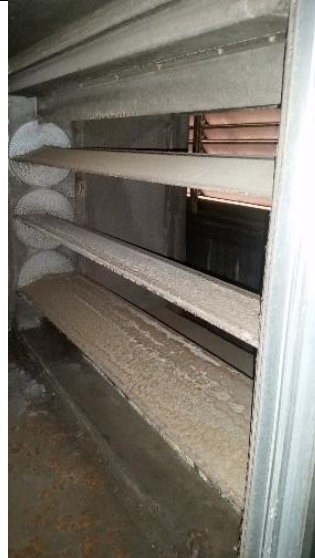
The fresh air intakes and air dampers were found to be in a dirty condition. The build up of dirt to this level will support micro-biological growths with a risk of contaminating the air delivered to the building

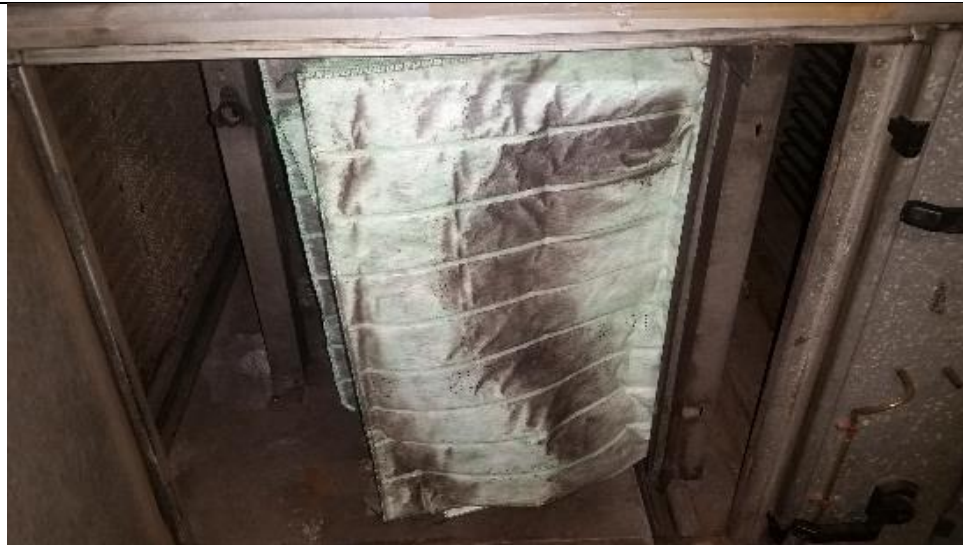
There were several instances of air paths around the filter banks. The filter support frames have been tampered with as it is unlikely have been delivered in this condition from the Flakt. Dirty air by-passes the filter and then fouls the next coil downstream, in most instances this is the run-around coil. This example below was found on AHU12 which serves part of the 5th floor shows the staining of the clean side of the filter where dirty air has impinged on its flow past. This also the probable cause of the dust staining seen at the room diffusers

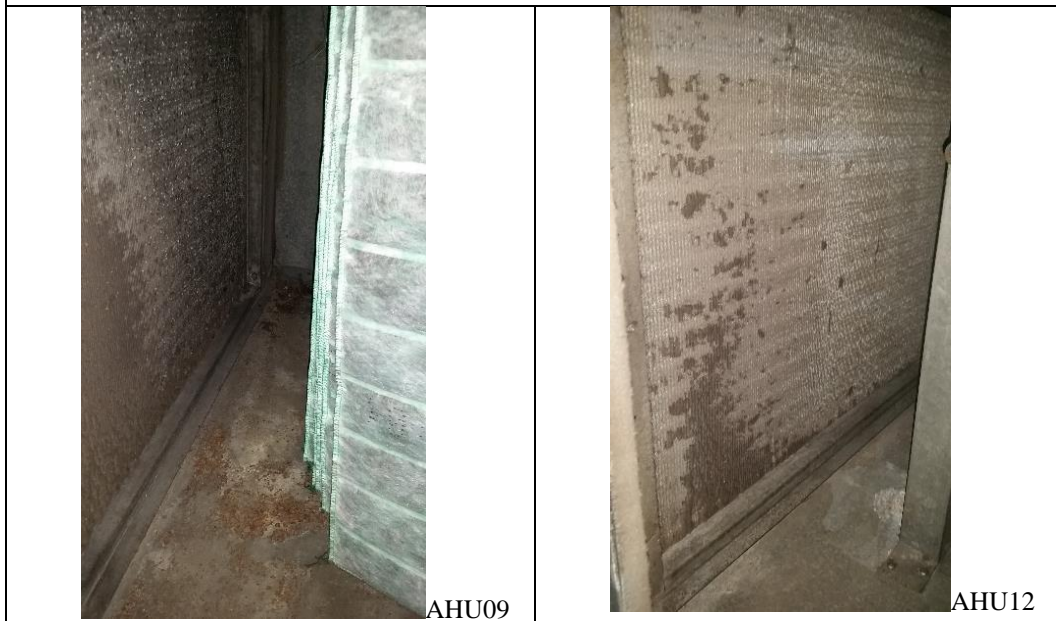
Table 6.3 Fouled AHU Coils

Several of the AHUs that had badly fouled and corroded coils, normally the run-around-coil that encounters the incoming air first. The amount of fouling suggests that the filters were being by-passed, collapsed or had been removed for prolonged periods. Fouling of coils will reduce air flow rate, increase fan energy use and accelerate deterioration of the coil.

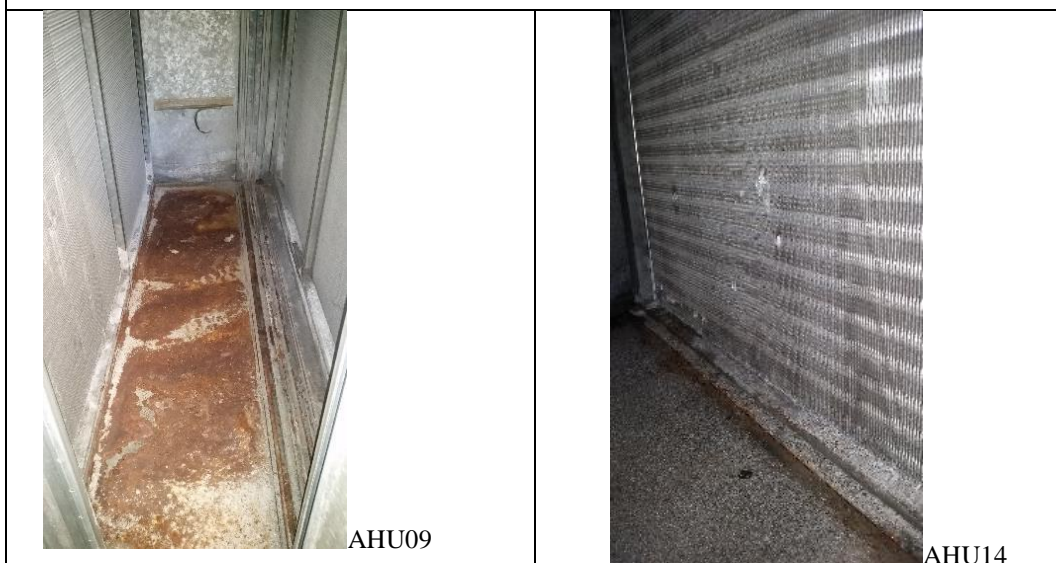
Table 6.4 Corrosion of the Supply Air Sections

The upstream sections of the supply AHUs showed evidence of corrosion particularly on the pans where it appeared that at some time in the past the AHUs suffered from water ponding. The extract sections seem to be less affected

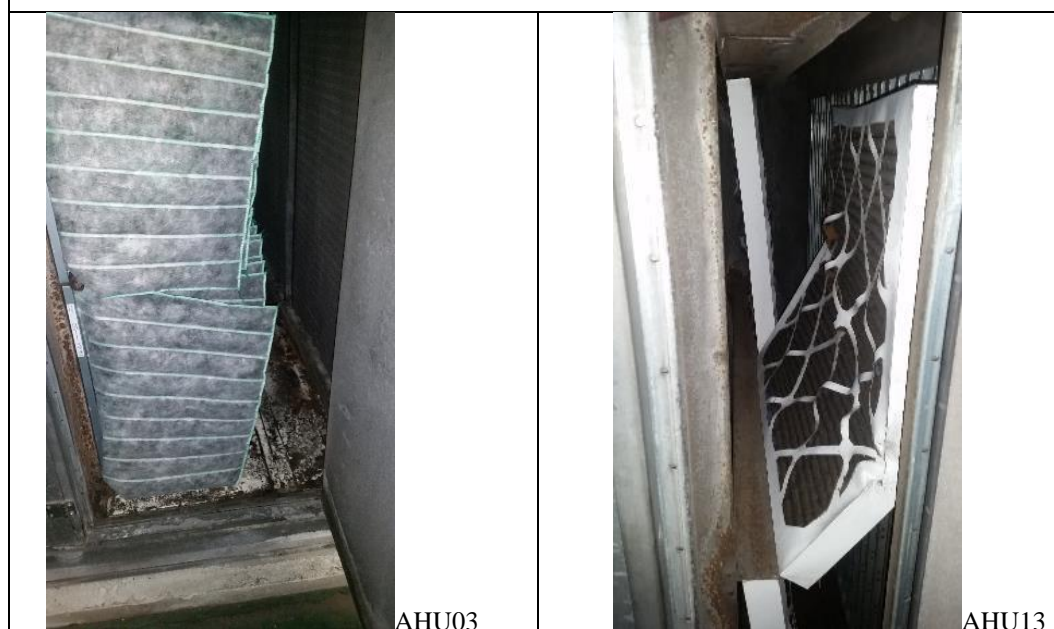
Table 6.5 Dirty and Poorly Fitted Filters

On several of the AHUs filters were found to be in a dirty condition and some poorly fitted/missing securing clips are allowing air to by-pass them contributing to dirty supply air.

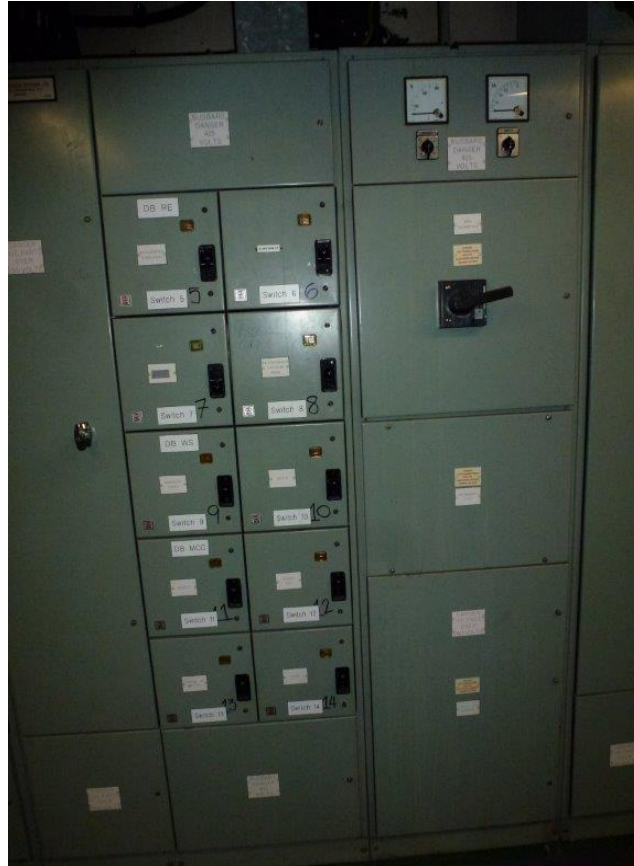
Figure 7.2 LV Switchgear

The switchpanel was not opened however from an external inspection it appears to be in a reasonable condition for its age. A problem with all switchgear as it ages is the diminishing availability of spare parts and replacements should a failure occur. It is likely that direct replacement switchfuses and MCCBs are no longer available therefore a strategy for how to reinstate supplies in the event of a failure should be considered.
