Toddbrook Reservoir

Inspection Report under Section 10 of the
Reservoirs Act 1975 (Amended)

April 2019
Confidential

Document reference: 381715 | CR02 | 01

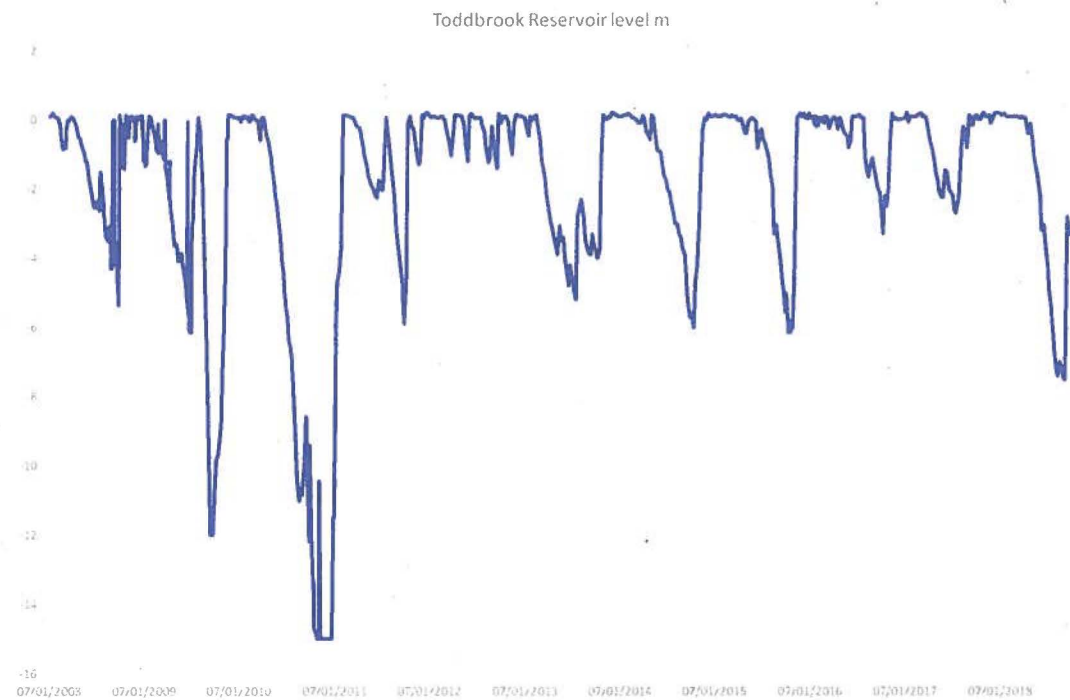
Figure 18: Water level records 2008 - 2018

It can be seen that the reservoir water levels drop to 5-6m below TWL most summers with the exception of 2009 and 2010 where levels dropped to 12 and 15m below TWL respectively.

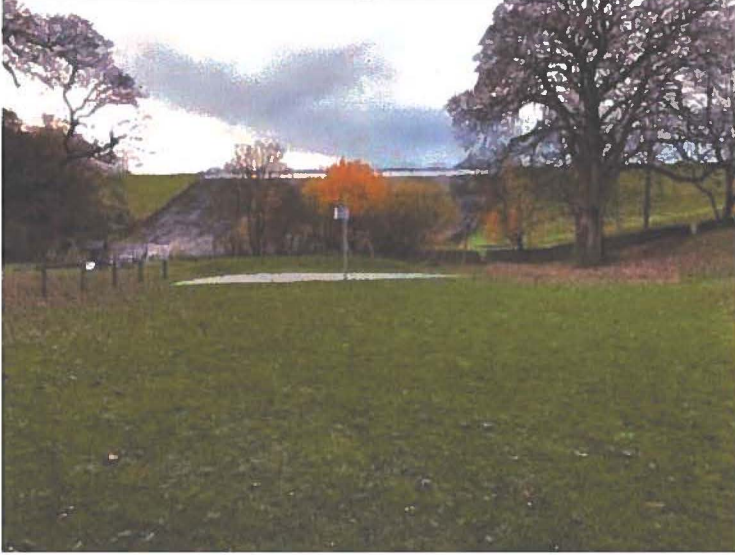
A photograph showing a grassy embankment in the foreground, with a line of trees in the middle ground. In the background, a reservoir is visible under a cloudy sky. The trees have some autumnal colors.	<p>1 – General view of embankment looking upstream</p>

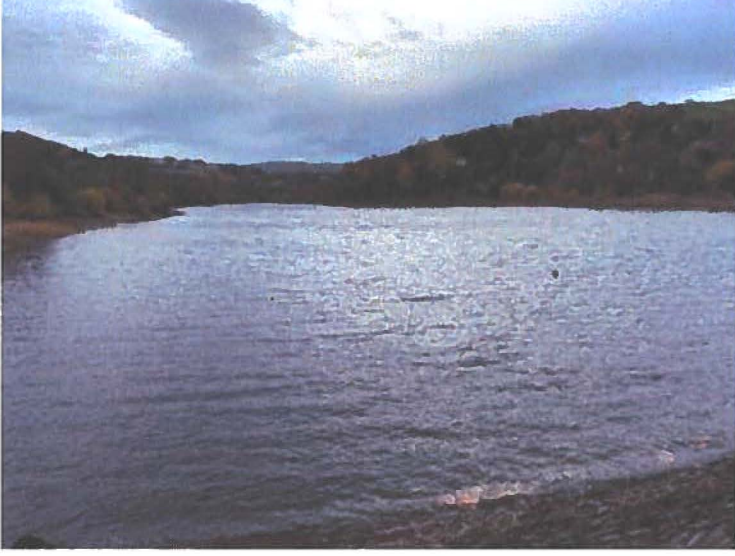
A photograph of a reservoir looking upstream. The water is calm with some ripples. The far bank is covered in dense trees and vegetation. The sky is overcast with grey clouds.	<p>2 – General view of reservoir looking upstream</p>

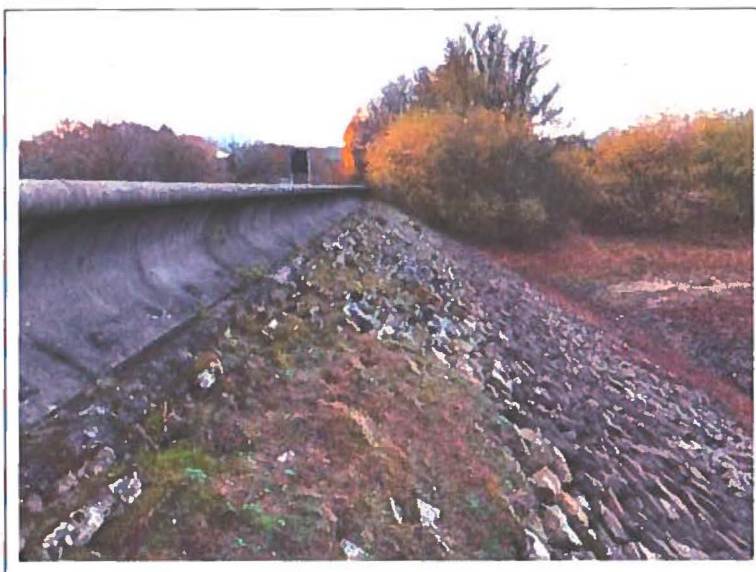
A photograph showing a close-up view of a dam's upstream pitching. The pitching is made of dark, irregular stones and is covered with patches of green moss and small plants. The background shows a line of trees with autumn foliage in shades of orange and yellow.	<p>3 – Upstream pitching right-hand mitre</p>

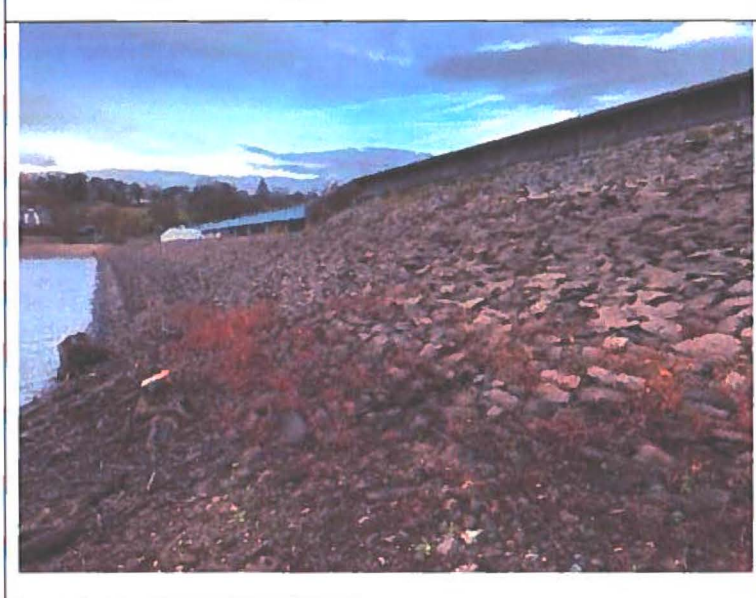
A photograph showing a wide view of the upstream pitching of a dam. The pitching is made of dark, irregular stones and is covered with patches of green moss and small plants. The background shows a line of trees with autumn foliage in shades of orange and yellow.	<p>4 – Upstream pitching from right-hand mitre</p>

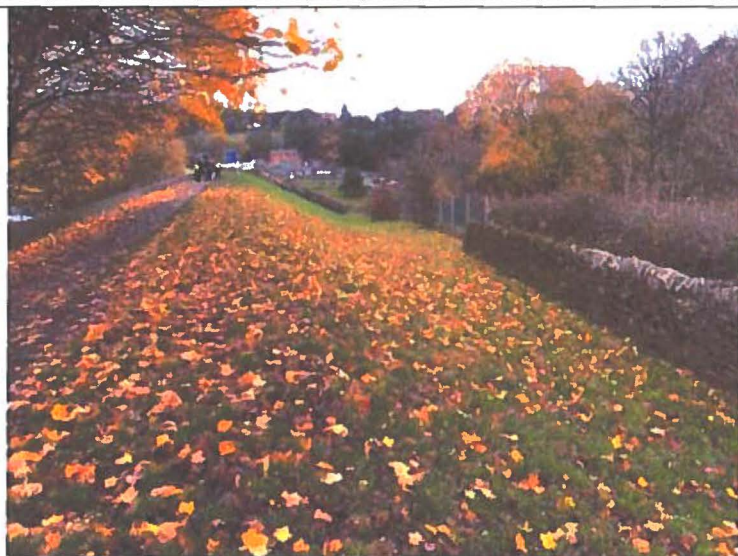
16 – Downstream face
from right-hand abutment

The downstream face has full grass coverage and was firm underfoot on the slope, at the toe and down both mitres, [REDACTED]

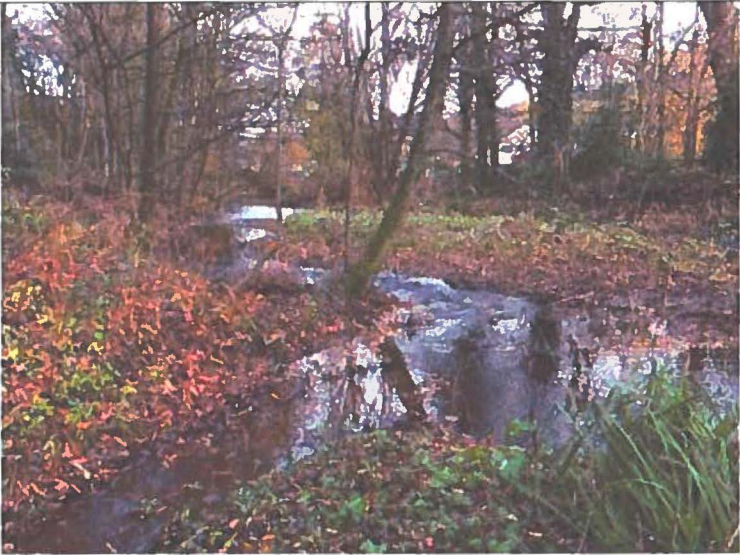
A photograph showing a river flowing through a wooded area. The water is dark and reflects the surrounding trees. The banks are covered with fallen leaves in shades of orange, red, and brown. The trees are mostly bare, suggesting autumn or winter.	<p>83 – View downstream from river outfall V-notch</p>

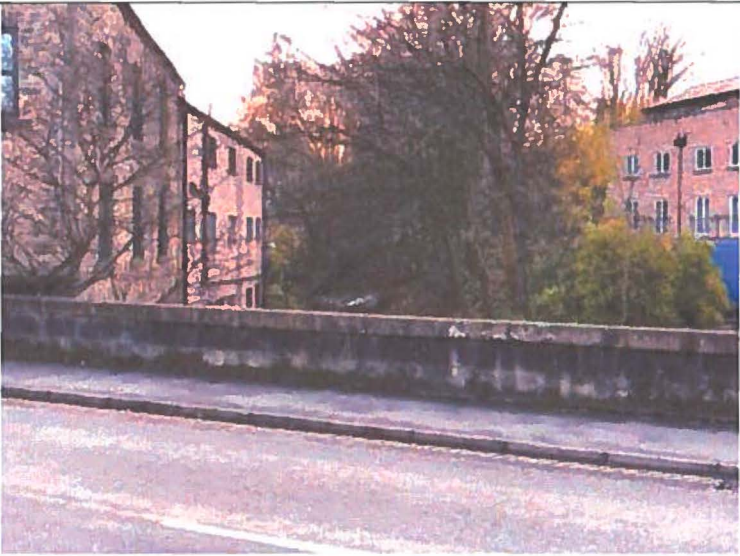
A photograph showing a view looking upstream from the center of a bridge. The bridge has a concrete parapet. In the background, there are brick buildings and trees. The water is visible in the distance.	<p>84 – View looking upstream from centre of Whalley Bridge</p>
