Report No: AR/08/5388

**BEACONHILL PRIMARY SCHOOL
LANGDALE DRIVE
CRAMLINGTON**

**Survey to identify asbestos based materials
carried out on behalf of Northumberland County Council**

Issue Date: 06 January 2009

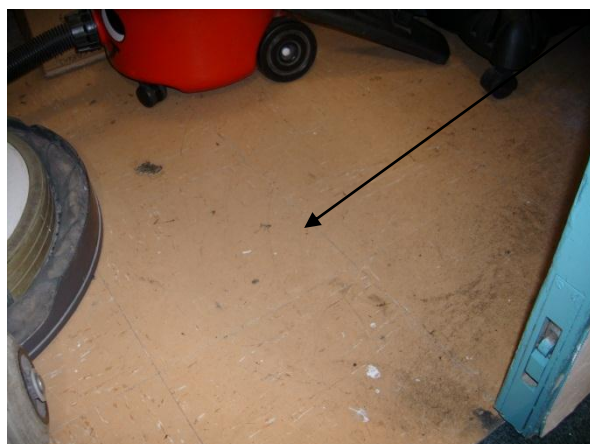
Library Store 1 – vinyl floor tiles are an ACM (sample BS/01). It is recommended they be left undisturbed and monitored.

Level of ID	Sample ID	Extent (m ² /m ³)	Product Type (1,2,3)	Condition (0,1,2,3)	Surface Treatment (0,1,2,3)	Asbestos Type (1,2,3)	Score	Access (IA,OA,EA)	Action (A1,A2,A3)
ID	BS/01	2m ²	1	0	0	1	2	EA	A3

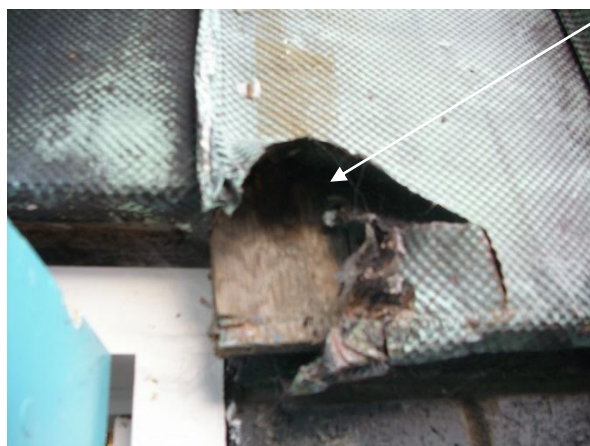
Boiler House – felt behind metal wall panels is an ACM (sample BS/02, report AR/04/0320). It is recommended it be left undisturbed and monitored.

Level of ID	Sample ID	Extent (m ² /m ³)	Product Type (1,2,3)	Condition (0,1,2,3)	Surface Treatment (0,1,2,3)	Asbestos Type (1,2,3)	Score	Access (IA,OA,EA)	Action (A1,A2,A3)
ID	BS/02	150m ²	1	0	0	1	2	OA	A3

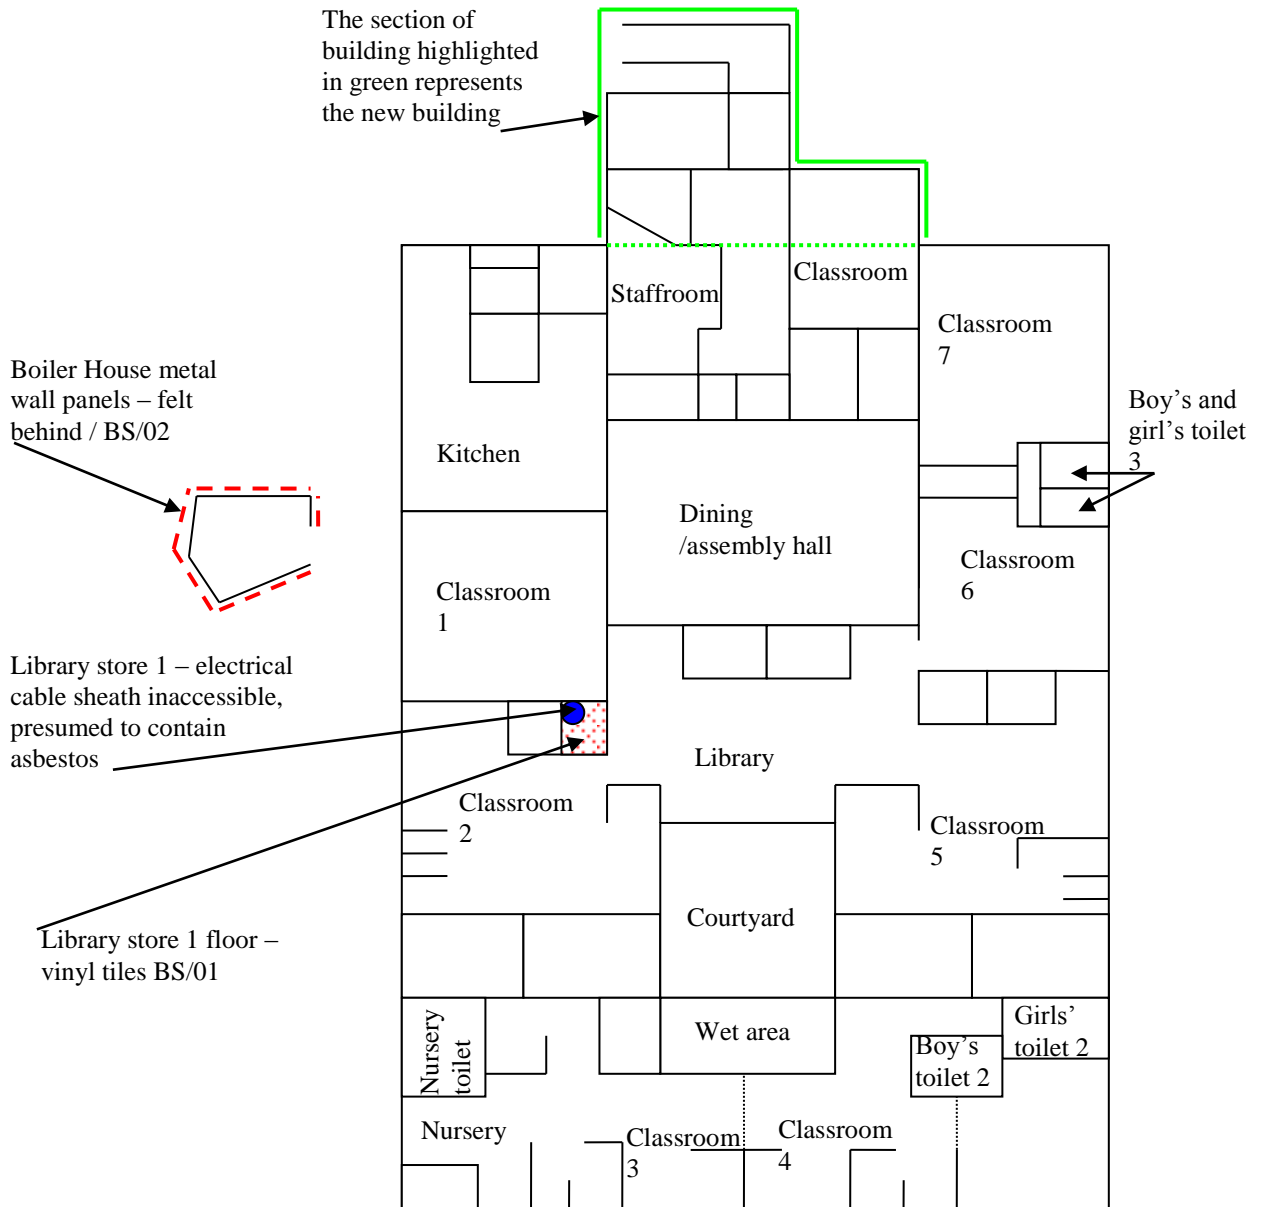
**Beaconhill Primary School
Floor Plan**

**DRAWING TO DEPICT ASBESTOS CONTAINING MATERIALS
AND ASBESTOS SAMPLE POINT LOCATIONS**
