Road Safety Audit Stage 1

Junction Improvements

Brighton Hill Roundabout

Basingstoke

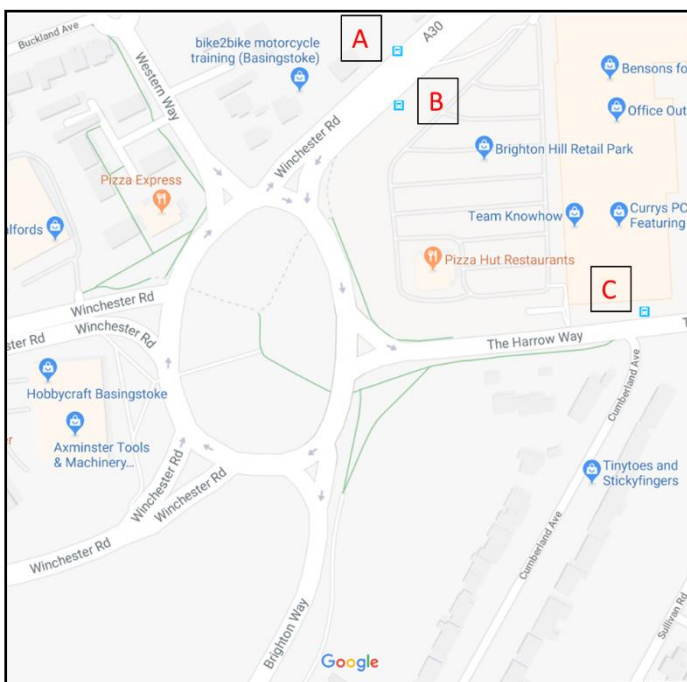
Fig 8: Location of Existing Bus Stops

The bus lay-by on S-W bound carriageway on A30 Winchester Road (B in picture above) has been changed to on-street bus stop.

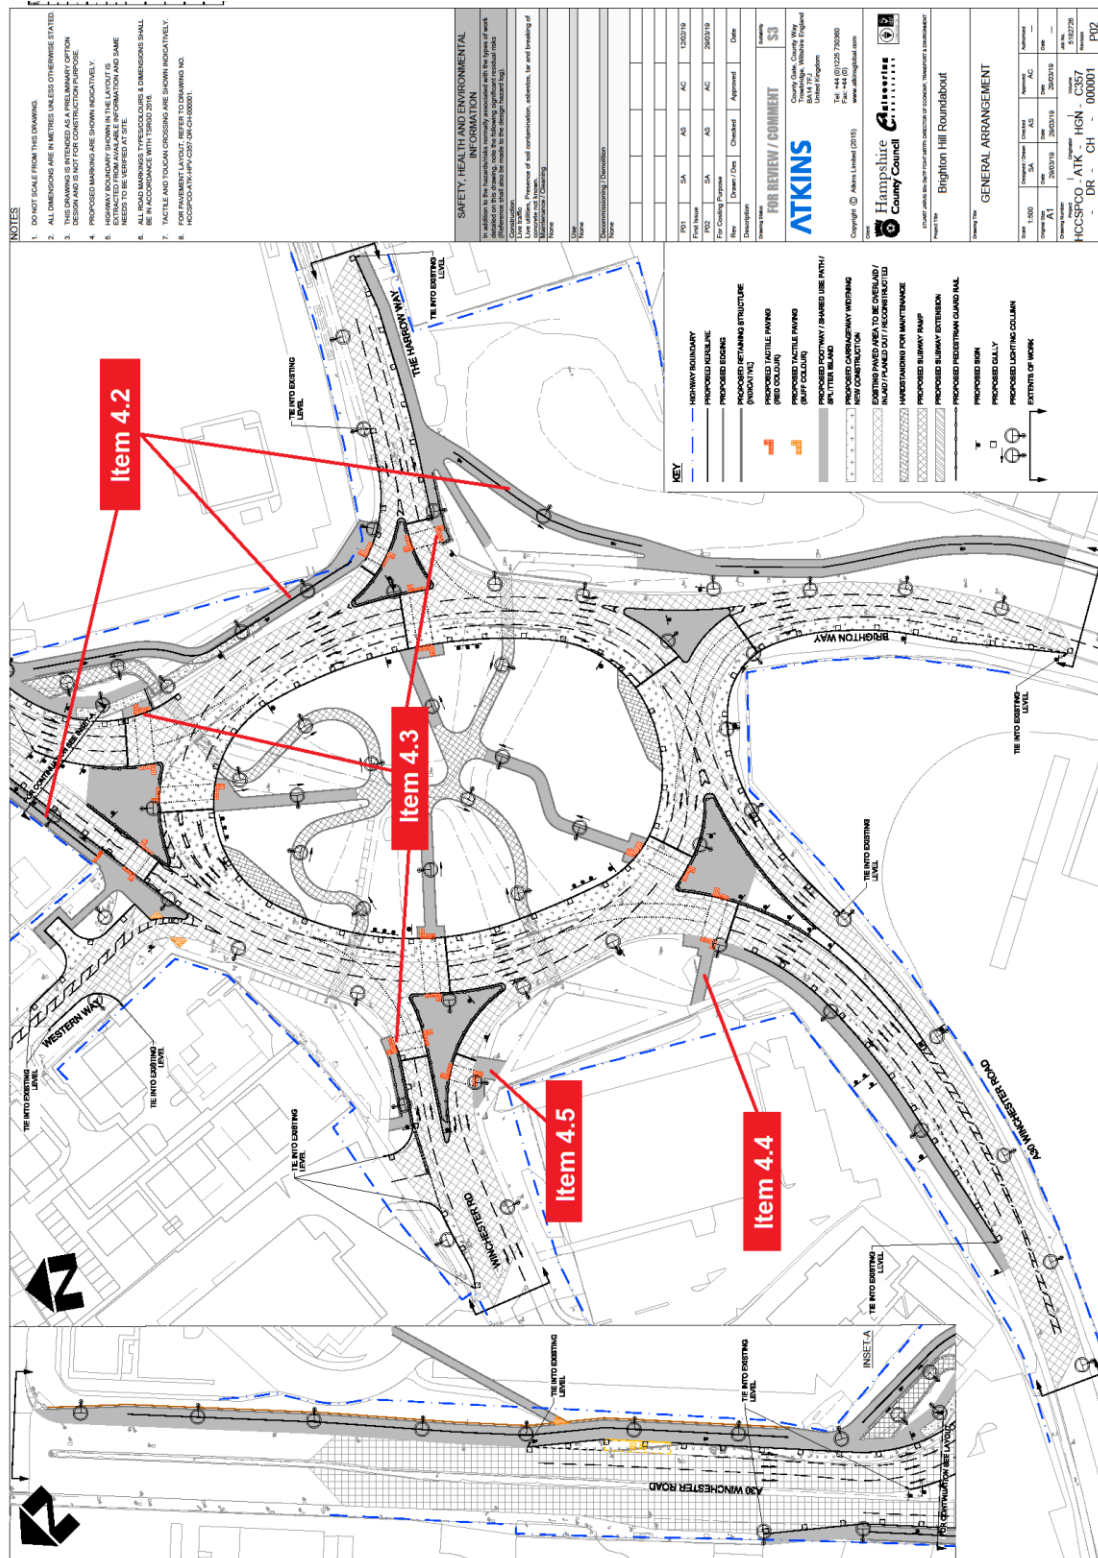
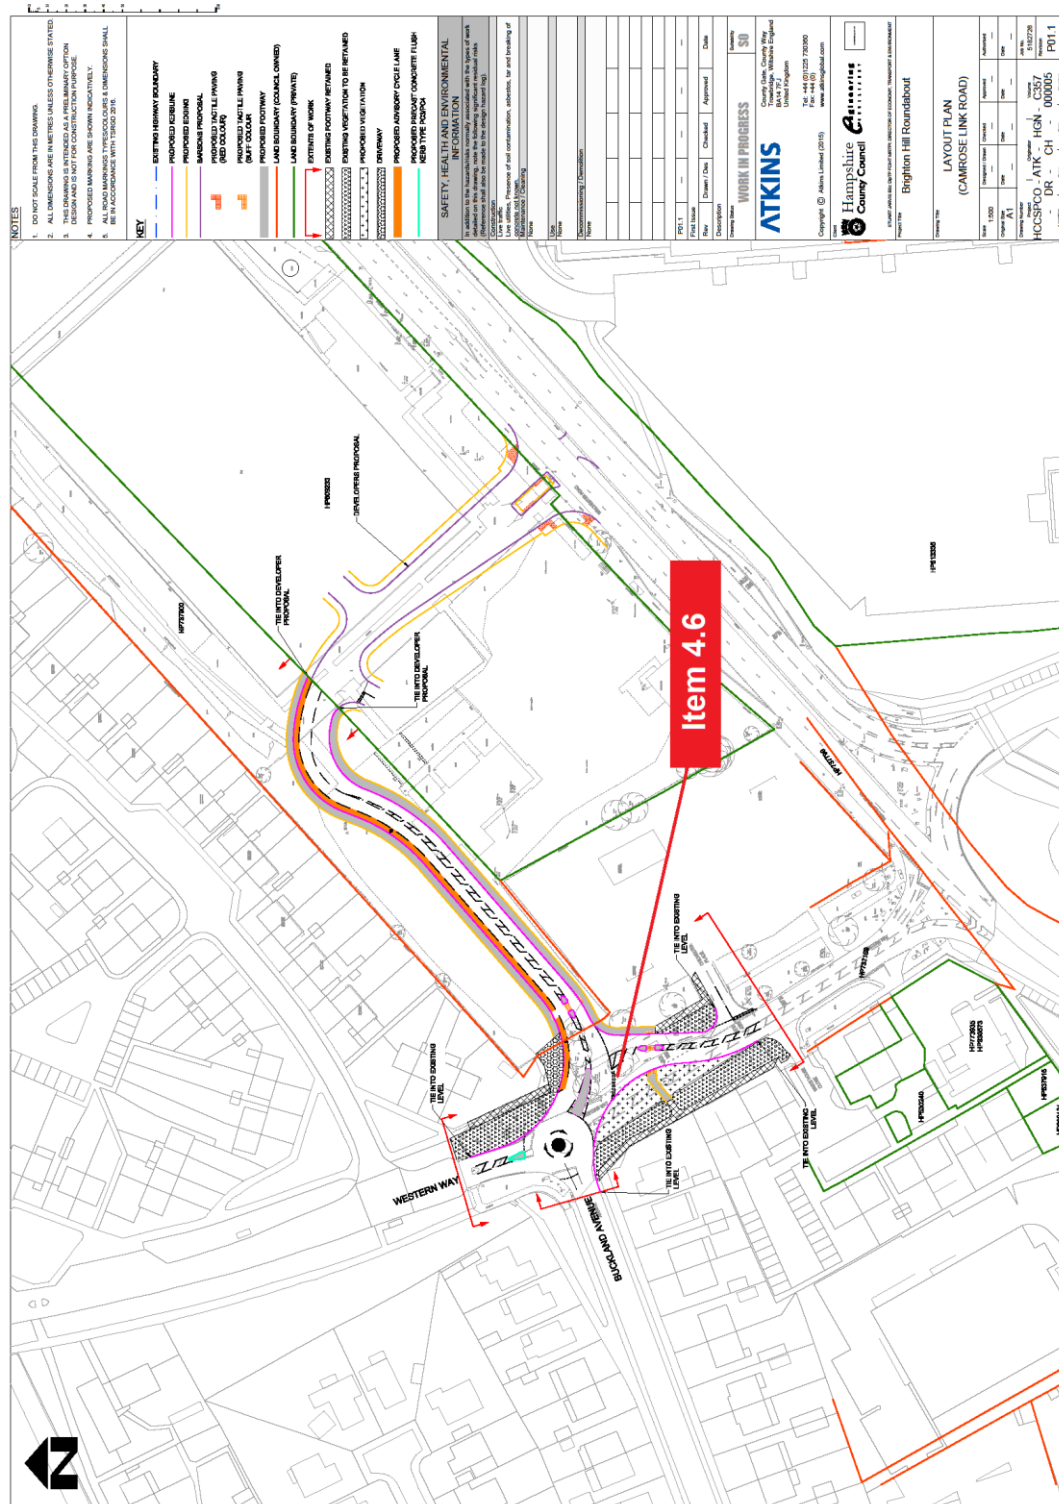
Annotated Plan

Location: Throughout the scheme.

Summary: A lack of cycle infrastructure will increase the risk of collisions between cyclists and pedestrians/vehicles.

The proposed at-grade crossings will be toucans, but there is no cycle infrastructure to connect these crossings with any existing off-road cycle routes or provide a link to the existing road network. As a result, cyclists may carry out undesirable manoeuvres which could lead to collisions with vehicles or pedestrians.

Location: The proposed segregated cycleway/footway on the A30 Winchester Road (east) and Brighton Way.

Summary: An incomplete cycle network will result in cyclists carrying out undesirable manoeuvres that may lead to collisions with vehicles or pedestrians.

There are proposed sections of segregated footway/cycleway on both sides of Winchester Road (east) and on the east side of Brighton Way, but these do not connect with any existing off- road cycle routes and there are no transitions to and from the carriageway. As a result, cyclists may continue along the footway or rejoin the carriageway at undesirable locations. This could lead to collisions with pedestrian or vehicles.

Location: The existing safety fencing around the outside of Brighton Hill roundabout.

Summary: Sections of safety fencing will have to be removed to facilitate the at-grade crossings.

There is existing safety fencing around the outside of the roundabout to prevent vehicles from entering the steep drops to the subway ramps. If the safety fencing is removed to facilitate the at-grade crossings, there is a risk of errant vehicles entering these areas which could increase the severity of a collision.

Location: The proposed ramp to the crossing on A30 Winchester Road (west)

Summary: The proposed ramp will be too steep for mobility impaired pedestrians to negotiate.

From a visual assessment, it looks as though the proposed ramp to the crossing on A30 Winchester Road (west) will be much steeper than the maximum recommended gradient for mobility impaired pedestrians. Wheelchair users may be unable to negotiate the ramp and there is a risk of tipping accidents.

Location: The proposed ramp to the south side of the crossing on old Winchester Road.

Summary: The proposed ramp may be too steep for mobility impaired pedestrians to negotiate.

From a visual assessment, it looks as though the proposed ramp to the crossing on old Winchester Road will be steeper than the maximum recommended gradient for mobility impaired pedestrians. Wheelchair users may be unable to negotiate the ramp and there is a risk of tipping accidents.

Location: The section of Western Way south of the new Camrose Link Road.

Summary: Difficult or inappropriate turning manoeuvres onto the new link road.

Traffic heading towards the A30 Winchester Road from the southern end of Western Way are prevented from turning right onto the new Camrose Link Road by an extended splitter island, and instead will have to turn left and then U-turn at the mini roundabout. It is unclear if vehicles, particularly Pizza Express delivery vehicles, are able to make this manoeuvre without being unduly restricted. There is also a risk of drivers attempting to turn right directly onto the link road to avoid the roundabout which may result in collisions with other vehicles.

Recommendation: Provide a coherent network of off-carriageway cycle links that connect the proposed toucan crossings to the strategic cycle network.

Recommendation: Provide a coherent cycle network.

Recommendation: Provide appropriate measure to protect vehicles from the steep drops.

Recommendation: The absolute maximum gradient of the ramp should be 1 in 12, but preferably no greater than 1 in 20. If this cannot be achieved, an alternative arrangement should be considered.

Recommendation: Review the access arrangement for the southern end of Western Way onto the new Camrose Link Road.
