Birmingham and Solihull
Mental Health NHS Foundation Trust

Management Asbestos Registers for Properties Containing
Asbestos Materials
2016.

Report type: Assessment of Asbestos Containing Materials

Report Date: 20th December 2016

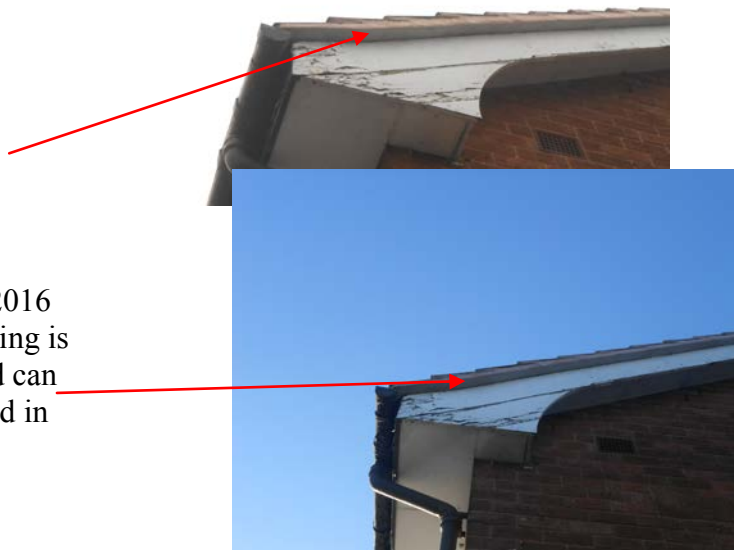
Reviewed November 2016
The cement under cloaking is
in a good condition and can
continue to be managed in
place.

Material Risk Score: 4

In general, the under cloaking is in good condition with no signs of slippage, or material breakage. This cement under cloaking should be managed in place.

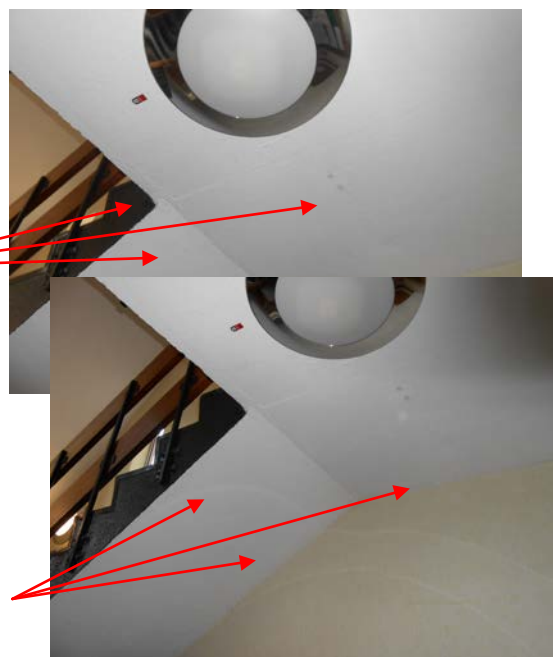
This Artex material to the underside and sides of the staircase is in a reasonable condition with some very small areas of damaged, it is recommended to paint the Artex surfaces with advice from a licensed asbestos contractor

Total Risk Score: 3 – Very low risk

The recommended action is to manage the material, by not allowing any disturbance of it, and with periodic checks, looking for any sign of cracks or water damage, the material is then perfectly safe.

Any small areas of damage to the Artex should be painted to seal the area; this should be done with the advice of a licensed asbestos contractor.

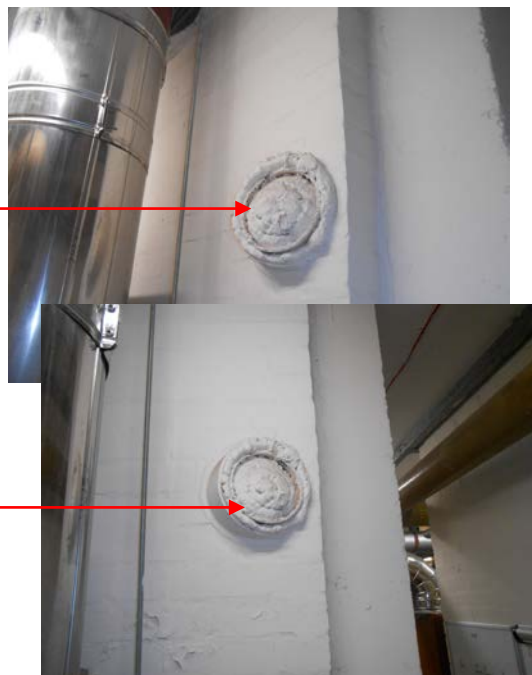
Reviewed November 2016
The woven rope seal is painted
and sealed and in a good
condition, it can continue to be
managed in place

Material Risk Score: 7

The recommended action is to manage the seal in situ until it can be disposed of correctly and place an asbestos label in a safe place on or near the woven seal in order to identify its nature.

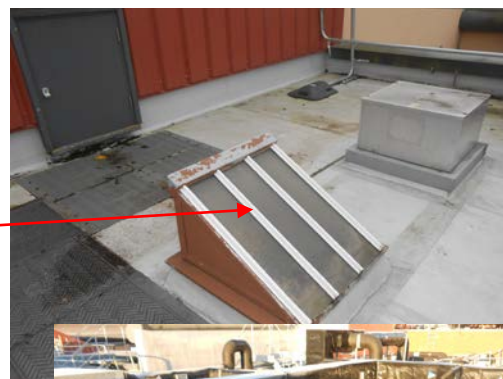
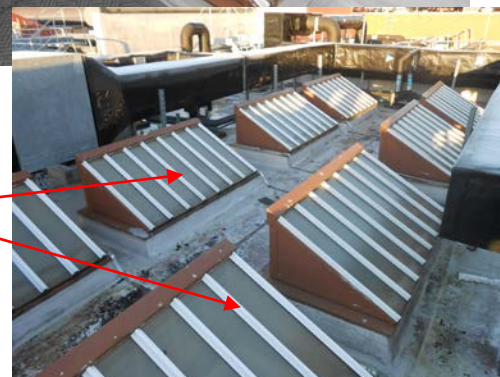
Reviewed November 2016
The pictures show a representation of the skylights with woven asbestos rope seals. All seals were checked and were in a good condition. They can continue to be managed in place

Total Risk Score: 7 – Medium Risk

The recommended action is to manage the seal in situ until it can be disposed of correctly and place an asbestos label in a safe place on or near the woven seal in order to identify its nature.

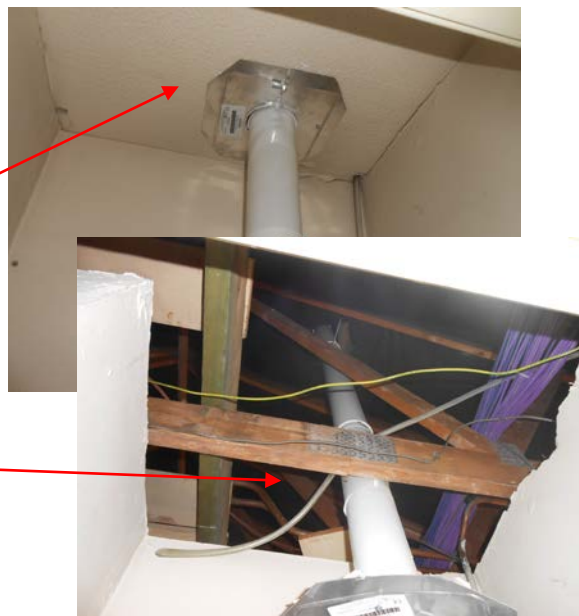
During the review, remains of the Artex coating were found to be on the metal plate around the flue pipes. It has since been notified by the site manager that these remains have been removed.

Material Risk Score: 3

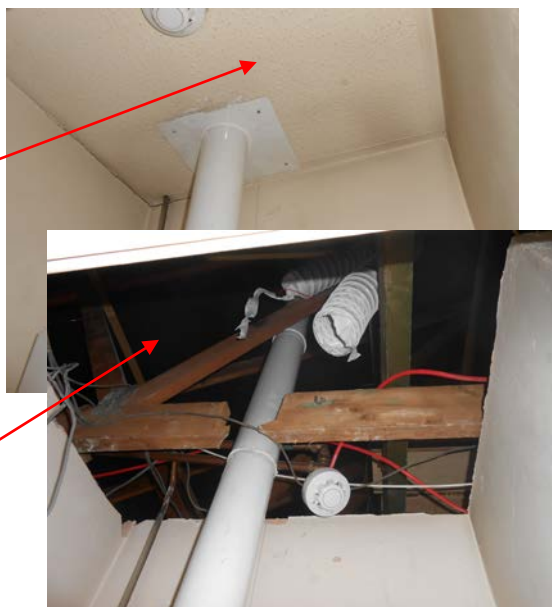
During the review, remains of the Artex coating were found to be on the metal plate around the flue pipes. It has since been notified by the site manager that these remains have been removed.

Material Risk Score: 3

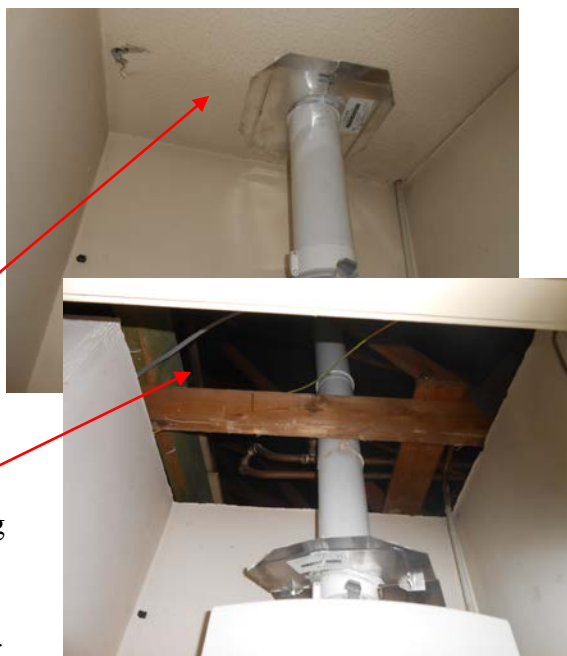
During the review, remains of the Artex coating were found to be on the metal plate around the flue pipes. It has since been notified by the site manager that these remains have been removed.

Material Risk Score: 3

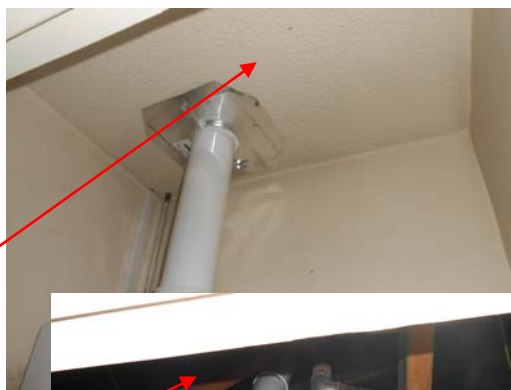
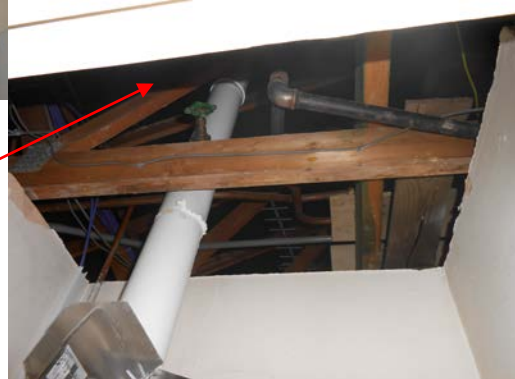
During the review, remains of the Artex coating were found to be on the metal plate around the flue pipes. It has since been notified by the site manager that these remains have been removed.

Material Risk Score: 3

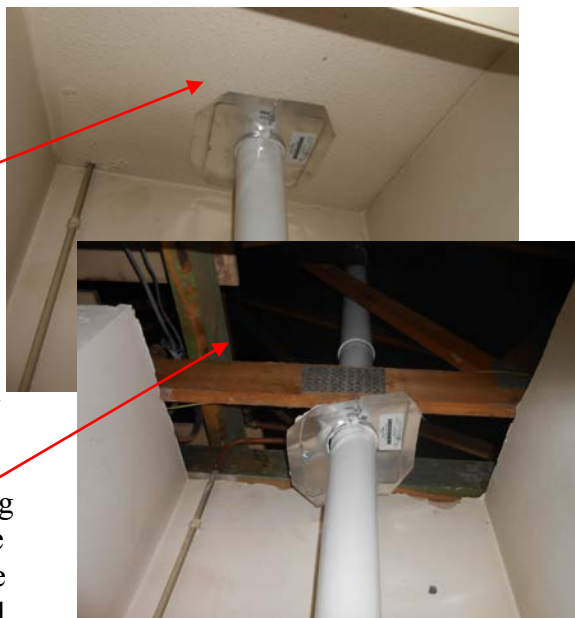
During the review, remains of the Artex coating were found to be on the metal plate around the flue pipes. It has since been notified by the site manager that these remains have been removed.

Material Risk Score: 3

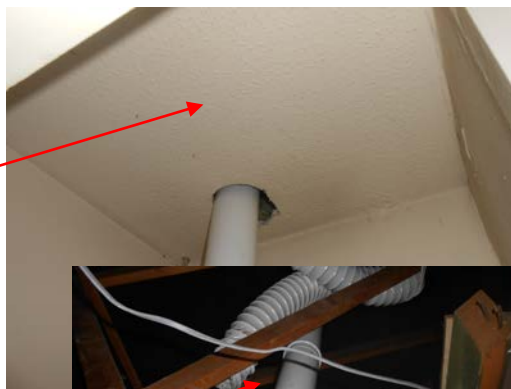
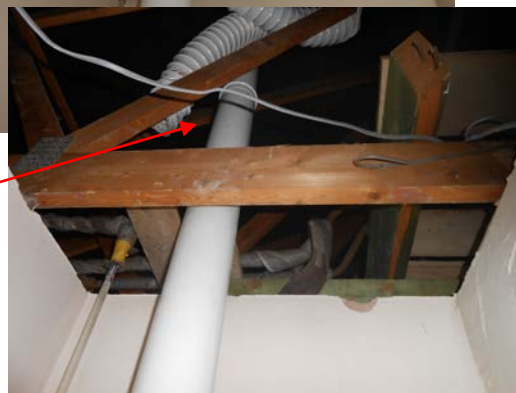
During the review, remains of the Artex coating were found to be on the metal plate around the flue pipes. It has since been notified by the site manager that these remains have been removed.

Material Risk Score: 3

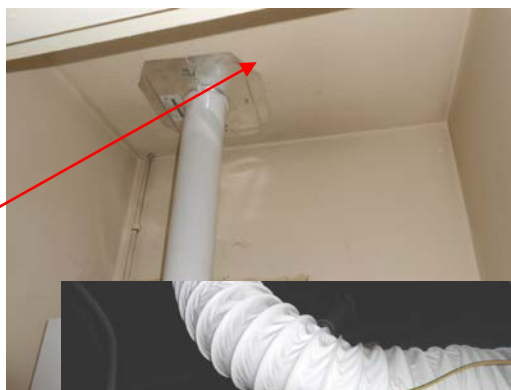
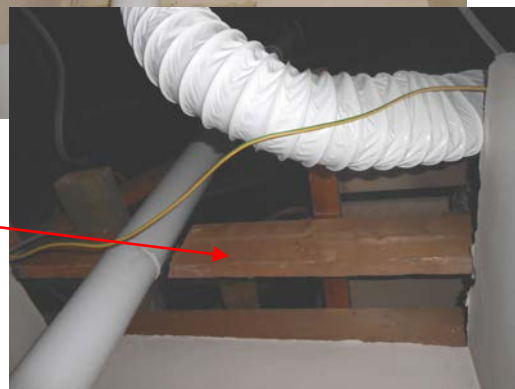
During the review, remains of the Artex coating were found to be on the metal plate around the flue pipes. It has since been notified by the site manager that these remains have been removed.

Material Risk Score: 3

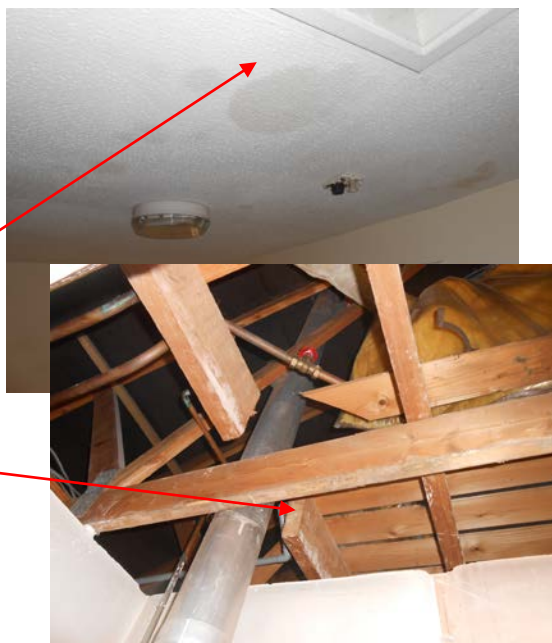
During the review, remains of the Artex coating were found to be on the metal plate around the flue pipes. It has since been notified by the site manager that these remains have been removed.

Material Risk Score: 3

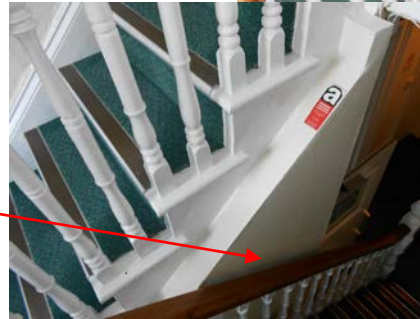
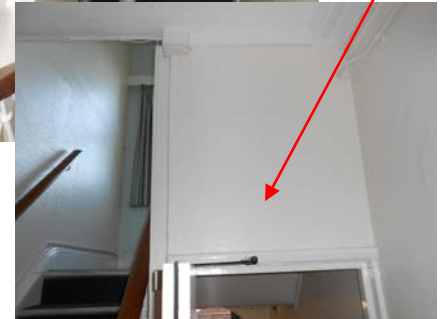
Reviewed November 2016
This insulation board are in good condition. They should be encapsulated further to reduce the risk of damage

Total Risk Score: 7 – Medium risk

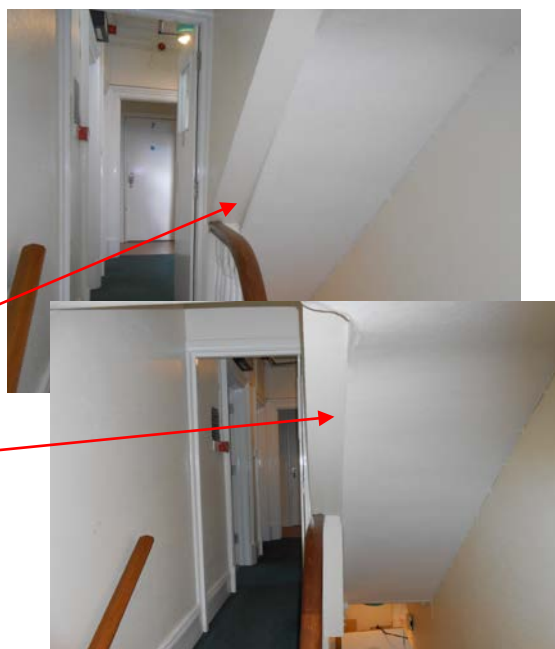
Reviewed November 2016
This insulation board are in good condition. They should be encapsulated further to reduce the risk of damage

Material Risk Score: 7

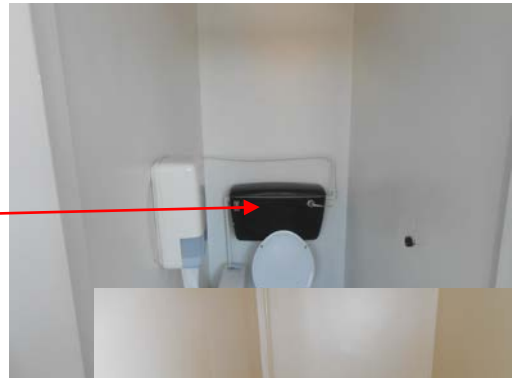
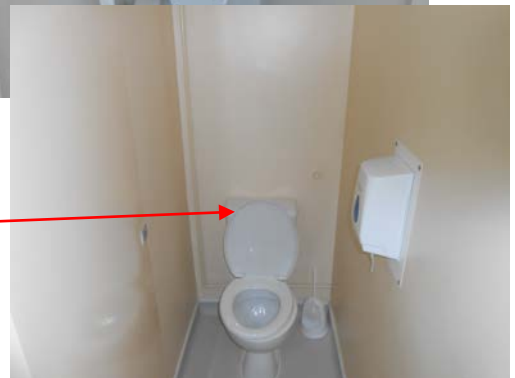
Reviewed November 2016
The Bakelite asbestos toilet
cistern has been removed

Material Risk Score: 4

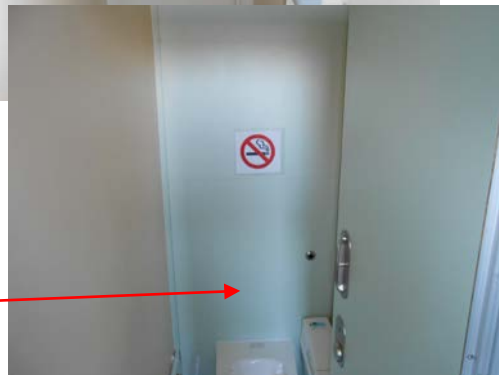
Reviewed November 2016
The Bakelite asbestos toilet
cistern has been removed

Material Risk Score: 4

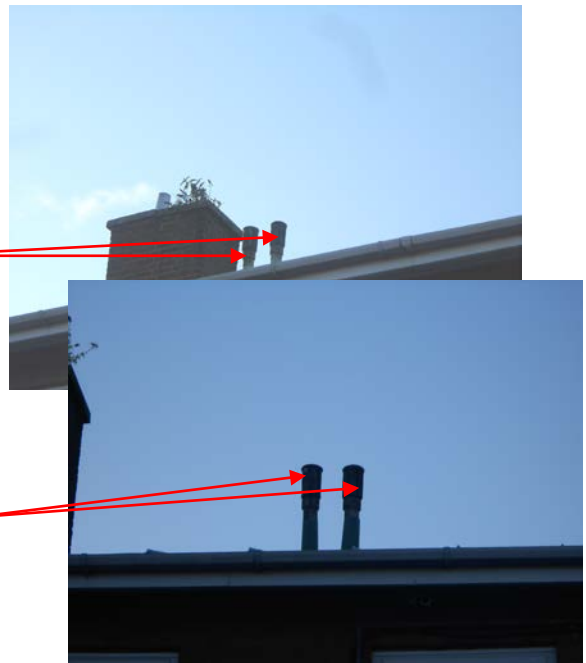
Reviewed November 2016
The cement flue cowls to the main roof are in good condition, they can continue to be managed in place

Material Risk Score: 4
Product Type: 1
Damage/deterioration: 1
Surface treatment: 1
Asbestos type: 1

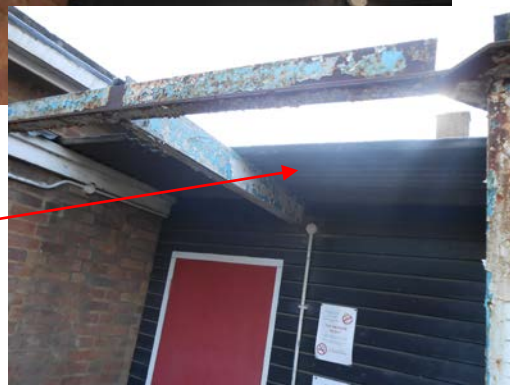
Reviewed November 2016
The corrugated cement roof sheets are still in situ. These cement sheets should be removed with advice from a licensed asbestos removal contractor

Material Risk Score: 5

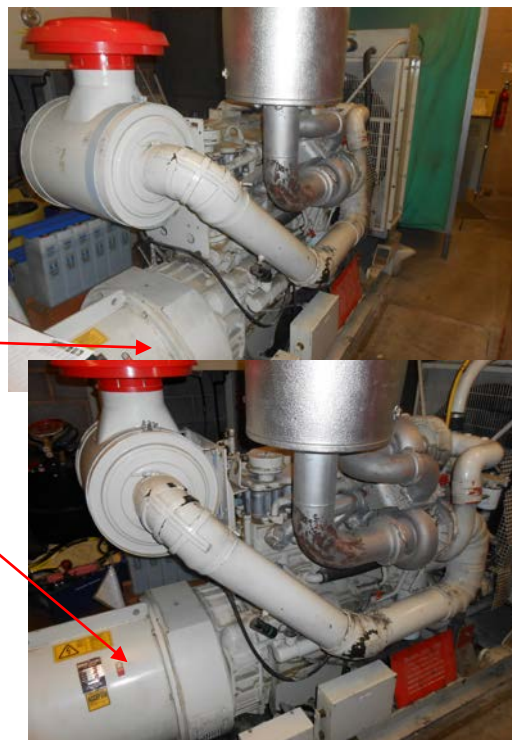
Reviewed November 2016
The flange gaskets within this generator are presumed to be in a good condition, there is no access inside the machine. The gaskets can continue to be managed in place

Material Risk Score: 3

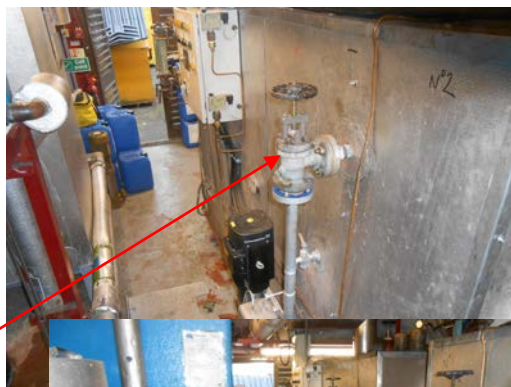
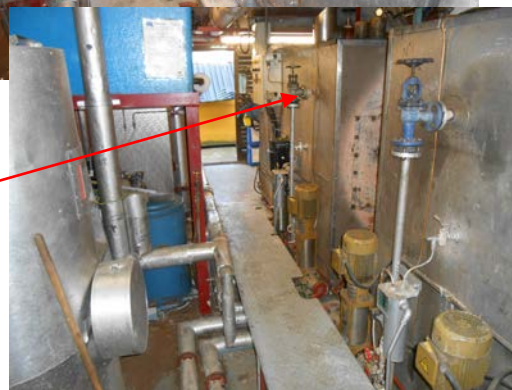
There are both modern and asbestos containing flange gaskets to the pipe work. They are all in good condition. All gaskets should be treated as asbestos materials unless it can be proved that they have been replaced with a modern gasket material

Material Risk Score: 3

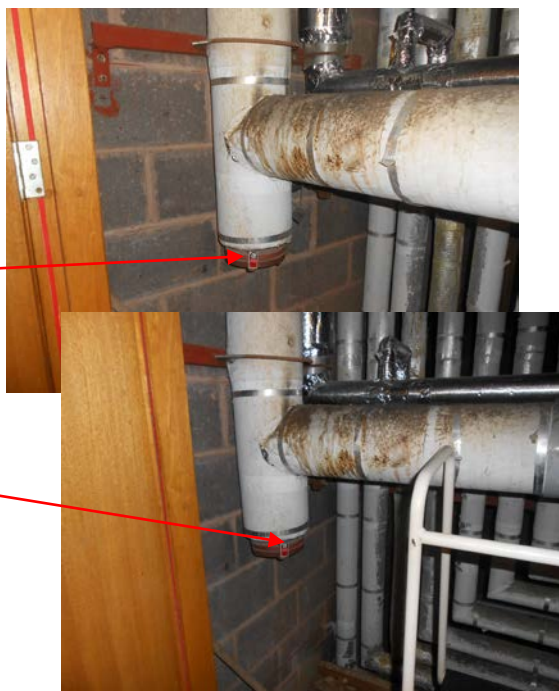
Reviewed November 2016
This and all flange gaskets in this
area are in a good condition and
can continue to be managed in
place

Material Risk Score: 3

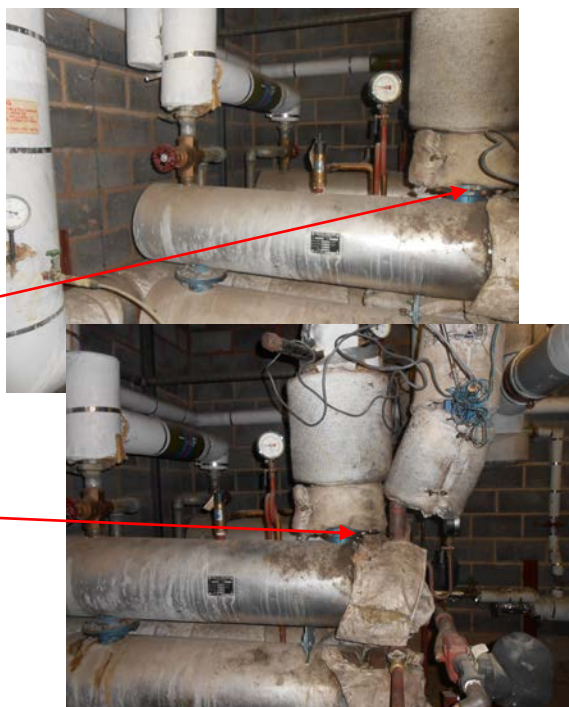
There are both modern and asbestos containing flange gaskets to the pipe work. They are all in good condition. All gaskets should be treated as asbestos materials unless it can be proved that they have been replaced with a modern gasket material

Material Risk Score: 3

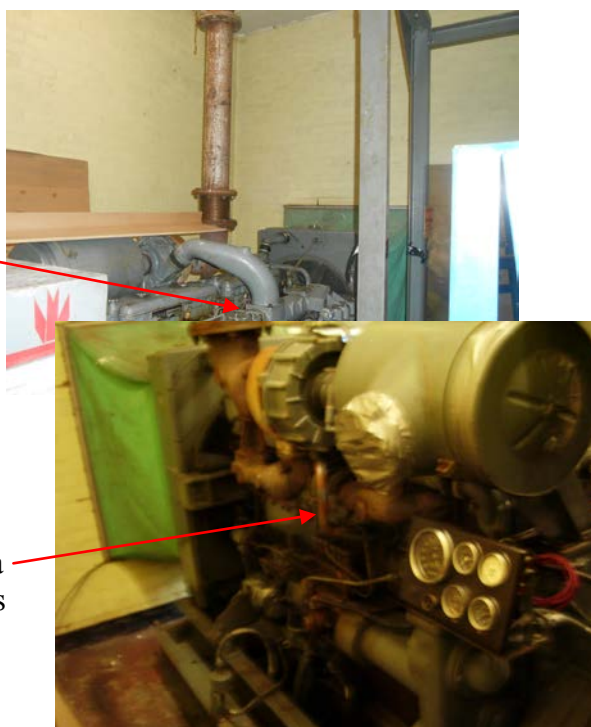
Reviewed November 2016
The flange gaskets within this generator are presumed to be in a good condition, there is no access inside the machine. The gaskets can continue to be managed in place

Material Risk Score: 3

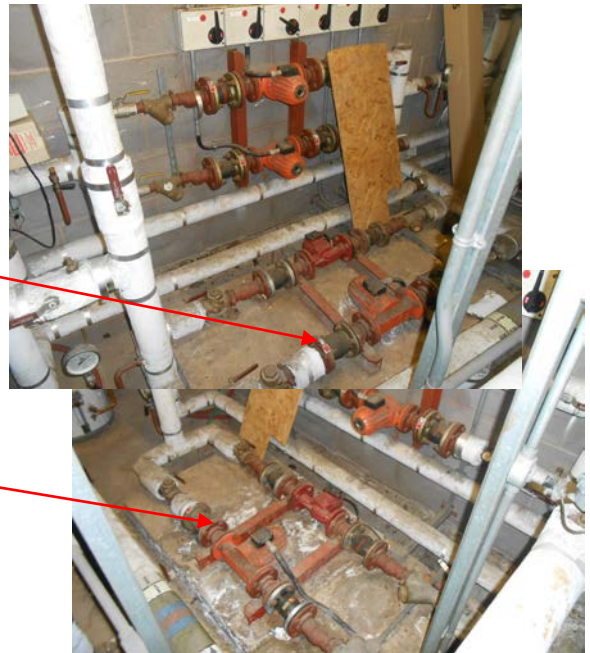
There are both modern and asbestos containing flange gaskets to the pipe work. They are all in good condition. All gaskets should be treated as asbestos materials unless it can be proved that they have been replaced with a modern gasket material

Material Risk Score: 3

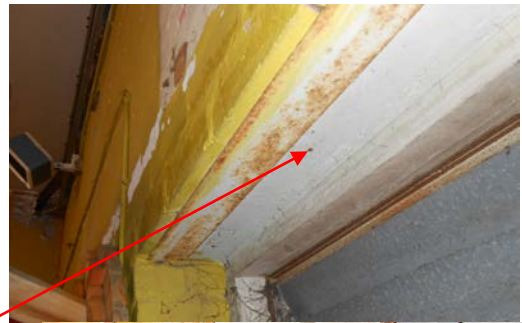
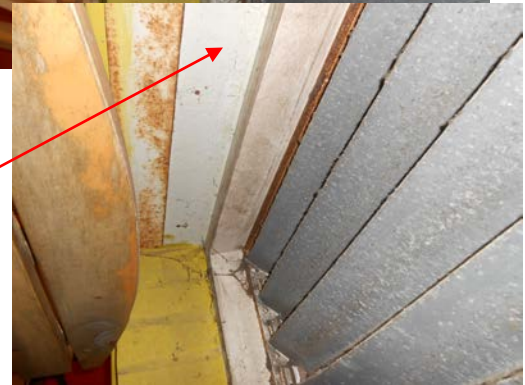
Reviewed November 2016
This AIB panel is in a good condition and can continue to be managed in place, it should be labelled to identify its asbestos content.

Material Risk Score: 6

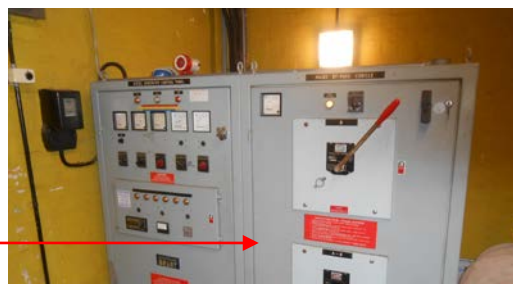
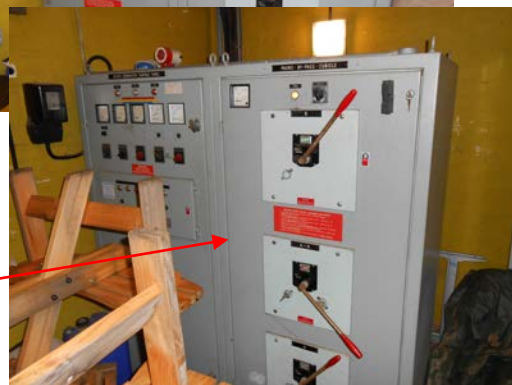
Reviewed November 2016
There was no access into the electrics due to all electrics being live. It is presumed that all internal asbestos material are in a good condition and can continue to be managed in place

Total Risk Score: 7 - Medium risk

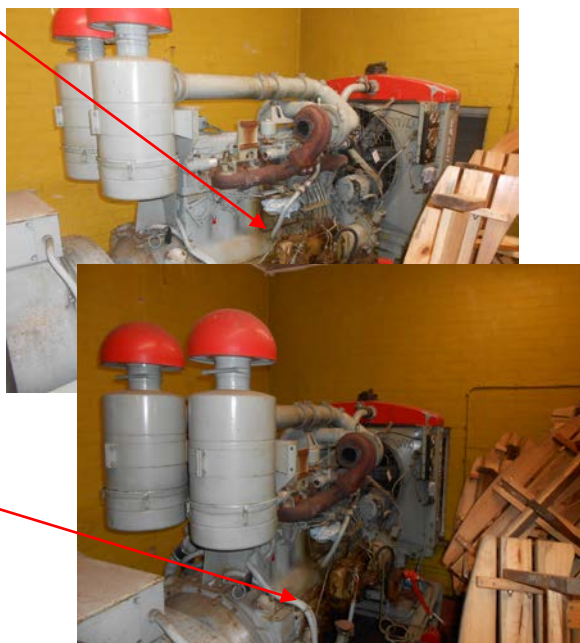
Reviewed November 2016
The flange gaskets within this generator are presumed to be in a good condition, there is no access inside the machine. The gaskets can continue to be managed in place

Material Risk Score: 3

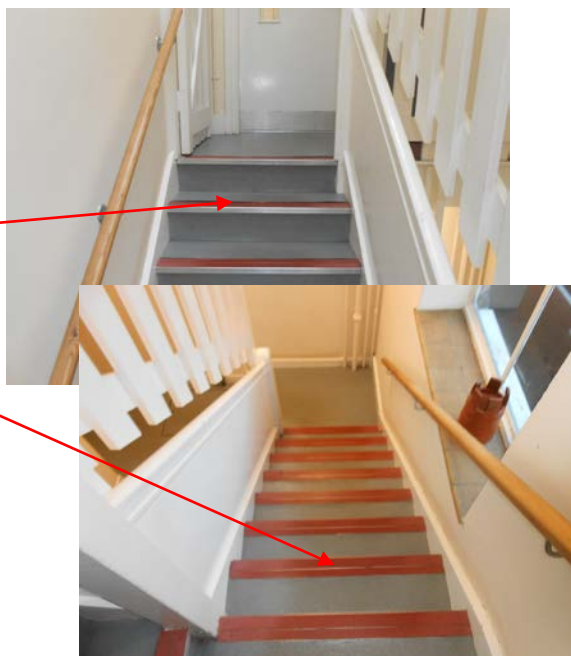
Reviewed November 2016
The vinyl stair nosings to this staircase are in a good condition and can continue to be managed in place.
If the grey vinyl flooring is placed, care should be taken as not to disturb the asbestos nosing materials

Material Risk Score: 3

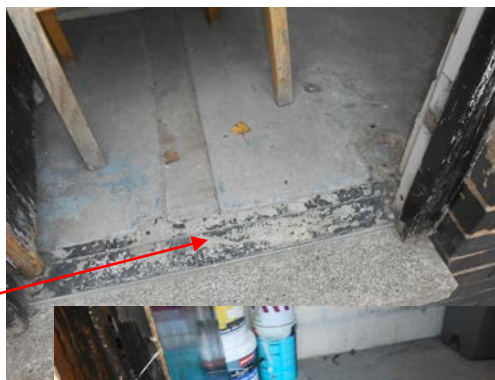
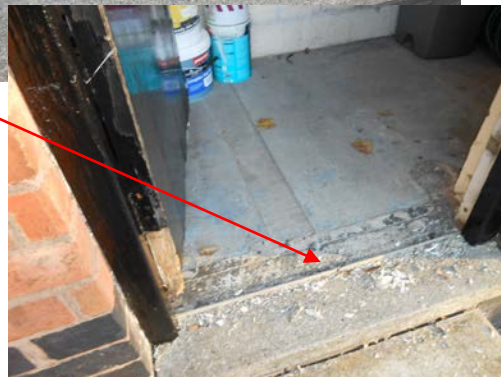
The bitumen adhesive to the floor is in a similar condition when previously checked in 2015, it can continue to be managed in place until a time where it can be removed safely

Material Risk Score: 4

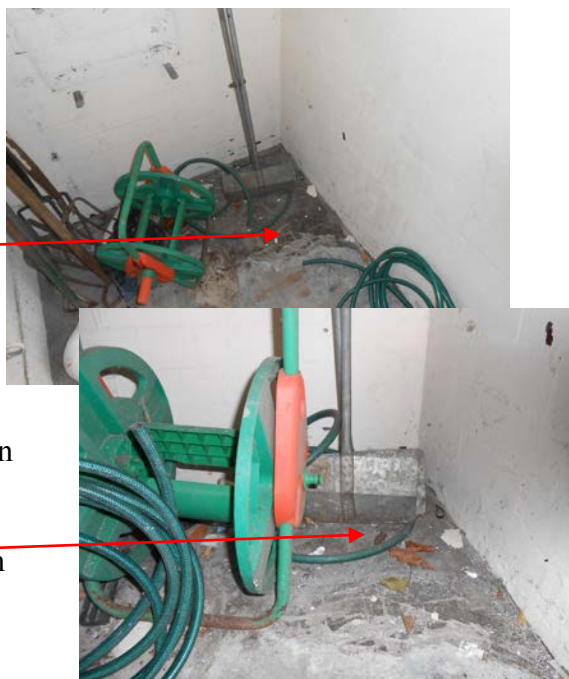
Reviewed November 2016
The vinyl flooring remains and bitumen adhesive to the floor is in a similar condition when previously checked in 2015, it can continue to be managed in place until a time where it can be removed safely

Material Risk Score: 3

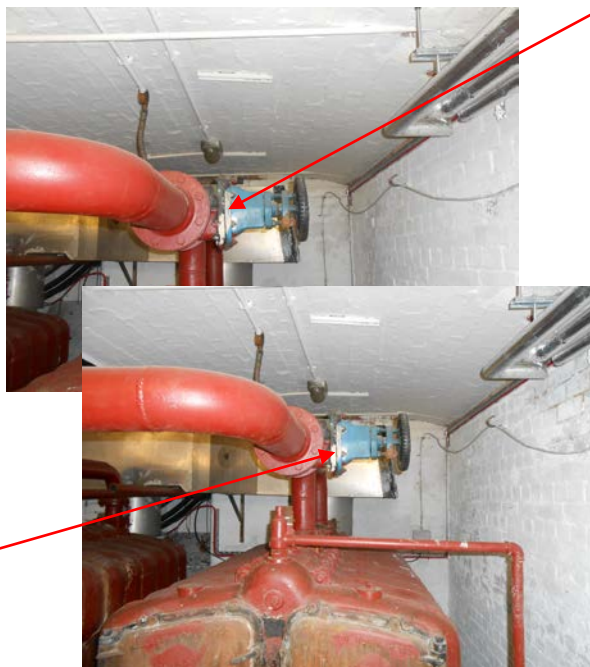
There are both modern and asbestos containing flange gaskets to the pipe work. They are all in good condition. All gaskets should be treated as asbestos materials unless it can be proved that they have been replaced with a modern gasket material

Material Risk Score: 3

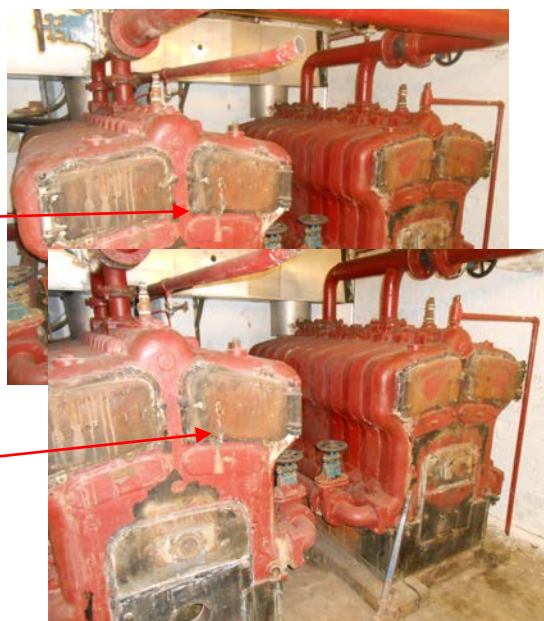
Material Risk Score: 7

Any areas of unpainted rope gaskets should be encapsulated by a licensed contractor to reduce the risk of accidentally damage to the rope gaskets.

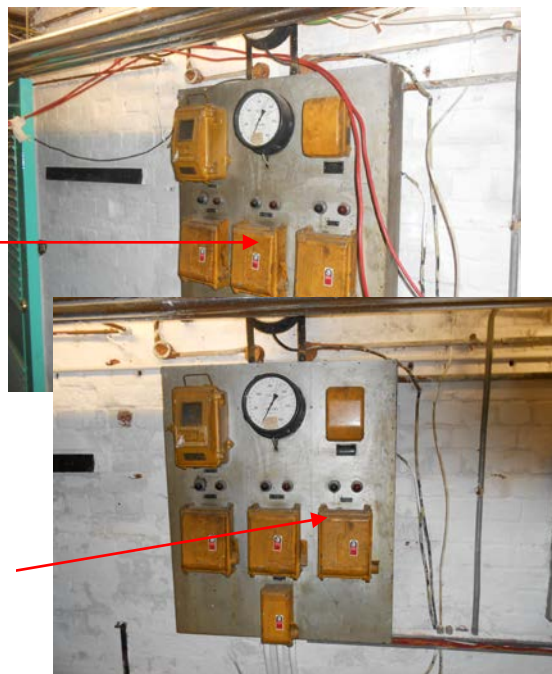
Reviewed November 2016
There was no access into the electrics due to all electrics being live. It is presumed that all internal asbestos material are in a good condition and can continue to be managed in place

Material Risk Score: 7

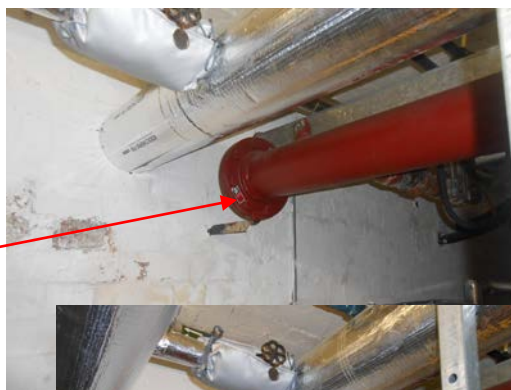
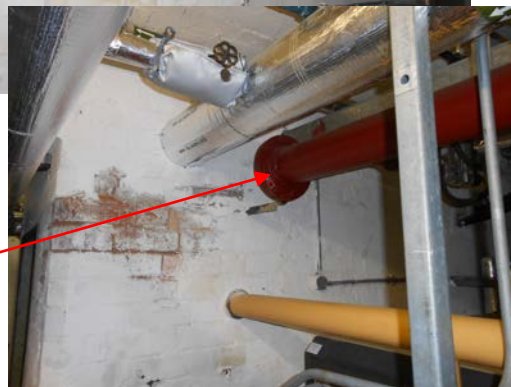
There are both modern and asbestos containing flange gaskets to the pipe work. They are all in good condition. All gaskets should be treated as asbestos materials unless it can be proved that they have been replaced with a modern gasket material

Material Risk Score: 3
