# **Asbestos Material & Priority Assessment Report**

**004 - Delta House TAJHQ**

**Survey Conducted by:** Riverside Environmental Services Ltd

**Survey Report Number** J099843

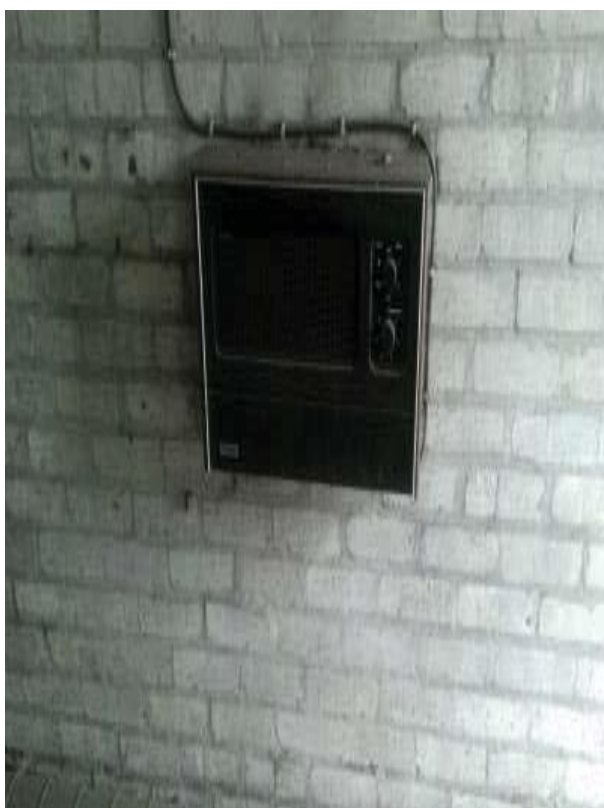
**Ground Floor G, Plant Room TAJAGG-DH-G-09**

Inspection Date	13/9/2016		
Component:	Wall Heater	Sample No.	J056577 Presumptive Sample 111
Survey Type	Type 2	Surveyor	Richard Farmer
Asbestos type	Crocidolite		
Quantity of Material	1m <sup>2</sup>

Material	2	Extent of Damage	0
Surface Treatment	2	Asbestos Type	3
<b>Material Assessment Total:</b>	<b>7</b>	<b>B</b>

Main Type of Activity	0	Extent of Material	1
Maintenance Activity	0	Location	2
Accessibility	0	Number of Occupants	0
Frequency of use	0	Average time is in use	0
Frequency of maintenance activity	0	<b>Risk Assessment Total:</b>	<b>1</b>
<b>Total Score:</b>	<b>8</b>	<b>Slight Risk</b>

Label and manage. This material does not require immediate attention.

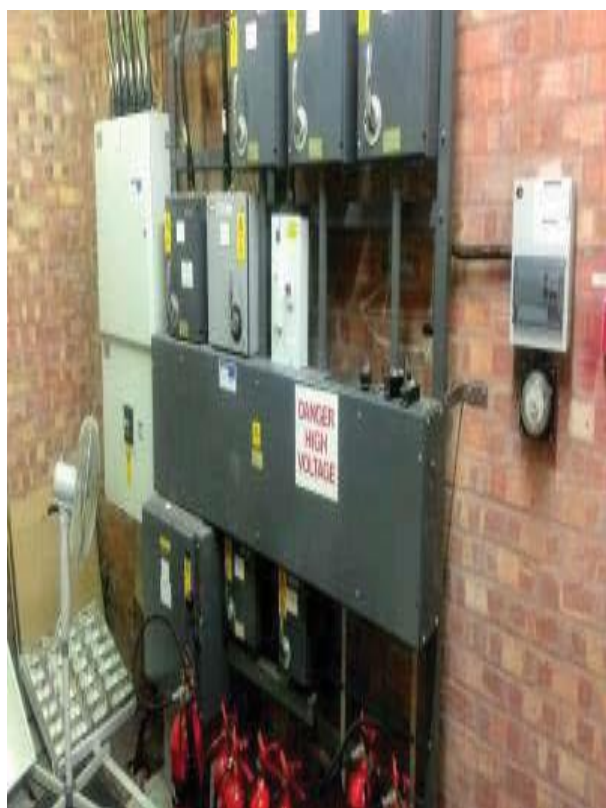
**Ground Floor G, Electrical Substation TAJAGG-DH-G-29**

Inspection Date	13/9/2016		
Component:	<b>Electrical Switch Gear</b>	Sample No.	<b>J056577 Presumptive Sample 91</b>
Survey Type	Type 2	Surveyor	Richard Farmer
Asbestos type	<b>Chrysotile</b>		
Quantity of Material	<b>0lm</b>

Material	2	Extent of Damage	0
Surface Treatment	1	Asbestos Type	3
<b>Material Assessment Total:</b>	<b>6</b>	<b>C</b>

Main Type of Activity	0	Extent of Material	0
Maintenance Activity	0	Location	3
Accessibility	0	Number of Occupants	0
Frequency of use	0	Average time is in use	0
Frequency of maintenance activity	0	<b>Risk Assessment Total:</b>	<b>1</b>
<b>Total Score:</b>	<b>7</b>	<b>Sound</b>

Incorporate asbestos containing materials into management plan until removal.

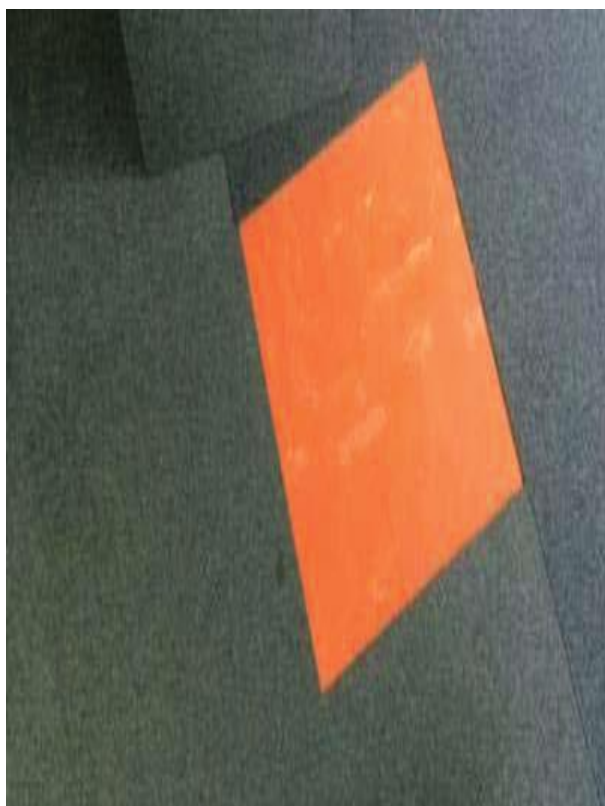
**First Floor 1, Office TAJAGG-DH-1-04**

Inspection Date	13/9/2016		
Component:	<b>Orange Floor Tiles</b>	Sample No.	<b>VCFD001470 - 104</b>
Survey Type	Type 2	Surveyor	Richard Farmer
Asbestos type	<b>Chrysotile</b>		
Quantity of Material	<b>500m<sup>2</sup></b>

Material	1	Extent of Damage	0
Surface Treatment	0	Asbestos Type	1
<b>Material Assessment Total:</b>	<b>2</b>	<b>D</b>

Main Type of Activity	1	Extent of Material	3
Maintenance Activity	0	Location	1
Accessibility	0	Number of Occupants	3
Frequency of use	3	Average time is in use	3
Frequency of maintenance activity	0	<b>Risk Assessment Total:</b>	<b>5</b>
<b>Total Score:</b>	<b>7</b>	<b>Sound</b>

Incorporate asbestos containing materials into management plan until removal.

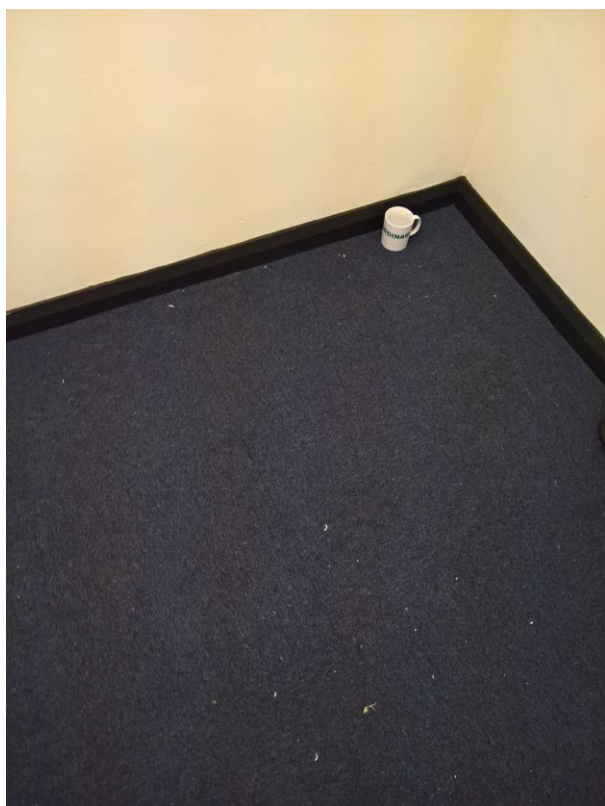
**First Floor 1, Circulation – Lobby TAJAGG-DH-1-09**

Inspection Date	13/9/2016		
Component:	<b>Orange Floor Tiles</b>	Sample No.	<b>VCFD001465 - 109</b>
Survey Type	Type 2	Surveyor	Richard Farmer
Asbestos type	<b>Chrysotile</b>		
Quantity of Material	<b>8m<sup>2</sup></b>

Material	1	Extent of Damage	1
Surface Treatment	0	Asbestos Type	1
<b>Material Assessment Total:</b>	<b>3</b>	<b>D</b>

Main Type of Activity	0	Extent of Material	1
Maintenance Activity	0	Location	2
Accessibility	2	Number of Occupants	0
Frequency of use	0	Average time is in use	0
Frequency of maintenance activity	0	<b>Risk Assessment Total:</b>	<b>2</b>
<b>Total Score:</b>	<b>5</b>	<b>Sound</b>

Incorporate asbestos containing materials into management plan until removal.

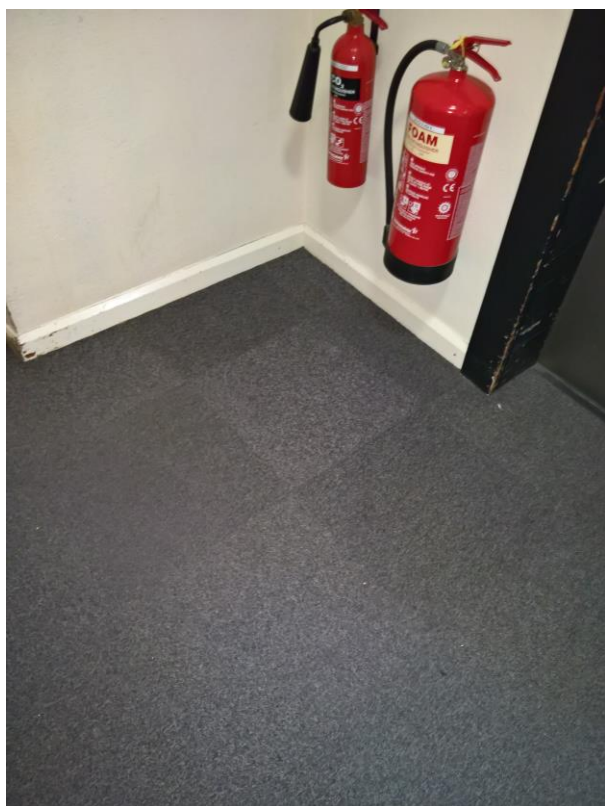
**First Floor 1, Circulation – Stairs TAJAGG-DH-1-S1**

Inspection Date	13/9/2016		
Component:	<b>Orange Floor Tiles</b>	Sample No.	<b>VCFD001470 - 1S1</b>
Survey Type	Type 2	Surveyor	Richard Farmer
Asbestos type	<b>Chrysotile</b>		
Quantity of Material	<b>20m<sup>2</sup></b>

Material	1	Extent of Damage	0
Surface Treatment	0	Asbestos Type	1
<b>Material Assessment Total:</b>	<b>2</b>	<b>D</b>

Main Type of Activity	1	Extent of Material	2
Maintenance Activity	0	Location	2
Accessibility	0	Number of Occupants	1
Frequency of use	3	Average time is in use	3
Frequency of maintenance activity	0	<b>Risk Assessment Total:</b>	<b>4</b>
<b>Total Score:</b>	<b>6</b>	<b>Sound</b>

Incorporate asbestos containing materials into management plan until removal.

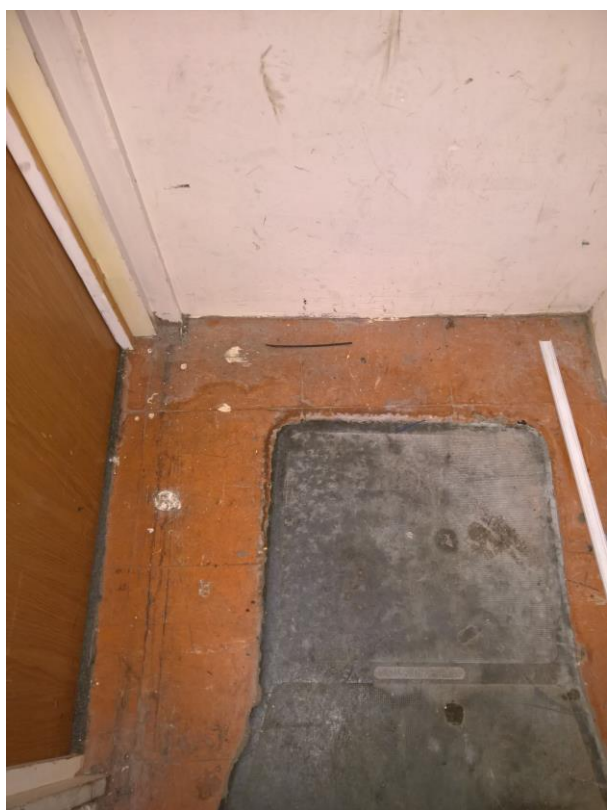
**Third Floor 3, Lift Motor Room TAJAGG-DH-3-04**

Inspection Date	13/9/2016		
Component:	<b>Bitumen Backed Orange Floor Tiles</b>	Sample No.	<b>FD001462</b>
Survey Type	Type 2	Surveyor	Richard Farmer
Asbestos type	<b>Chrysotile</b>		
Quantity of Material	<b>2m<sup>2</sup></b>

Material	1	Extent of Damage	1
Surface Treatment	0	Asbestos Type	1
<b>Material Assessment Total:</b>	<b>3</b>	<b>D</b>

Main Type of Activity	0	Extent of Material	1
Maintenance Activity	0	Location	3
Accessibility	2	Number of Occupants	1
Frequency of use	0	Average time is in use	0
Frequency of maintenance activity	0	<b>Risk Assessment Total:</b>	<b>2</b>
<b>Total Score:</b>	<b>5</b>	<b>Sound</b>

Keep Asbestos containing materials on management plan and continue to monitor.

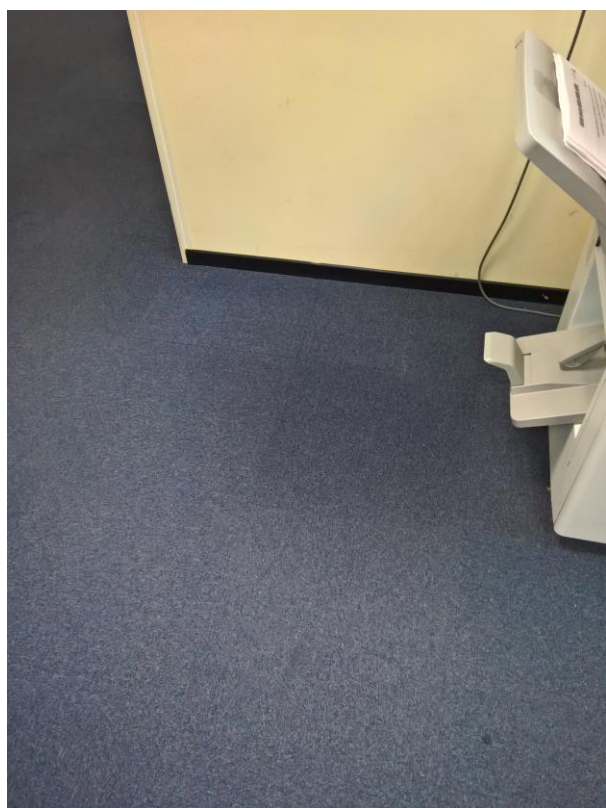
**Third Floor 3, Photocopy Room TAJAGG-DH-3-08**

Inspection Date	3/11/2016		
Component:	<b>Bitumen Backed Orange Floor Tiles</b>	Sample No.	<b>VCFD001462 - 308</b>
Survey Type	Type 2	Surveyor	Richard Farmer
Asbestos type	<b>Chrysotile</b>		
Quantity of Material	<b>20m<sup>2</sup></b>

Material	1	Extent of Damage	1
Surface Treatment	0	Asbestos Type	1
<b>Material Assessment Total:</b>	<b>3</b>	<b>D</b>

Main Type of Activity	1	Extent of Material	2
Maintenance Activity	0	Location	2
Accessibility	0	Number of Occupants	1
Frequency of use	3	Average time is in use	2
Frequency of maintenance activity	0	<b>Risk Assessment Total:</b>	<b>4</b>
<b>Total Score:</b>	<b>7</b>	<b>Sound</b>

Keep ACM on management plan and continue to monitor.

Actions Arising	Due Date	Est. Cost
Label & Manage	3-11-2016	£0

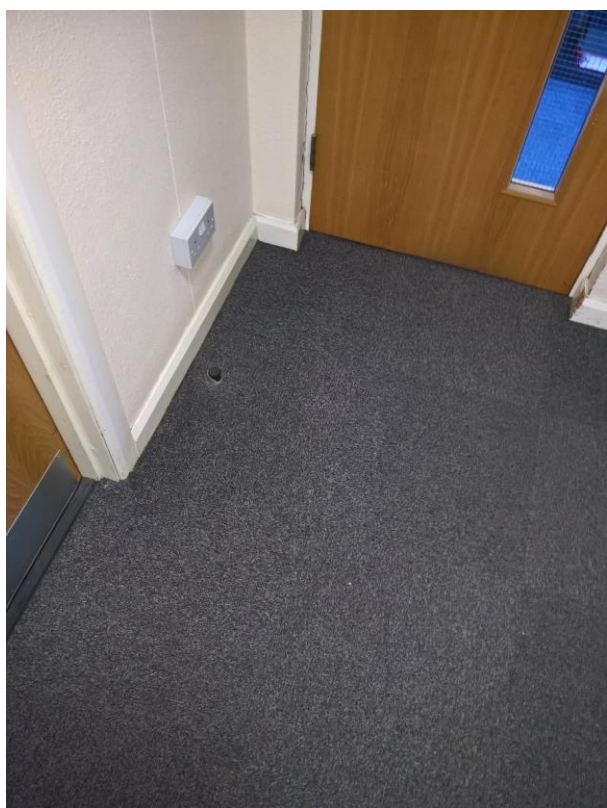
**Third Floor 3, Circulation – Stairs TAJAGG-DH-3-S1**

Inspection Date	13/9/2016		
Component:	<b>Bitumen Backed Orange Floor Tiles</b>	Sample No.	<b>VCFD001462 - 3S1</b>
Survey Type	Type 2	Surveyor	Richard Farmer
Asbestos type	<b>Chrysotile</b>		
Quantity of Material	<b>10m<sup>2</sup></b>

Material	1	Extent of Damage	1
Surface Treatment	0	Asbestos Type	1
<b>Material Assessment Total:</b>	<b>3</b>	<b>D</b>

Main Type of Activity	1	Extent of Material	1
Maintenance Activity	0	Location	2
Accessibility	0	Number of Occupants	2
Frequency of use	3	Average time is in use	2
Frequency of maintenance activity	0	<b>Risk Assessment Total:</b>	<b>4</b>
<b>Total Score:</b>	<b>7</b>	<b>Sound</b>

Keep ACM on management plan and continue to monitor.

Actions Arising	Due Date	Est. Cost
Label & Manage	3-11-2016	£0

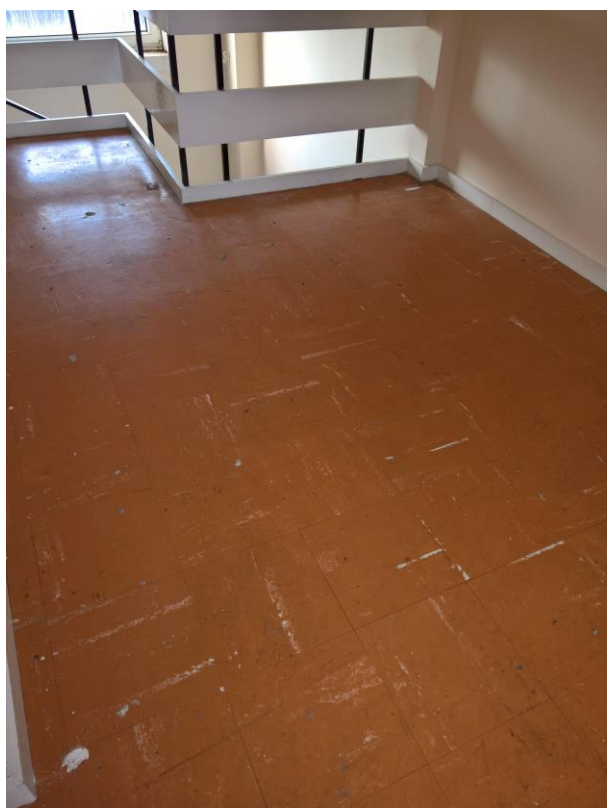
**Third Floor 3, Circulation – Stairs TAJAGG-DH-3-S2**

Inspection Date	13/9/2016		
Component:	<b>Orange Floor Tiles With Bitumen Adhesive</b>	Sample No.	<b>FD001465</b>
Survey Type	Type 2	Surveyor	Richard Farmer
Asbestos type	<b>Chrysotile</b>		
Quantity of Material	<b>20lm</b>

Material	1	Extent of Damage	1
Surface Treatment	0	Asbestos Type	1
<b>Material Assessment Total:</b>	<b>3</b>	<b>D</b>

Main Type of Activity	1	Extent of Material	2
Maintenance Activity	0	Location	2
Accessibility	2	Number of Occupants	0
Frequency of use	0	Average time is in use	0
Frequency of maintenance activity	0	<b>Risk Assessment Total:</b>	<b>3</b>
<b>Total Score:</b>	<b>6</b>	<b>Sound</b>

Keep ACM on management plan and continue to monitor.

Actions Arising	Due Date	Est. Cost
Label & Manage	14-11-2016	£0

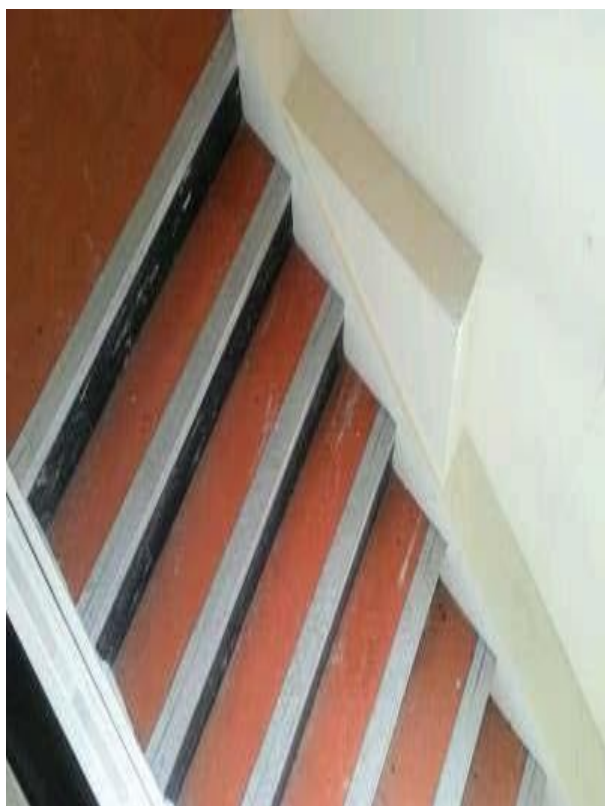
**Third Floor 3, Circulation – Stairs TAJAGG-DH-3-S2**

Inspection Date	13/9/2016		
Component:	<b>Stair Nosing</b>	Sample No.	<b>FD001466</b>
Survey Type	Type 2	Surveyor	Richard Farmer
Asbestos type	<b>Chrysotile</b>		
Quantity of Material	<b>12lm</b>

Material	1	Extent of Damage	0
Surface Treatment	0	Asbestos Type	1
<b>Material Assessment Total:</b>	<b>2</b>	<b>D</b>

Main Type of Activity	1	Extent of Material	2
Maintenance Activity	0	Location	2
Accessibility	2	Number of Occupants	0
Frequency of use	0	Average time is in use	0
Frequency of maintenance activity	0	<b>Risk Assessment Total:</b>	<b>3</b>
<b>Total Score:</b>	<b>5</b>	<b>Sound</b>

Keep ACM on management plan and continue to monitor.

<b>Actions Arising</b>	<b>Due Date</b>	<b>Est. Cost</b>
Label & Manage	3-11-2016	£0

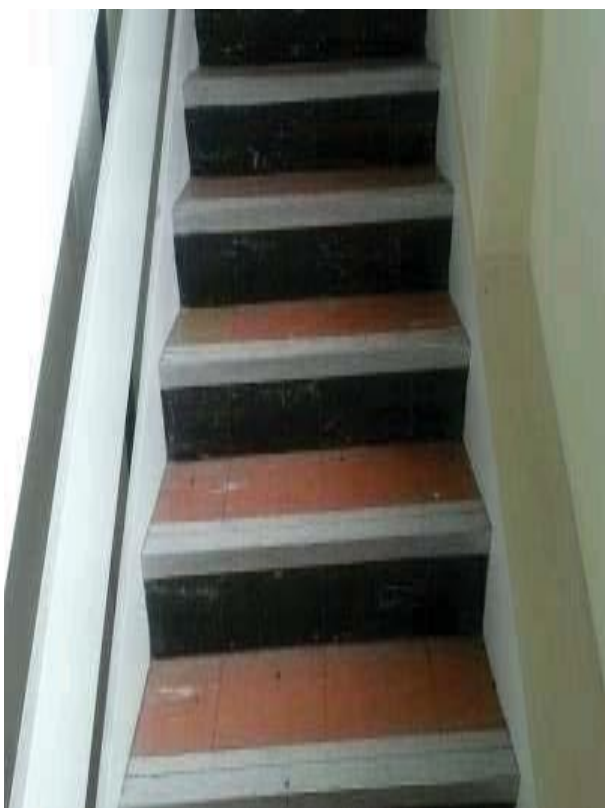
**Third Floor 3, Circulation – Stairs TAJAGG-DH-3-S2**

Inspection Date	13/9/2016		
Component:	<b>Black Floor Tiles</b>	Sample No.	<b>FD001468</b>
Survey Type	Type 2	Surveyor	Richard Farmer
Asbestos type	<b>Chrysotile</b>		
Quantity of Material	<b>4m<sup>2</sup></b>

Material	1	Extent of Damage	0
Surface Treatment	0	Asbestos Type	1
<b>Material Assessment Total:</b>	<b>2</b>	<b>D</b>

Main Type of Activity	1	Extent of Material	1
Maintenance Activity	0	Location	2
Accessibility	2	Number of Occupants	0
Frequency of use	0	Average time is in use	0
Frequency of maintenance activity	0	<b>Risk Assessment Total:</b>	<b>3</b>
<b>Total Score:</b>	<b>5</b>	<b>Sound</b>

Incorporate asbestos containing materials into management plan until removal.

<b>Actions Arising</b>	<b>Due Date</b>	<b>Est. Cost</b>
Label Material	3-11-2016	£0

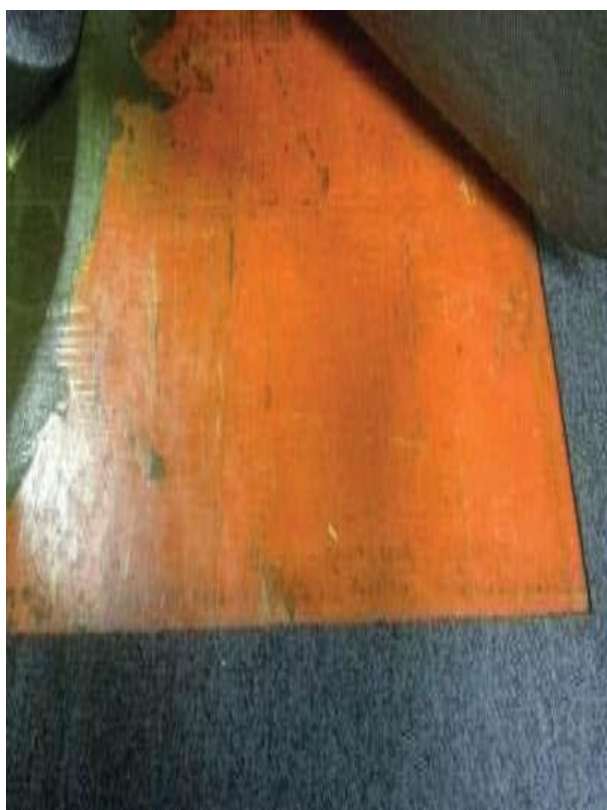
**Second Floor 2, Office TAJAGG-DH-2-05**

Inspection Date	13/9/2016		
Component:	<b>Orange Floor Tiles With Bitumen Adhesive</b>	Sample No.	<b>FD001470</b>
Survey Type	Type 2	Surveyor	Richard Farmer
Asbestos type	<b>Chrysotile</b>		
Quantity of Material	<b>500m<sup>2</sup></b>

Material	1	Extent of Damage	0
Surface Treatment	0	Asbestos Type	1
<b>Material Assessment Total:</b>	<b>2</b>	<b>D</b>

Main Type of Activity	1	Extent of Material	3
Maintenance Activity	0	Location	1
Accessibility	0	Number of Occupants	3
Frequency of use	3	Average time is in use	3
Frequency of maintenance activity	0	<b>Risk Assessment Total:</b>	<b>5</b>
<b>Total Score:</b>	<b>7</b>	<b>Sound</b>

Incorporate asbestos containing materials into management plan until removal.

Actions Arising	Due Date	Est. Cost
Label & Manage	3-11-2016	£0

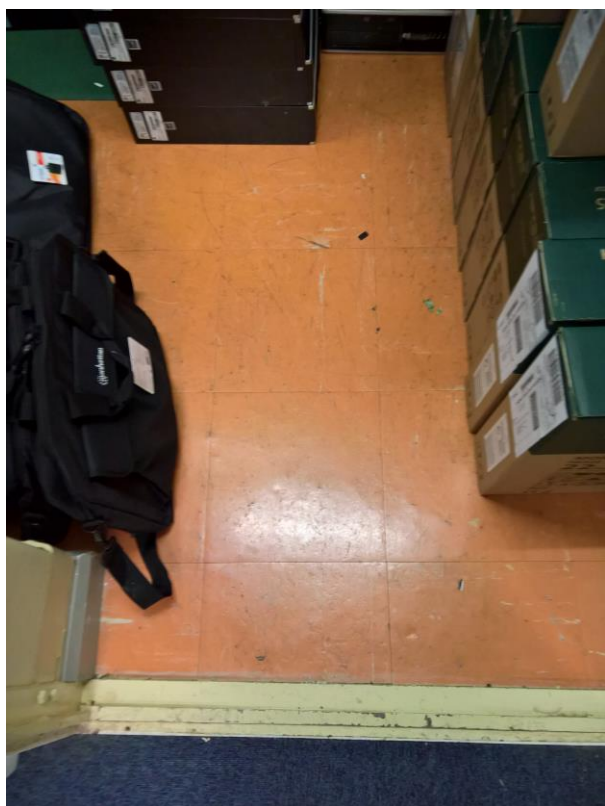
**Second Floor 2, Store TAJAGG-DH-2-10**

Inspection Date	13/9/2016		
Component:	<b>Orange Floor Tiles</b>	Sample No.	<b>VCFD001470 - 210</b>
Survey Type	Type 2	Surveyor	Richard Farmer
Asbestos type	<b>Chrysotile</b>		
Quantity of Material	<b>6m<sup>2</sup></b>

Material	1	Extent of Damage	0
Surface Treatment	0	Asbestos Type	1
<b>Material Assessment Total:</b>	<b>2</b>	<b>D</b>

Main Type of Activity	0	Extent of Material	1
Maintenance Activity	0	Location	3
Accessibility	2	Number of Occupants	0
Frequency of use	0	Average time is in use	0
Frequency of maintenance activity	0	<b>Risk Assessment Total:</b>	<b>2</b>
<b>Total Score:</b>	<b>4</b>	<b>Sound</b>

Incorporate asbestos containing materials into management plan until removal.

<b>Actions Arising</b>	<b>Due Date</b>	<b>Est. Cost</b>
Label & Manage	3-11-2016	£0

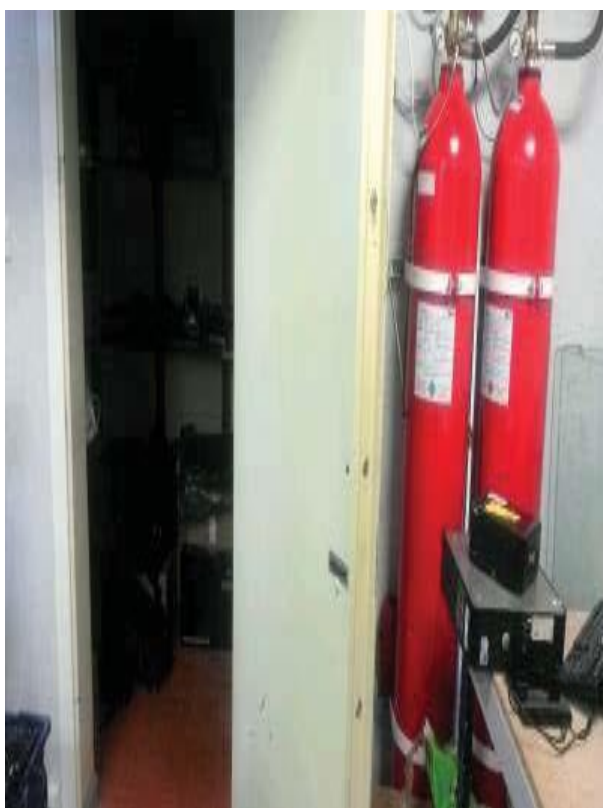
**Second Floor 2, Store TAJAGG-DH-2-10**

Inspection Date	13/9/2016		
Component:	<b>Steel Encased Door</b>	Sample No.	<b>J056577 Presumptive Sample 100</b>
Survey Type	Type 2	Surveyor	Richard Farmer
Asbestos type	<b>Amosite, Chrysotile, Crocidolite</b>		
Quantity of Material	<b>2m<sup>2</sup></b>

Material	2	Extent of Damage	0
Surface Treatment	2	Asbestos Type	3
<b>Material Assessment Total:</b>	<b>7</b>	<b>B</b>

This material requires no immediate attention.

Main Type of Activity	0	Extent of Material	1
Maintenance Activity	0	Location	2
Accessibility	0	Number of Occupants	0
Frequency of use	0	Average time is in use	0
Frequency of maintenance activity	0	<b>Risk Assessment Total:</b>	<b>1</b>
<b>Total Score:</b>	<b>8</b>	<b>Slight Risk</b>

Actions Arising	Due Date	Est. Cost
Label & Manage	3-11-2016	£0

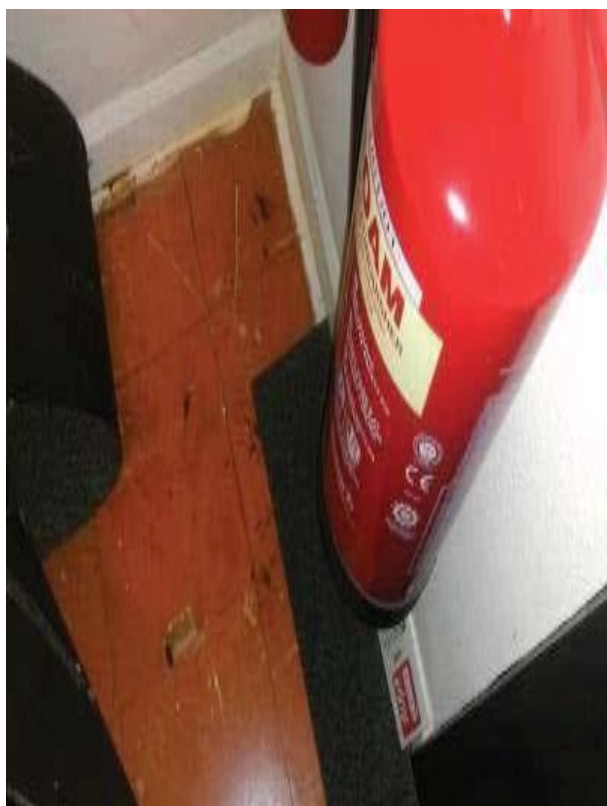
**Second Floor 2, Circulation – Stairs TAJAGG-DH-2-S1**

Inspection Date	13/9/2016		
Component:	<b>Orange Floor Tiles</b>	Sample No.	<b>VCFD001470 - 2S1</b>
Survey Type	Type 2	Surveyor	Richard Farmer
Asbestos type	<b>Chrysotile</b>		
Quantity of Material	<b>20m<sup>2</sup></b>

Material	1	Extent of Damage	0
Surface Treatment	0	Asbestos Type	1
<b>Material Assessment Total:</b>	<b>2</b>	<b>D</b>

Main Type of Activity	0	Extent of Material	2
Maintenance Activity	0	Location	2
Accessibility	0	Number of Occupants	1
Frequency of use	3	Average time is in use	1
Frequency of maintenance activity	0	<b>Risk Assessment Total:</b>	<b>3</b>
<b>Total Score:</b>	<b>5</b>	<b>Sound</b>

Keep asbestos containing materials on management plan and continue to monitor.

<b>Actions Arising</b>	<b>Due Date</b>	<b>Est. Cost</b>
Label & Manage	3-11-2016	£0

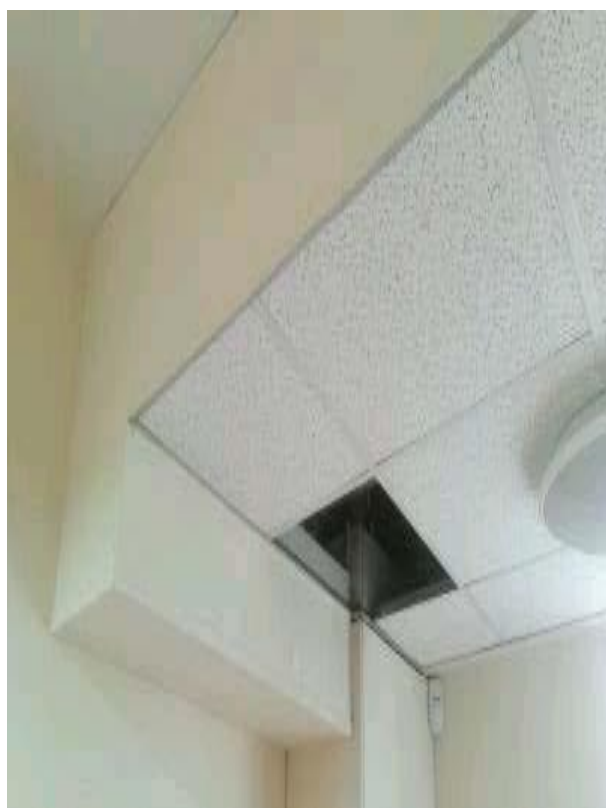
**Second Floor 2, Circulation – Stairs TAJAGG-DH-2-S2**

Inspection Date	13/9/2016		
Component:	<b>Insulating Board Upstand</b>	Sample No.	<b>FD001467</b>
Survey Type	Type 2	Surveyor	Richard Farmer
Asbestos type	<b>Amosite</b>		
Quantity of Material	<b>5m<sup>2</sup></b>

Material	2	Extent of Damage	1
Surface Treatment	2	Asbestos Type	2
<b>Material Assessment Total:</b>	<b>7</b>	<b>B</b>

Keep ACM on management plan and continue to monitor. Item is unsealed above ceiling tiles.

Main Type of Activity	0	Extent of Material	1
Maintenance Activity	0	Location	2
Accessibility	0	Number of Occupants	0
Frequency of use	0	Average time is in use	0
Frequency of maintenance activity	0	<b>Risk Assessment Total:</b>	<b>1</b>
<b>Total Score:</b>	<b>8</b>	<b>Slight Risk</b>

<b>Actions Arising</b>	<b>Due Date</b>	<b>Est. Cost</b>
Encapsulate, Label & Manage	3-11-2016	£0

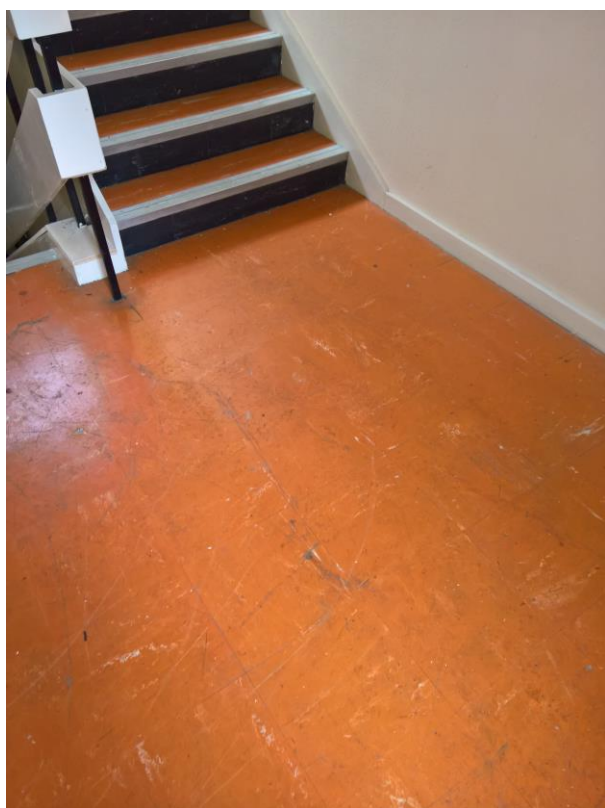
**Second Floor 2, Circulation – Stairs TAJAGG-DH-2-S2**

Inspection Date	13/9/2016		
Component:	<b>Orange Floor Tiles With Bitumen Adhesive</b>	Sample No.	<b>VCFD001465 - 2S2</b>
Survey Type	Type 2	Surveyor	Richard Farmer
Asbestos type	<b>Chrysotile</b>		
Quantity of Material	<b>10m<sup>2</sup></b>

Material	1	Extent of Damage	1
Surface Treatment	0	Asbestos Type	1
<b>Material Assessment Total:</b>	<b>3</b>	<b>D</b>

Main Type of Activity	0	Extent of Material	1
Maintenance Activity	0	Location	2
Accessibility	2	Number of Occupants	0
Frequency of use	0	Average time is in use	0
Frequency of maintenance activity	0	<b>Risk Assessment Total:</b>	<b>2</b>
<b>Total Score:</b>	<b>5</b>	<b>Sound</b>

Keep ACM on management plan and continue to monitor.

Actions Arising	Due Date	Est. Cost
Label & Manage	3-11-2016	£0

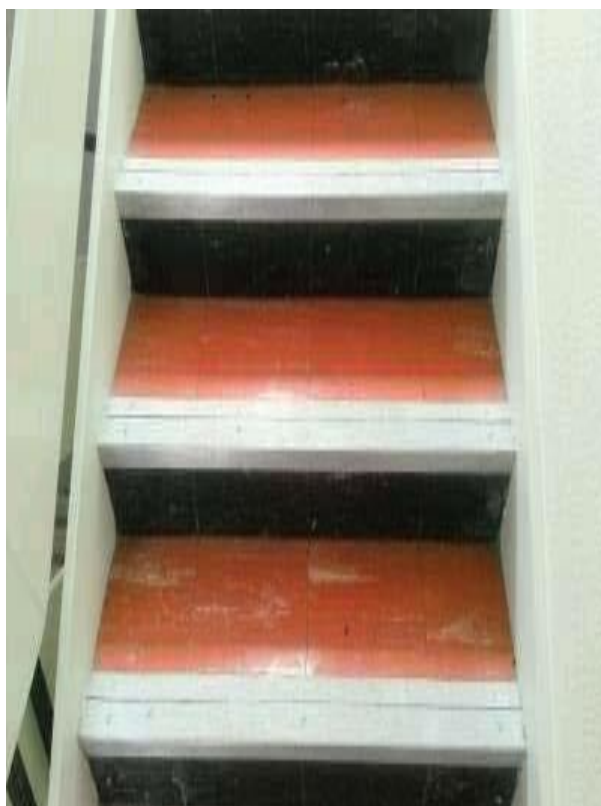
**Second Floor 2, Circulation – Stairs TAJAGG-DH-2-S2**

Inspection Date	13/9/2016		
Component:	Stair Nosing	Sample No.	VCFD001466 - 2S2
Survey Type	Type 2	Surveyor	Richard Farmer
Asbestos type	Chrysotile		
Quantity of Material	20lm

Material	1	Extent of Damage	0
Surface Treatment	0	Asbestos Type	1
<b>Material Assessment Total:</b>	<b>2</b>	<b>D</b>

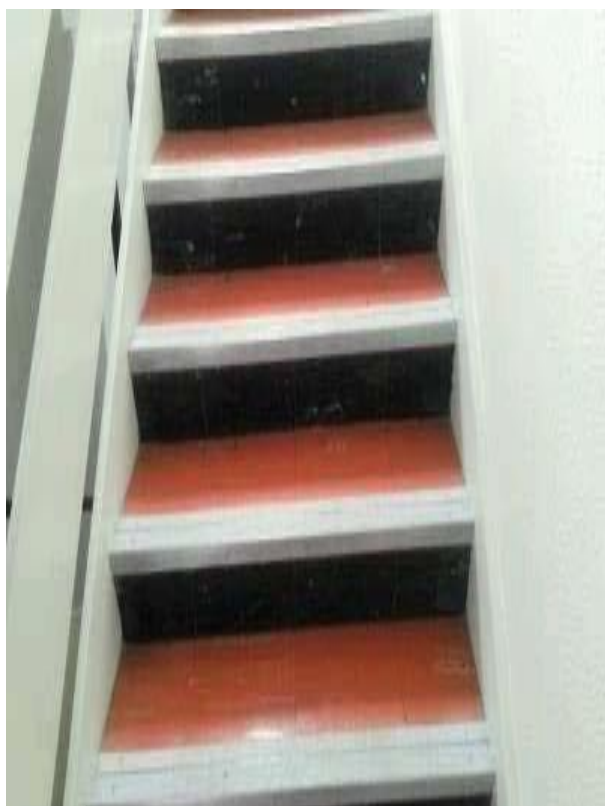
Material	1	Extent of Damage	0
Surface Treatment	0	Asbestos Type	1
<b>Material Assessment Total:</b>	<b>2</b>	<b>D</b>

Keep ACM on management plan and continue to monitor.

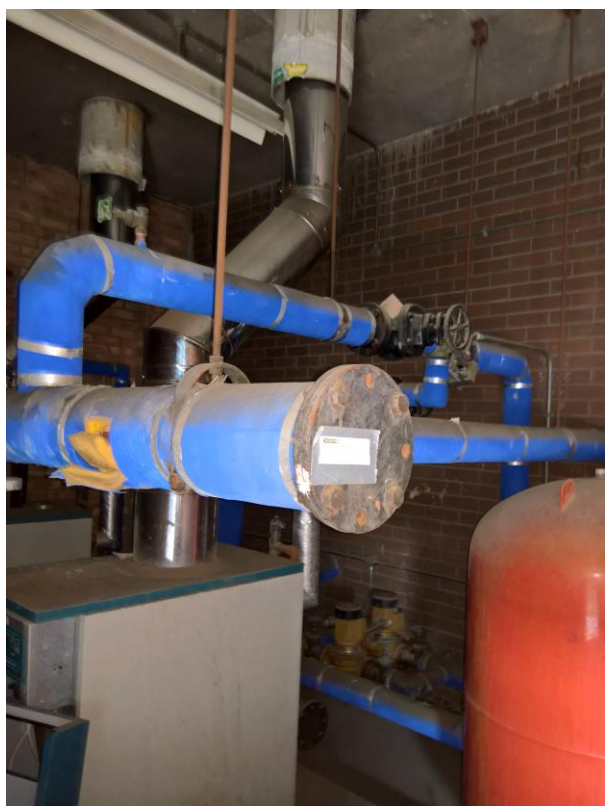
Material	1	Extent of Damage	0
Surface Treatment	0	Asbestos Type	1
<b>Material Assessment Total:</b>	<b>2</b>	<b>D</b>

Incorporate asbestos containing materials into management plan until removal.

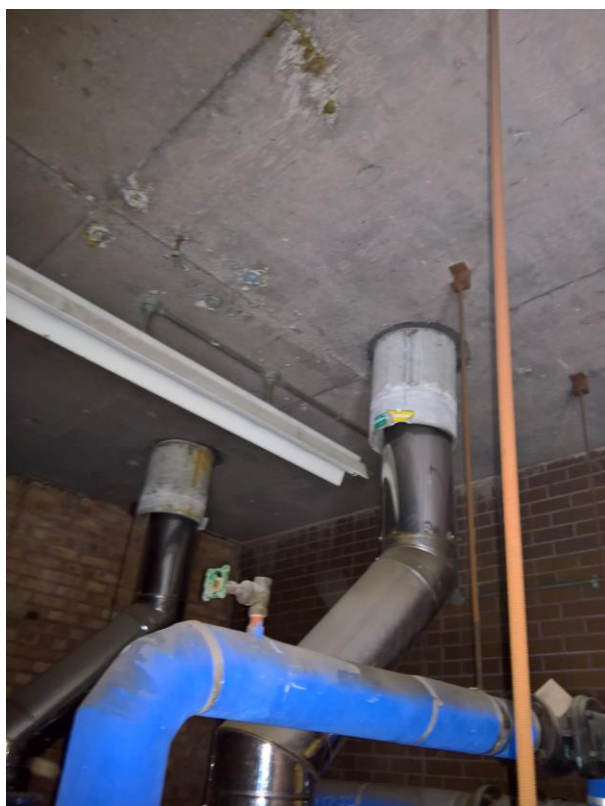
Material	1	Extent of Damage	1
Surface Treatment	1	Asbestos Type	2
<b>Material Assessment Total:</b>	<b>5</b>	<b>C</b>

Incorporate asbestos containing materials into management plan until removal.

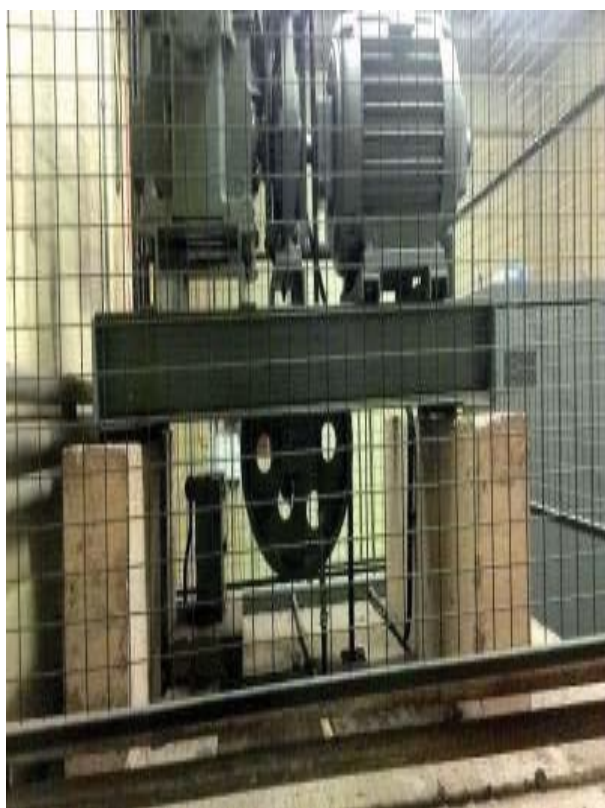
Material	1	Extent of Damage	0
Surface Treatment	0	Asbestos Type	1
<b>Material Assessment Total:</b>	<b>2</b>	<b>D</b>

This material requires no immediate attention. No access during 2016 re-inspection.

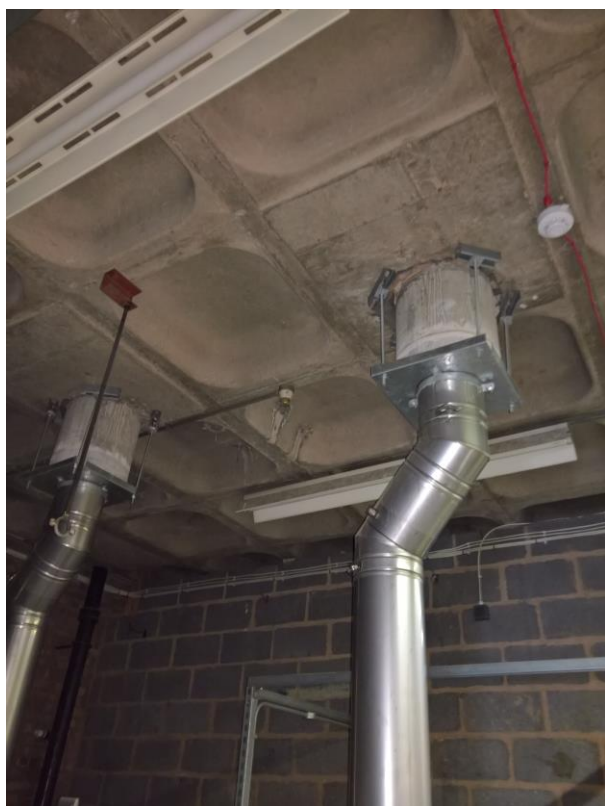
Material	1	Extent of Damage	1
Surface Treatment	1	Asbestos Type	2
<b>Material Assessment Total:</b>	<b>5</b>	<b>C</b>

Incorporate asbestos containing materials into management plan until removal.

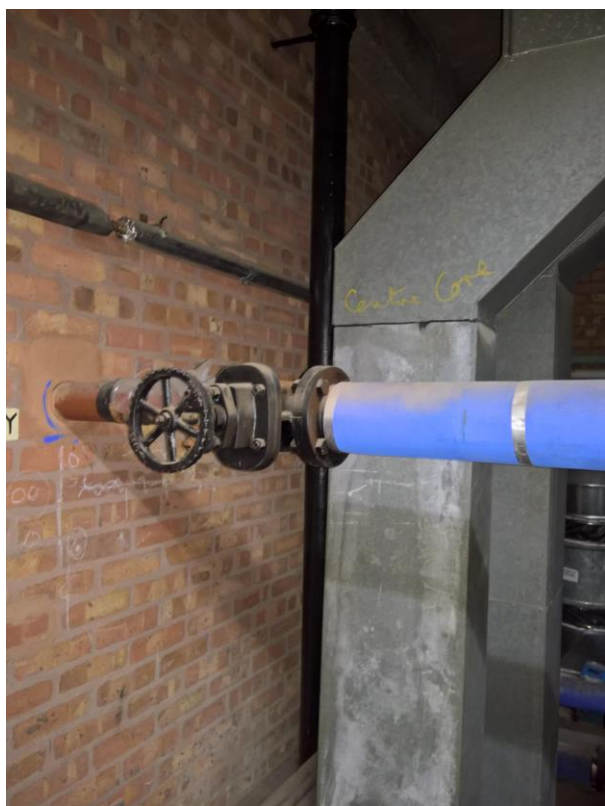
Material	1	Extent of Damage	0
Surface Treatment	0	Asbestos Type	1
<b>Material Assessment Total:</b>	<b>2</b>	<b>D</b>

Incorporate asbestos containing materials into management plan until removal.

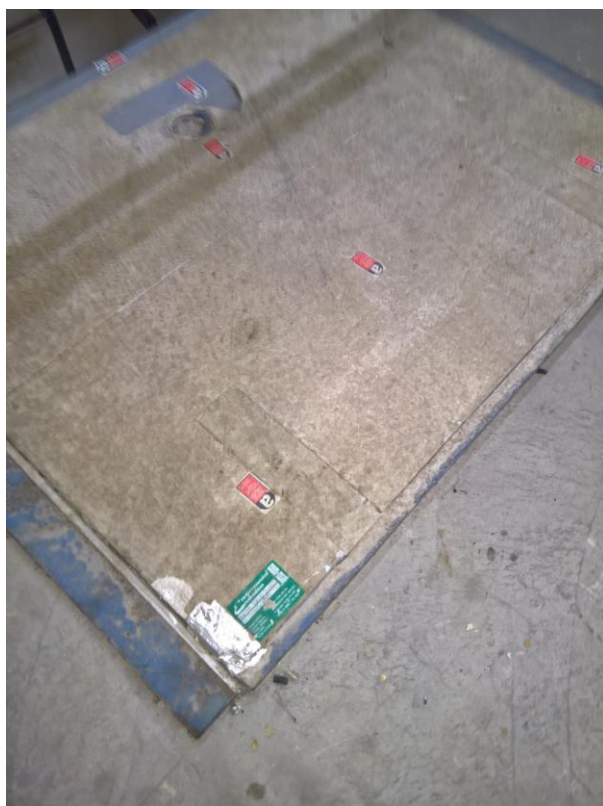
Material	2	Extent of Damage	2
Surface Treatment	2	Asbestos Type	2
<b>Material Assessment Total:</b>	<b>8</b>	<b>B</b>

Item has areas of damage. Encapsulation required.

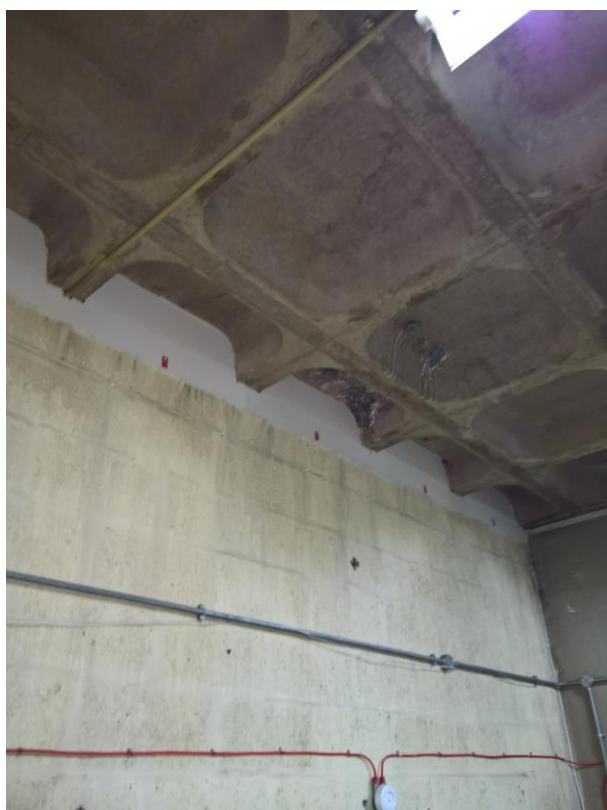
Material	2	Extent of Damage	1
Surface Treatment	1	Asbestos Type	2
<b>Material Assessment Total:</b>	<b>6</b>	<b>C</b>

Keep asbestos containing materials on management plan and continue to monitor.

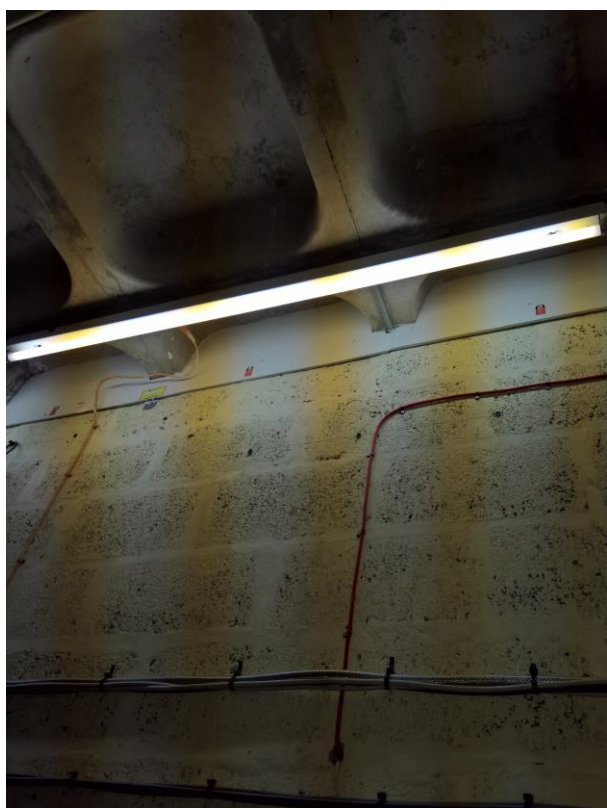
Material	2	Extent of Damage	1
Surface Treatment	1	Asbestos Type	2
<b>Material Assessment Total:</b>	<b>6</b>	<b>C</b>

Keep asbestos containing materials on management plan and continue to monitor.
