# Asbestos Material & Priority Assessment Report

## CAMHS/Lodge Road TAJ51

Survey Conducted by: Riverside Environmental Services Ltd

**Survey Report Number J099844**

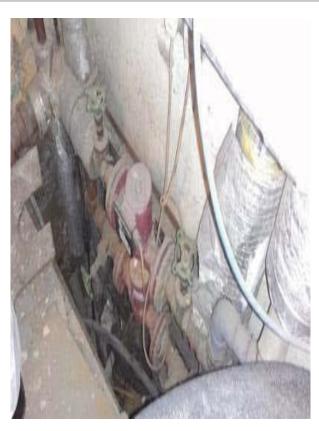
CAMHS/Lodge Road TAJ51
Sample Record Number: J054909PS69
Building External Element
Position Location (Cachet

Inspection Date	14/9/2016		
Component:	Gaskets	Sample No.	J054909PS69
Survey Type	Type 2	Surveyor	Richard Farmer
Asbestos type	·	Chrysotile	
Quantity of Material		10N°

Material	2	Extent of Damage 0
Surface Treatment	1	Asbestos Type 1
Material Assessment Total:	4	C

This material requires no immediate attention.

Total Score:	6 Sound	
Frequency of maintenance activity	1 Risk Assessment Total:	2
Frequency of use	$oxed{0}$ Average time is in use	0
Accessibility	0 Number of Occupants	0
Maintenance Activity	0 Location	2
Main Type of Activity	$\left 0\right $ Extent of Material	0

Actions Arising	<b>Due Date</b>	Est. Cost
Label & Manage	9-11-2016	£0

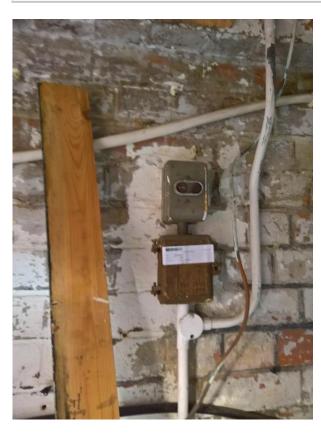
Sample Record Number: FU000410 Basement -1, Plant Room 007-03-(-1)-001

Position Location :Flash Guard

Inspection Date	14/9/2016		
Component:	Flash Guard	Sample No.	FU000410
Survey Type	Type 2	Surveyor	Richard Farmer
Asbestos type	·	Chrysotile	
Quantity of Material		2N°

Material	2	Extent of Damage	2
Surface Treatment	2	Asbestos Type	1
Material Assessment Total:		В

Main Type of Activity	0 Extent of Material	0
Maintenance Activity	0 Location	2
Accessibility	0 Number of Occupants	0
Frequency of use	0 Average time is in use	0
Frequency of maintenance activity	0 Risk Assessment Total:	1
Total Score:	8 Slight Risk

Restrict access and remove the material as soon as is practicable.

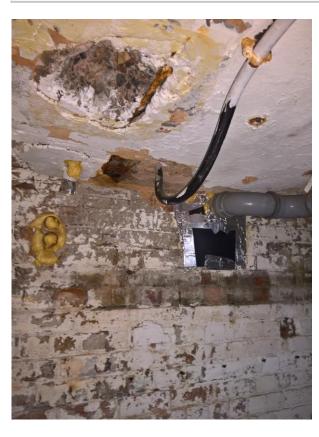
Sample Record Number: FU000411 Basement -1, Plant Room 007-03-(-1)-001

**Position Location :**Walls

Inspection Date	14/9/2016		
Component:	Residue	Sample No.	FU000411
Survey Type	Type 2	Surveyor	Richard Farmer
Asbestos type	·	Chrysotile	
Quantity of Material		10m <sup>2</sup>

Material	3	Extent of Damage	3
Surface Treatment	3	Asbestos Type	1
Material Assessment Total:		A

Main Type of Activity	0	Extent of Material
Maintenance Activity	0	Location
Accessibility	0	Number of Occupants
Frequency of use	0	Average time is in use
Frequency of maintenance activity	1	Risk Assessment Total:
Total Score:	12	Slight Risk

Restrict access and remove the material as soon as possible.

Actions Arising	<b>Due Date</b>	Est. Cost
Remove under Controlled Conditions by Approved	9-11-2016	f0
Contractor.	7 11 2010	~~

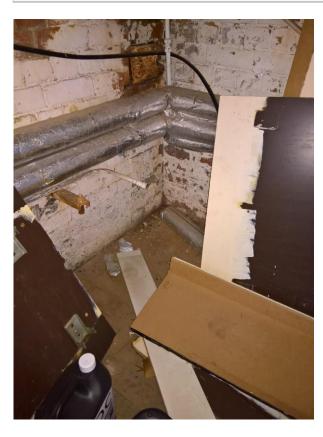
Sample Record Number: FU000412

**Position Location :**Behind Pipework

Inspection Date	14/9/2016		
Component:	Residue	Sample No.	FU000412
Survey Type	Type 2	Surveyor	Richard Farmer
Asbestos type		Chrysotile	
Quantity of Material		8lm

Material	3	Extent of Damage	3
Surface Treatment	2	Asbestos Type	1
Material Assessment Total:	9	В

Main Type of Activity	0	Extent of Material	1
Maintenance Activity	0	Location	2
Accessibility	0	Number of Occupants	0
Frequency of use	0	Average time is in use	0
Frequency of maintenance activity	1	Risk Assessment Total:	2
Total Score:	11	Slight Risk

Restrict access and remove material as soon as possible.

Actions Arising	<b>Due Date</b>	Est. Cost
Remove under Controlled Conditions by Approved	9-11-2016	f0
Contractor.	7 11 2010	~~

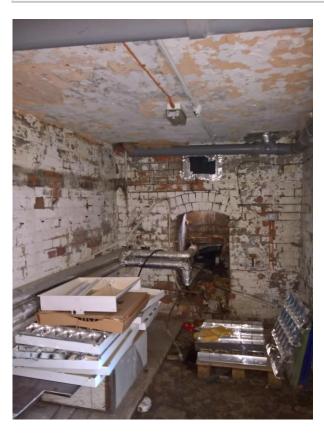
Sample Record Number: FU000413 Basement -1, Plant Room 007-03-(-1)-001

**Position Location :**Wall

Inspection Date	14/9/2016		
Component:	Residue	Sample No.	FU000413
Survey Type	Type 2	Surveyor	Richard Farmer
Asbestos type		Chrysotile	
Quantity of Material		10m <sup>2</sup>

Material	3	Extent of Damage	3
Surface Treatment	2	Asbestos Type	1
Material Assessment Total:	9	В

Main Type of Activity	0	Extent of Material	1
Maintenance Activity	0	Location	2
Accessibility	0	Number of Occupants	0
Frequency of use	0	Average time is in use	0
Frequency of maintenance activity	1	Risk Assessment Total:	2
Total Score:	11	Slight Risk

Restrict access and remove material as soon as possible.

Actions Arising	<b>Due Date</b>	Est. Cost
Remove under Controlled Conditions by Approved Contractor.	9-11-2016	£0

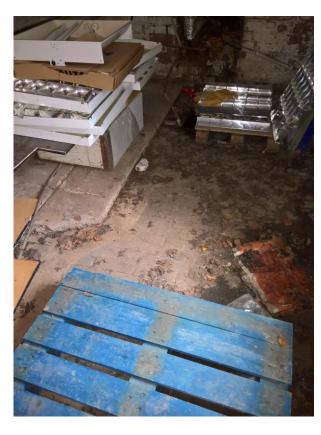
Sample Record Number: FU000414

**Position Location :**Floor

Inspection Date	14/9/2016		
Component:	Dust Debris	Sample No.	FU000414
Survey Type	Type 2	Surveyor	Richard Farmer
Asbestos type	·	Chrysotile	
Quantity of Material		15m <sup>2</sup>

Material	3	Extent of Damage	3
Surface Treatment	2	Asbestos Type	1
Material Assessment Total:	9	В

Main Type of Activity	0	Extent of Material	2
Maintenance Activity	0	Location	2
Accessibility	0	Number of Occupants	0
Frequency of use	0	Average time is in use	0
Frequency of maintenance activity	1	Risk Assessment Total:	2
Total Score:	11	Slight Risk

Restrict access and remove material as soon as possible.

Actions Arising	<b>Due Date</b>	Est. Cost
Remove under Controlled Conditions by Approved Contractor.	9-11-2016	£0

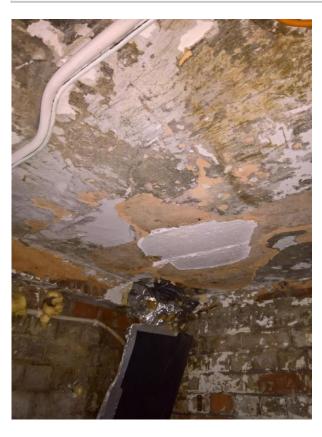
Sample Record Number: FU000415

**Position Location :**Ceiling

Inspection Date	14/9/2016		
Component:	Residue	Sample No.	FU000415
Survey Type	Type 2	Surveyor	Richard Farmer
Asbestos type		Chrysotile	·
Quantity of Material		1m <sup>2</sup>

Material	3	Extent of Damage	3
Surface Treatment	2	Asbestos Type	1
Material Assessment Total:	9	В

Main Type of Activity	0	Extent of Material	1
Maintenance Activity	0	Location	2
Accessibility	0	Number of Occupants	0
Frequency of use	0	Average time is in use	0
Frequency of maintenance activity	1	Risk Assessment Total:	2
Total Score:	11	Slight Risk

Restrict access and remove material as soon as possible.

Actions Arising	<b>Due Date</b>	Est. Cost
Remove under Controlled Conditions by Approved Contractor.	9-11-2016	£0
