Asbestos Material & Priority Assessment Report

Edward Street Community Team Base TAJ05

Survey Conducted by: Riverside Environmental Services Ltd

Survey Report Number J099846

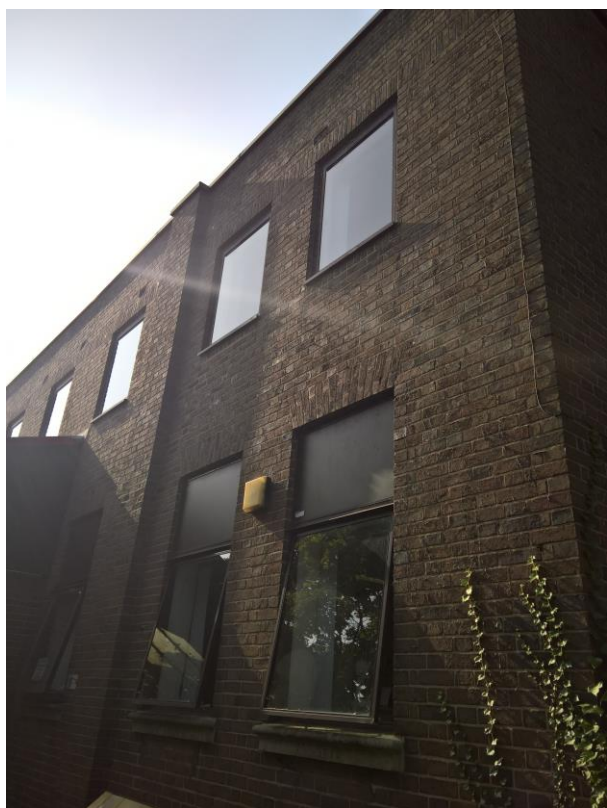
Sample Record Number: FU000385

Position Location : Above Windows

Inspection Date	14/9/2016		
Component:	Infill Panels	Sample No.	FU000385
Survey Type	Type 2	Surveyor	Richard Farmer
Asbestos type	Chrysotile		
Quantity of Material	25m²

Material	1	Extent of Damage	1
Surface Treatment	1	Asbestos Type	1
Material Assessment Total:	4	C

Main Type of Activity	0	Extent of Material	2
Maintenance Activity	0	Location	0
Accessibility	0	Number of Occupants	0
Frequency of use	0	Average time is in use	0
Frequency of maintenance activity	0	Risk Assessment Total:	1
Total Score:	5	Sound

Incorporate asbestos containing materials within management plan until removal.

Actions Arising	Due Date	Est. Cost
Label & Manage	11-11-2016	£0

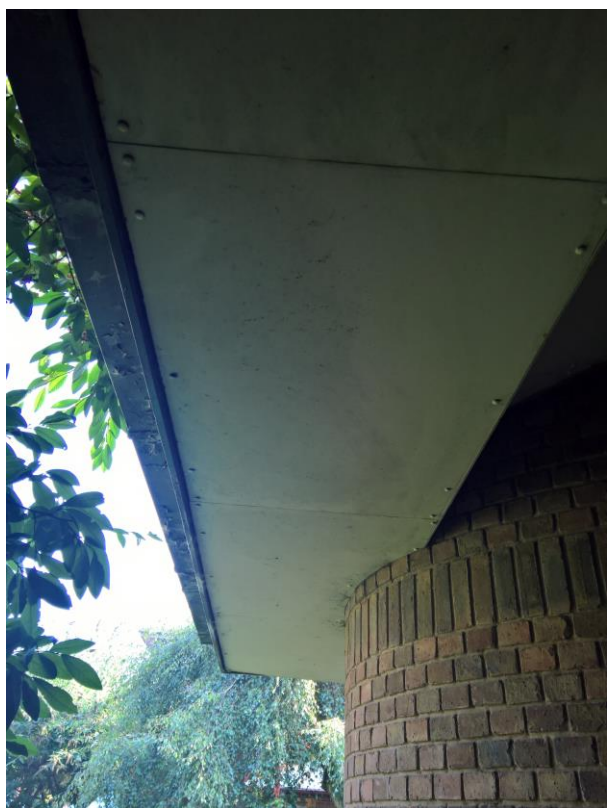
Sample Record Number: FU000384

Position Location :Soffits & Canopies

Inspection Date	14/9/2016		
Component:	Soffit & Canopies	Sample No.	FU000384
Survey Type	Type 2	Surveyor	Richard Farmer
Asbestos type	Chrysotile		
Quantity of Material	250m²

Material	1	Extent of Damage	1
Surface Treatment	1	Asbestos Type	1
Material Assessment Total:	4	C

Main Type of Activity	0	Extent of Material	1
Maintenance Activity	0	Location	0
Accessibility	0	Number of Occupants	0
Frequency of use	0	Average time is in use	0
Frequency of maintenance activity	0	Risk Assessment Total:	0
Total Score:	4	Sound

Incorporate asbestos containing materials into management plan until removal.

Actions Arising	Due Date	Est. Cost
Label & Manage	11-11-2016	£0

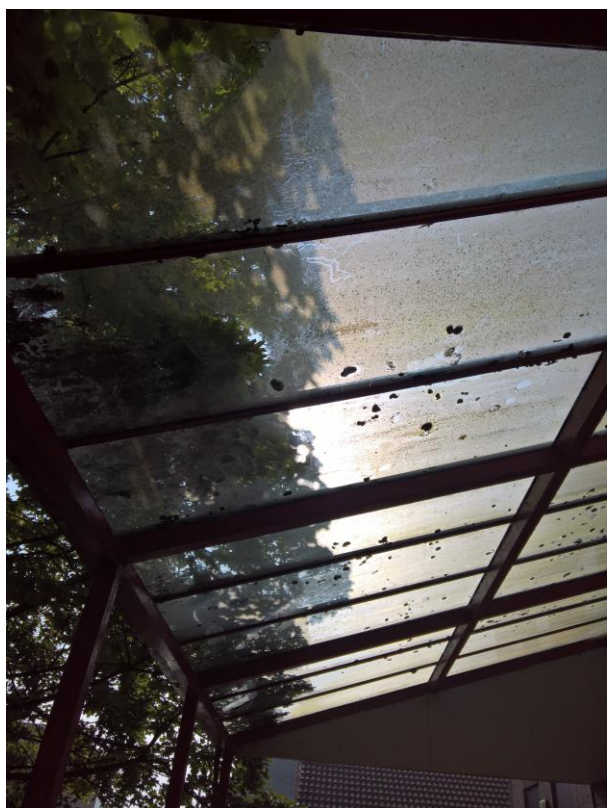
Sample Record Number: FU000387

Position Location : To all metal & glass skylights

Inspection Date	14/9/2016		
Component:	Glass seals	Sample No.	FU000387
Survey Type	Type 2	Surveyor	Richard Farmer
Asbestos type	Chrysotile		
Quantity of Material	400lm

Material	2	Extent of Damage	1
Surface Treatment	2	Asbestos Type	1
Material Assessment Total:	6	C

Main Type of Activity	0	Extent of Material	1
Maintenance Activity	0	Location	0
Accessibility	0	Number of Occupants	1
Frequency of use	0	Average time is in use	0
Frequency of maintenance activity	0	Risk Assessment Total:	0
Total Score:	6	Sound

Incorporate asbestos containing materials within management plan until removal.

Actions Arising	Due Date	Est. Cost
Label & Manage	11-11-2016	£0

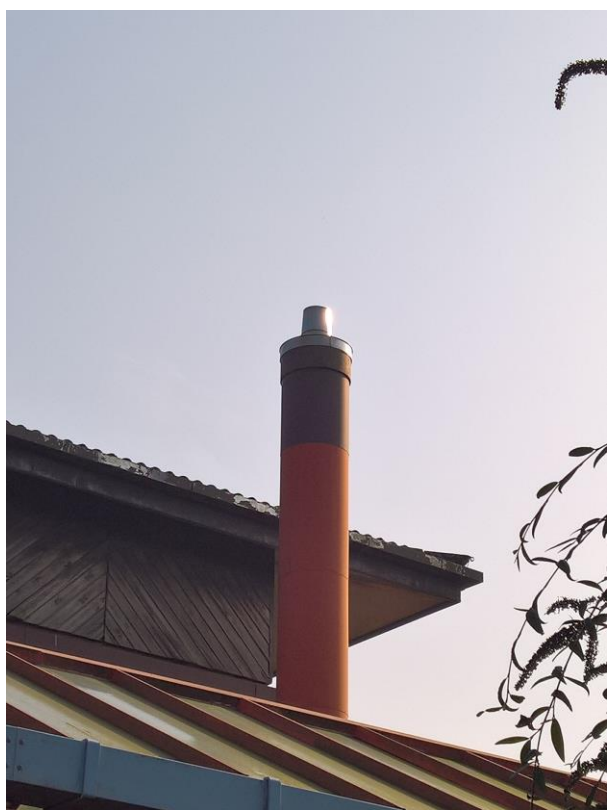
Sample Record Number: Presumptive Sample 87

Position Location : pipe within metal casing

Inspection Date	14/9/2016		
Component:	Flue pipe within metal casing	Sample No.	Presumptive Sample 87
Survey Type	Type 2	Surveyor	Richard Farmer
Asbestos type	Crocidolite		
Quantity of Material	35lm

Material	1	Extent of Damage	1
Surface Treatment	1	Asbestos Type	3
Material Assessment Total:	6	C

Main Type of Activity	0	Extent of Material	1
Maintenance Activity	0	Location	0
Accessibility	0	Number of Occupants	0
Frequency of use	0	Average time is in use	0
Frequency of maintenance activity	0	Risk Assessment Total:	0
Total Score:	6	Sound

Incorporate asbestos containing materials within the management plan until removal.

Actions Arising	Due Date	Est. Cost
Label & Manage	11-11-2016	£0

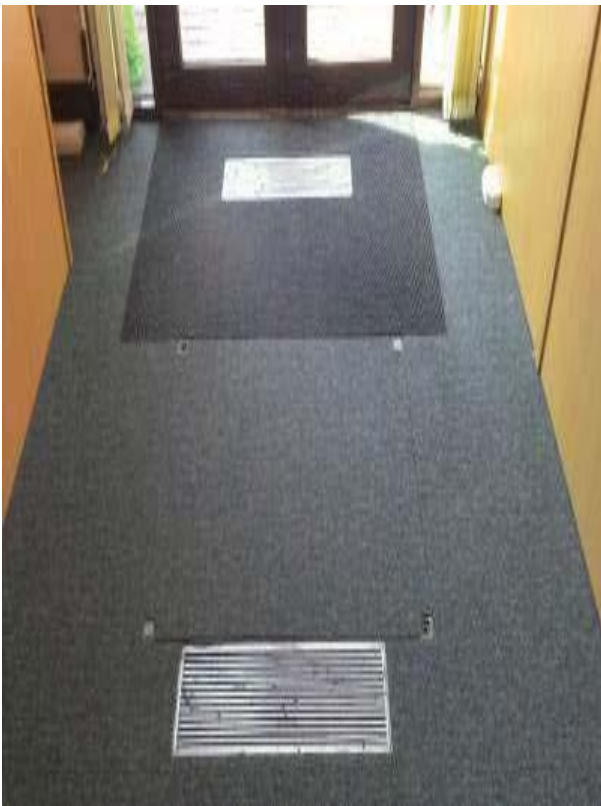
Sample Record Number: Presumptive Sample 88

Position Location : Within all floor service ducts

Inspection Date	14/9/2016		
Component:	Insulation to pipework	Sample No.	Presumptive Sample 88
Survey Type	Type 2	Surveyor	Richard Farmer
Asbestos type	Crocidolite		
Quantity of Material	100lm

Material	3	Extent of Damage	0
Surface Treatment	1	Asbestos Type	3
Material Assessment Total:	7	B

Presumed based on basement assessments.
Incorporate asbestos containing materials into the management plan until removed.

Total Score:	7	Sound
---------------------	----------	--------------

Actions Arising	Due Date	Est. Cost
Label & Manage	11-11-2016	£0

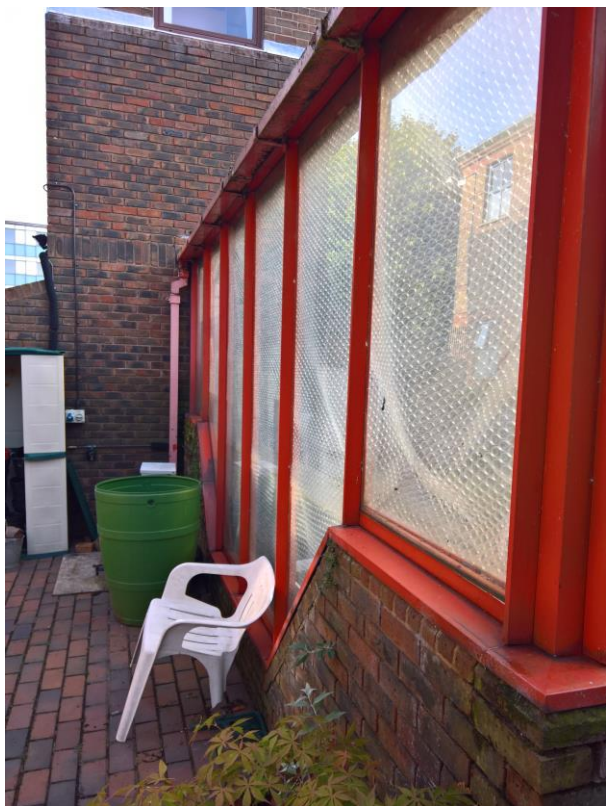
Sample Record Number: FU000387

Position Location : To metal framework & glass

Inspection Date	14/9/2016		
Component:	Glass seals	Sample No.	FU000387
Survey Type	Type 2	Surveyor	Richard Farmer
Asbestos type	Chrysotile		
Quantity of Material	75lm

Material	2	Extent of Damage	1
Surface Treatment	2	Asbestos Type	1
Material Assessment Total:	6	C

Main Type of Activity	0	Extent of Material	1
Maintenance Activity	0	Location	0
Accessibility	0	Number of Occupants	1
Frequency of use	0	Average time is in use	0
Frequency of maintenance activity	0	Risk Assessment Total:	0
Total Score:	6	Sound

Label and manage material.

Actions Arising	Due Date	Est. Cost
Label & Manage	11-11-2016	£0

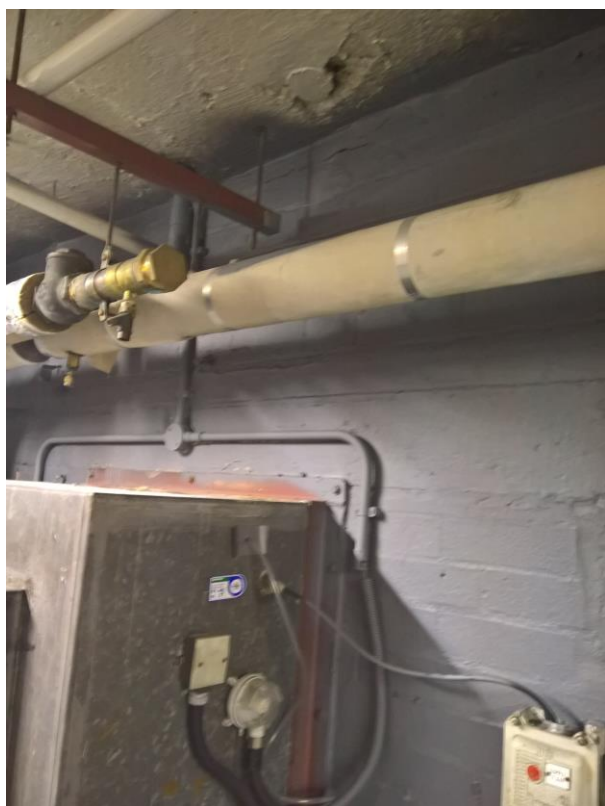
Sample Record Number: FU000375

Position Location : Walls

Inspection Date	14/9/2016		
Component:	Residue	Sample No.	FU000375
Survey Type	Type 2	Surveyor	Richard Farmer
Asbestos type	Chrysotile, Crocidolite		
Quantity of Material	50m²

Material	3	Extent of Damage	3
Surface Treatment	2	Asbestos Type	3
Material Assessment Total:	11

Main Type of Activity	0	Extent of Material	2
Maintenance Activity	0	Location	2
Accessibility	1	Number of Occupants	1
Frequency of use	0	Average time is in use	0
Frequency of maintenance activity	1	Risk Assessment Total:	3
Total Score:	14	Moderate Risk

Incorporate asbestos containing materials into the management plan until removal.

Actions Arising	Due Date	Est. Cost
Label & Manage	11-11-2016	£0

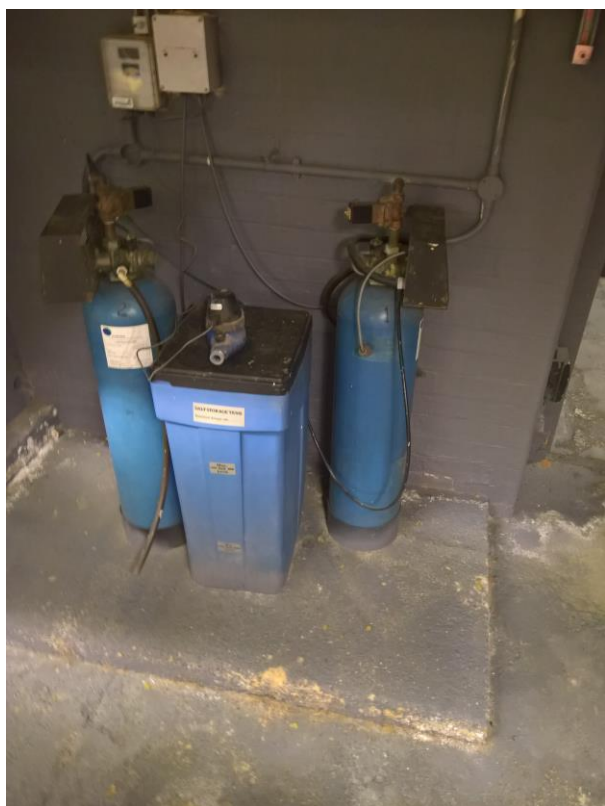
Sample Record Number: FU000376

Position Location : Walls

Inspection Date	14/9/2016		
Component:	Residue	Sample No.	FU000376
Survey Type	Type 2	Surveyor	Richard Farmer
Asbestos type	Chrysotile, Crocidolite		
Quantity of Material	50m²

Material	3	Extent of Damage	3
Surface Treatment	2	Asbestos Type	3
Material Assessment Total:	11

Main Type of Activity	0	Extent of Material	1
Maintenance Activity	0	Location	2
Accessibility	0	Number of Occupants	1
Frequency of use	0	Average time is in use	0
Frequency of maintenance activity	1	Risk Assessment Total:	2
Total Score:	13	Moderate Risk

Incorporate asbestos containing materials into management plan until removal.

Actions Arising	Due Date	Est. Cost
Label & Manage	11-11-2016	£0

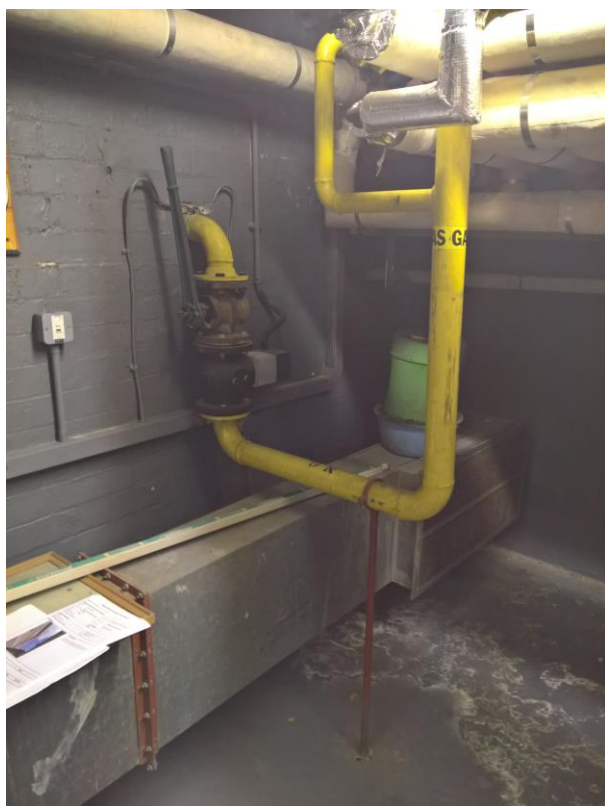
Sample Record Number: FU000378

Position Location :All Plant & Equipment

Inspection Date	14/9/2016		
Component:	Dust & Debris	Sample No.	FU000378
Survey Type	Type 2	Surveyor	Richard Farmer
Asbestos type	Chrysotile		
Quantity of Material	50m²

Material	3	Extent of Damage	3
Surface Treatment	3	Asbestos Type	1
Material Assessment Total:	10	A

Basement area has undergone cleaning. Walls and floors were then encapsulated with ET150 07/12/14 During the re-inspection, no obvious asbestos dust or debris was found on plant, however inspection within joints and within equipment was not possible.

Main Type of Activity	0	Extent of Material	2
Maintenance Activity	0	Location	2
Accessibility	0	Number of Occupants	1
Frequency of use	0	Average time in use	1
Frequency of maintenance activity	1	Risk Assessment Total:	3
Total Score:	13	Moderate Risk

Actions Arising	Due Date	Est. Cost
Label & Manage	11-11-2016	£0

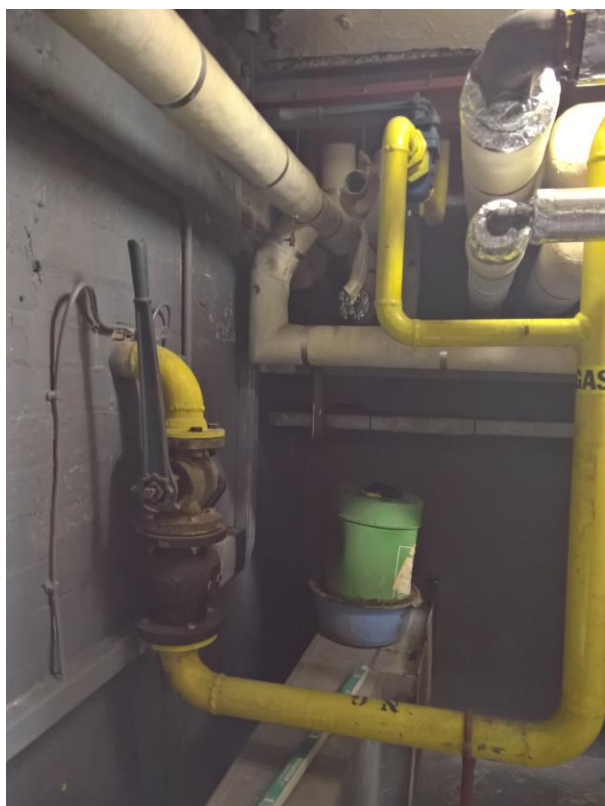
Sample Record Number: Presumptive Sample 70

Position Location : To all pipework

Inspection Date	14/9/2016		
Component:	Gaskets	Sample No.	Presumptive Sample 70
Survey Type	Type 2	Surveyor	Richard Farmer
Asbestos type	Chrysotile		
Quantity of Material	50N°

Material	1	Extent of Damage	1
Surface Treatment	0	Asbestos Type	1
Material Assessment Total:	3	D

Main Type of Activity	0	Extent of Material	0
Maintenance Activity	0	Location	2
Accessibility	0	Number of Occupants	0
Frequency of use	0	Average time is in use	0
Frequency of maintenance activity	0	Risk Assessment Total:	1
Total Score:	4	Sound

Incorporate asbestos containing materials into the management plan until removal.

Actions Arising	Due Date	Est. Cost
Label & Manage	11-11-2016	£0

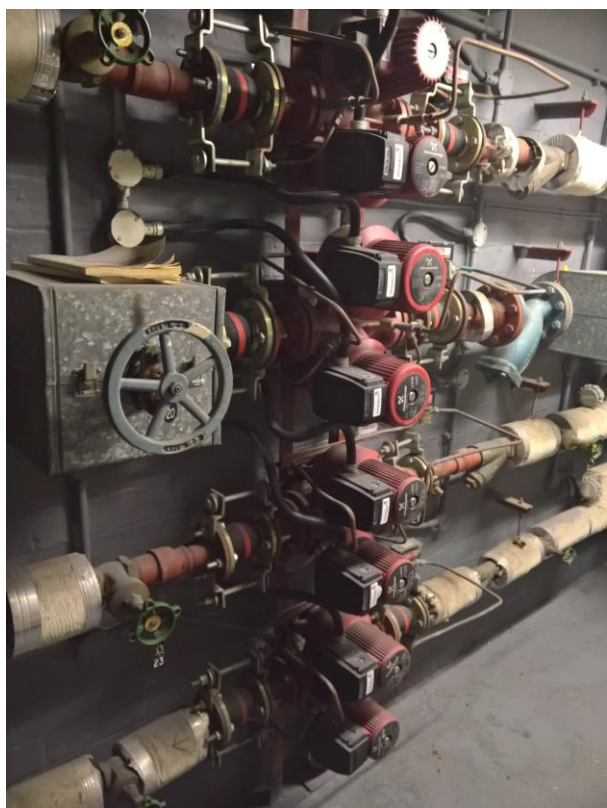
Sample Record Number: Presumptive Sample 75

Position Location : To all pipework

Inspection Date	14/9/2016		
Component:	Gaskets	Sample No.	Presumptive Sample 75
Survey Type	Type 2	Surveyor	Richard Farmer
Asbestos type	Chrysotile		
Quantity of Material	50N°

Material	1	Extent of Damage	1
Surface Treatment	0	Asbestos Type	1
Material Assessment Total:	3	D

Main Type of Activity	0	Extent of Material	0
Maintenance Activity	0	Location	2
Accessibility	0	Number of Occupants	0
Frequency of use	0	Average time is in use	0
Frequency of maintenance activity	0	Risk Assessment Total:	1
Total Score:	4	Sound

Incorporate asbestos containing materials into the management plan until removal.

Actions Arising	Due Date	Est. Cost
Label & Manage	11-11-2016	£0

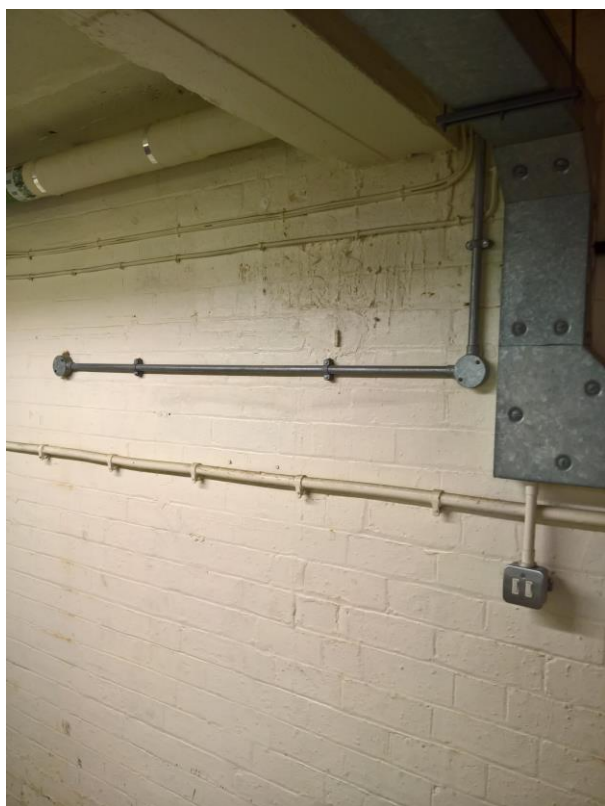
Sample Record Number: FU000380

Position Location : Walls

Inspection Date	14/9/2016		
Component:	Debris	Sample No.	FU000380
Survey Type	Type 2	Surveyor	Richard Farmer
Asbestos type	Chrysotile, Crocidolite		
Quantity of Material	50m²

Material	3	Extent of Damage	3
Surface Treatment	3	Asbestos Type	3
Material Assessment Total:	12

Main Type of Activity	0	Extent of Material	1
Maintenance Activity	0	Location	2
Accessibility	2	Number of Occupants	0
Frequency of use	0	Average time is in use	0
Frequency of maintenance activity	1	Risk Assessment Total:	3
Total Score:	15	Moderate Risk

Item requires encapsulation. Incorporate asbestos containing materials into management plan until removal.

Actions Arising	Due Date	Est. Cost
Encapsulate, Label & Manage	11-11-2016	£0

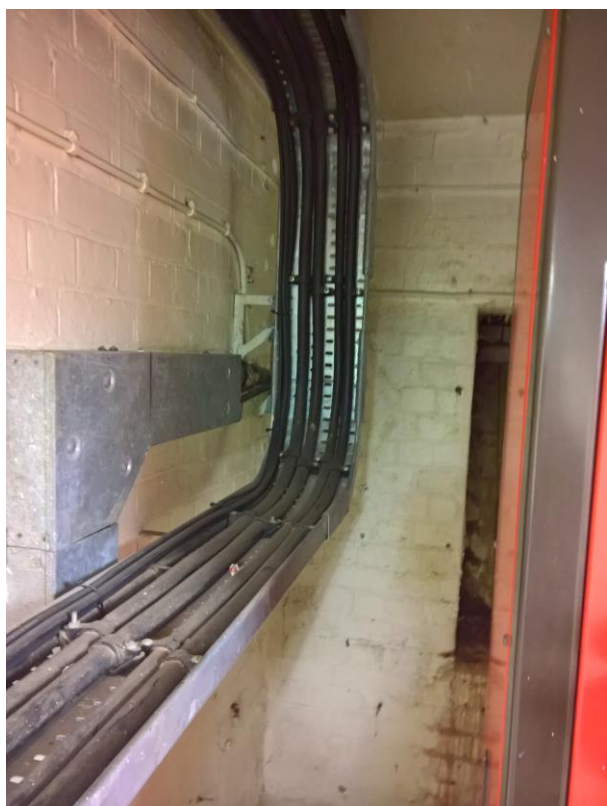
Sample Record Number: FU000381

Position Location : Walls

Inspection Date	14/9/2016		
Component:	Residue	Sample No.	FU000381
Survey Type	Type 2	Surveyor	Richard Farmer
Asbestos type	Chrysotile, Crocidolite		
Quantity of Material	50m²

Material	3	Extent of Damage	3
Surface Treatment	3	Asbestos Type	3
Material Assessment Total:	12

Main Type of Activity	0	Extent of Material	1
Maintenance Activity	0	Location	2
Accessibility	2	Number of Occupants	0
Frequency of use	0	Average time is in use	0
Frequency of maintenance activity	1	Risk Assessment Total:	3
Total Score:	15	Moderate Risk

Item requires encapsulation. Incorporate asbestos containing materials into management plan until removal.

Actions Arising	Due Date	Est. Cost
Encapsulate, Label & Manage	11-11-2016	£0

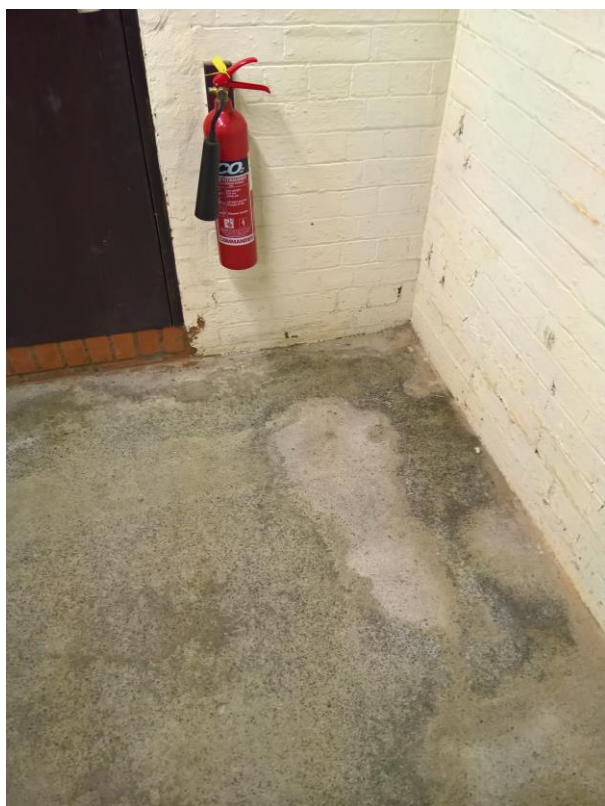
Sample Record Number: FU000382

Position Location : Floor

Inspection Date	14/9/2016		
Component:	Debris	Sample No.	FU000382
Survey Type	Type 2	Surveyor	Richard Farmer
Asbestos type	Chrysotile, Crocidolite		
Quantity of Material	50m ²

Material	3	Extent of Damage	3
Surface Treatment	3	Asbestos Type	3
Material Assessment Total:	12

Main Type of Activity	0	Extent of Material	1
Maintenance Activity	0	Location	2
Accessibility	2	Number of Occupants	0
Frequency of use	0	Average time is in use	0
Frequency of maintenance activity	1	Risk Assessment Total:	3
Total Score:	15	Moderate Risk

Incorporate asbestos containing materials into management plan until removal.

Actions Arising	Due Date	Est. Cost
Remove under Controlled Conditions by Approved Contractor.	11-11-2016	£0

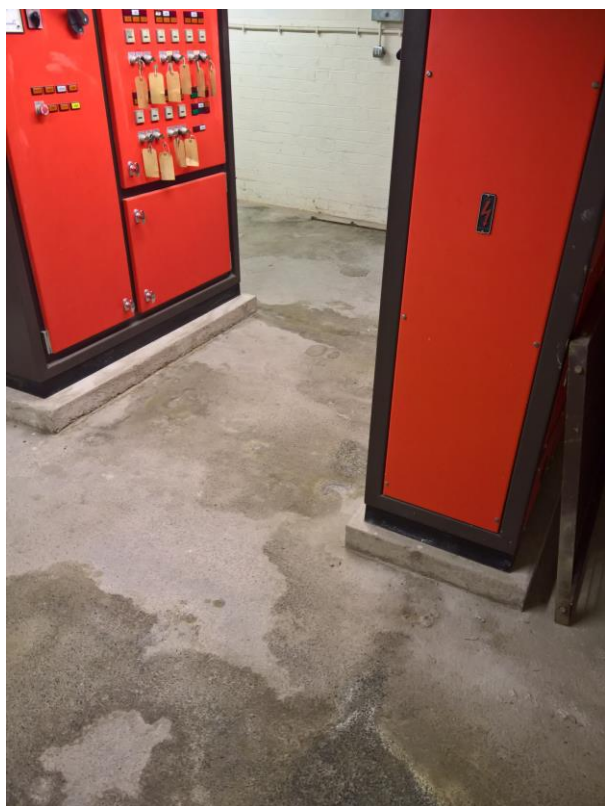
Sample Record Number: FU000383

Position Location : Floor

Inspection Date	14/9/2016		
Component:	Debris	Sample No.	FU000383
Survey Type	Type 2	Surveyor	Richard Farmer
Asbestos type	Crocidolite		
Quantity of Material	50m²

Material	3	Extent of Damage	3
Surface Treatment	3	Asbestos Type	3
Material Assessment Total:	12

Main Type of Activity	0	Extent of Material	1
Maintenance Activity	0	Location	2
Accessibility	2	Number of Occupants	0
Frequency of use	0	Average time is in use	0
Frequency of maintenance activity	1	Risk Assessment Total:	3
Total Score:	15	Moderate Risk

Incorporate asbestos containing material into management plan until removal.

Actions Arising	Due Date	Est. Cost
Remove under Controlled Conditions by Approved Contractor.	11-11-2016	£0
