Asbestos Material & Priority Assessment Report

006 - Pond Lane TAJ53

Survey Conducted by: Riverside Environmental Services Ltd

Survey Report Number J099850

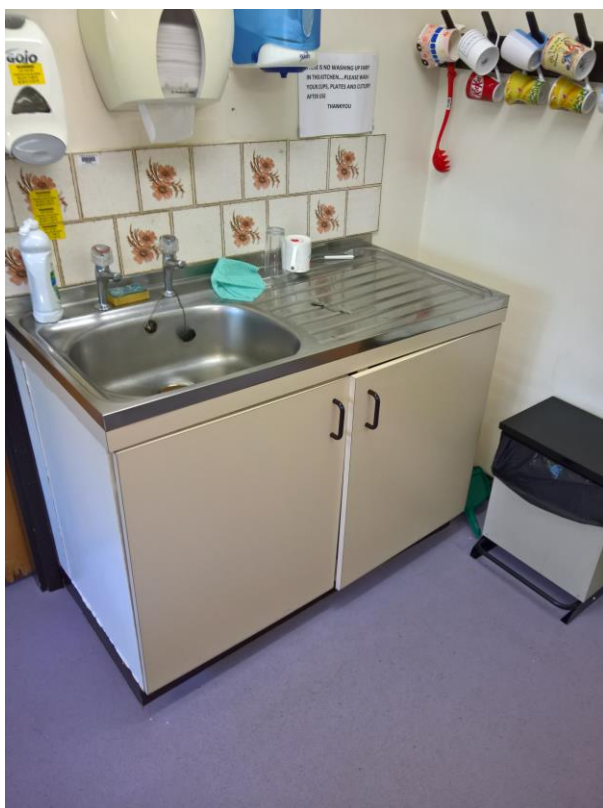
Sample Record Number: FU000428

First Floor 1, Kitchen TAJAGG-PL-1-02

Position Location : Sink

Inspection Date	16/9/2016		
Component:	Sink Pad	Sample No.	FU000428
Survey Type	Type 2	Surveyor	Richard Farmer
Asbestos type	Chrysotile		
Quantity of Material	2Nº

Material	1	Extent of Damage	0
Surface Treatment	0	Asbestos Type	1
Material Assessment Total:	2	D

This material requires no immediate attention.

Main Type of Activity	1	Extent of Material	0
Maintenance Activity	0	Location	2
Accessibility	1	Number of Occupants	1
Frequency of use	3	Average time is in use	1
Frequency of maintenance activity	1	Risk Assessment Total:	5
Total Score:	7	Sound

Actions Arising	Due Date	Est. Cost
Label & Manage	9-11-2016	£0

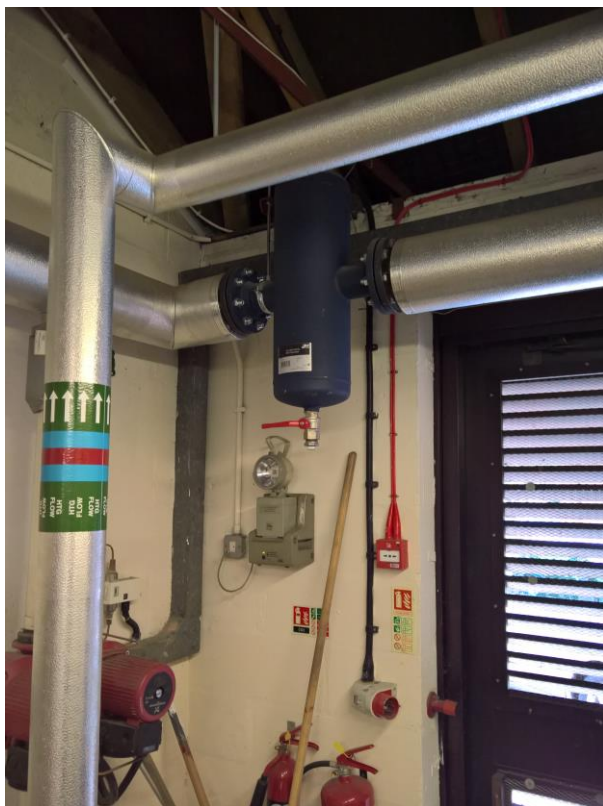
Sample Record Number: J054910PS21

Ground Floor G, Kitchenette TAJAGG-PL-G-11

Position Location : Pipework

Inspection Date	16/9/2016		
Component:	Gaskets	Sample No.	J054910PS21
Survey Type	Type 2	Surveyor	Richard Farmer
Asbestos type	Chrysotile		
Quantity of Material	20N°

Material	2	Extent of Damage	0
Surface Treatment	1	Asbestos Type	1
Material Assessment Total:	4	C

This material needs no immediate attention.

Main Type of Activity	2	Extent of Material	0
Maintenance Activity	0	Location	2
Accessibility	0	Number of Occupants	0
Frequency of use	2	Average time is in use	1
Frequency of maintenance activity	2	Risk Assessment Total:	5
Total Score:	9	Slight Risk

Actions Arising	Due Date	Est. Cost
Label & Manage	9-11-2016	£0

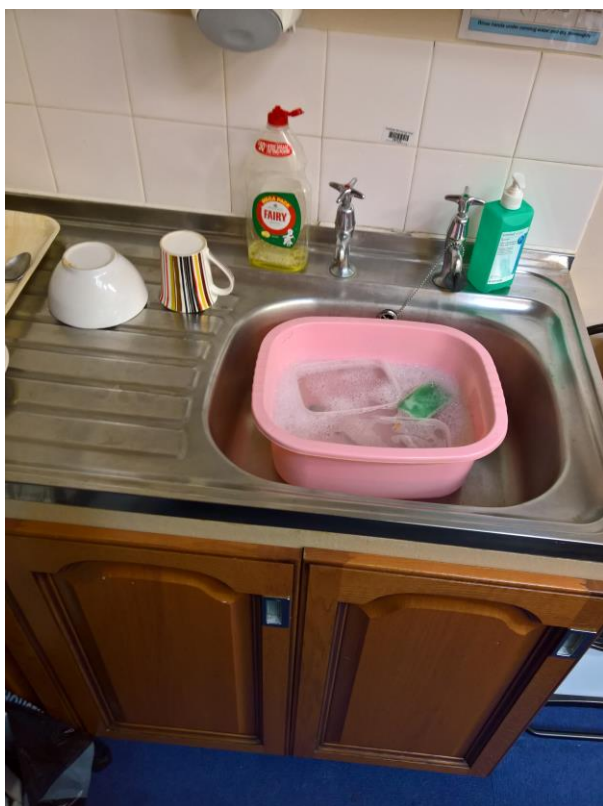
Sample Record Number: FU000424

Ground Floor G, Cupboard – Cleaners TAJAGG-PL-G-62

Position Location : Sink Pads

Inspection Date	16/9/2016		
Component:	Sink Pads	Sample No.	FU000424
Survey Type	Type 2	Surveyor	Richard Farmer
Asbestos type	Chrysotile		
Quantity of Material	2Nº

Material	1	Extent of Damage	0
Surface Treatment	0	Asbestos Type	1
Material Assessment Total:	2	D

This material requires no immediate attention.

Main Type of Activity	1	Extent of Material	0
Maintenance Activity	0	Location	2
Accessibility	1	Number of Occupants	1
Frequency of use	3	Average time is in use	1
Frequency of maintenance activity	1	Risk Assessment Total:	5
Total Score:	7	Sound

Actions Arising	Due Date	Est. Cost
Label & Manage	9-11-2016	£0
