Asbestos Material & Priority Assessment Report

001 - Penn Hospital TAJ52

Survey Conducted by: Riverside Environmental Services Ltd

Survey Report Number J099842

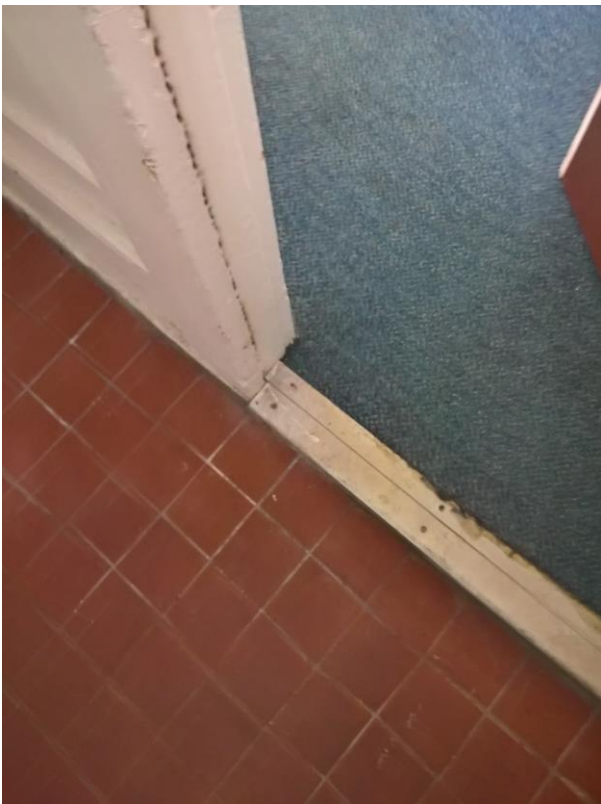
Sample Record Number: FU000448

Inspection Date	12/9/2016		
Component:	Grey Stair Nosing	Sample No.	FU000448
Survey Type	Type 2	Surveyor	Richard Farmer
Asbestos type	Chrysotile		
Quantity of Material	1lm

Material	1	Extent of Damage	1
Surface Treatment	0	Asbestos Type	1
Material Assessment Total:	3	D

This material requires no immediate attention. Incorporate ACM into management plan until removal.

Actions Arising	Due Date	Est. Cost
Label & Manage	11-11-2016	£0

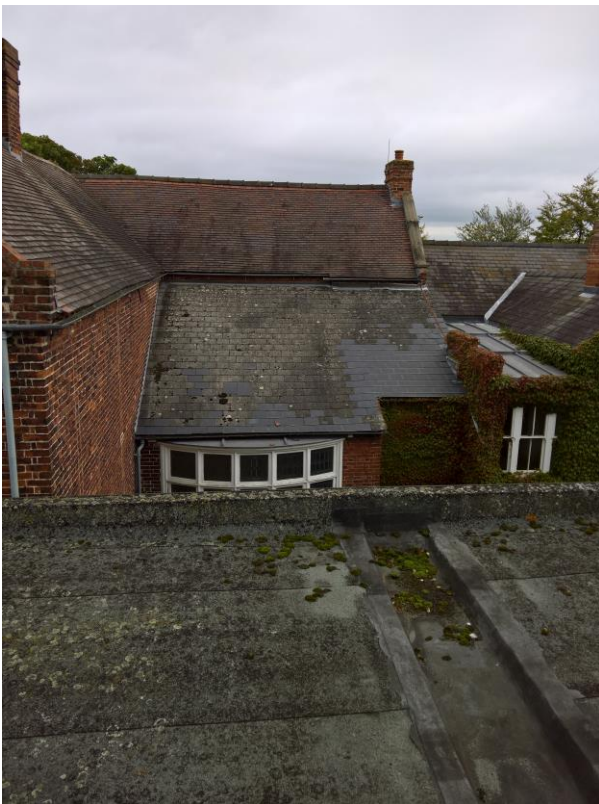
Sample Record Number: J070863PS121

Inspection Date	12/9/2016		
Component:	Roof Tiles	Sample No.	J070863PS121
Survey Type	Management	Surveyor	Richard Farmer
Asbestos type	Chrysotile		
Quantity of Material	20m²

Material	1	Extent of Damage	0
Surface Treatment	1	Asbestos Type	1
Material Assessment Total:	3	D

Located to the roof of the room. Incorporate ACM into management plan until removal.

Actions Arising	Due Date	Est. Cost
Label & Manage	11-11-2016	£0

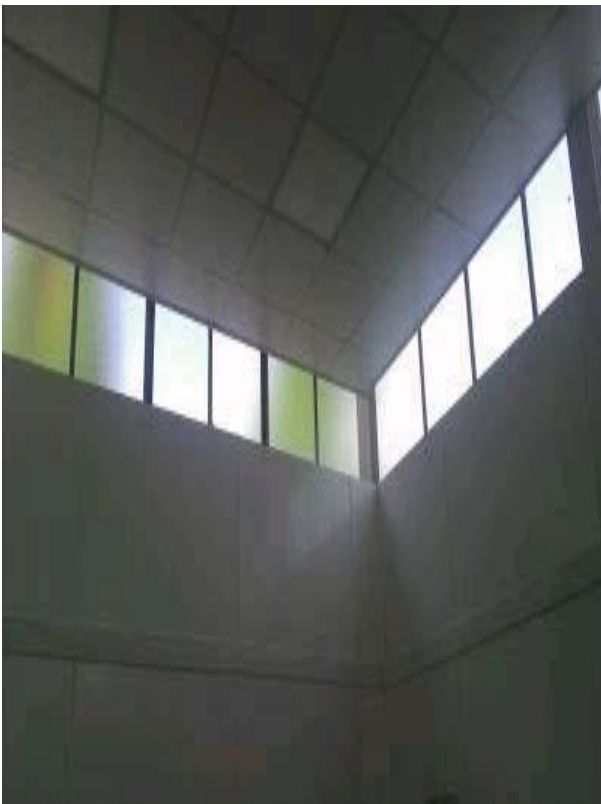
Sample Record Number: FU000452

Inspection Date	12/9/2016		
Component:	Rope Seals	Sample No.	FU000452
Survey Type	Management	Surveyor	Richard Farmer
Asbestos type	Chrysotile		
Quantity of Material	50lm

Material	2	Extent of Damage	0
Surface Treatment	2	Asbestos Type	1
Material Assessment Total:	5	C

Incorporate ACM into management plan until removal.

Actions Arising	Due Date	Est. Cost
Label & Manage	11-11-2016	£0

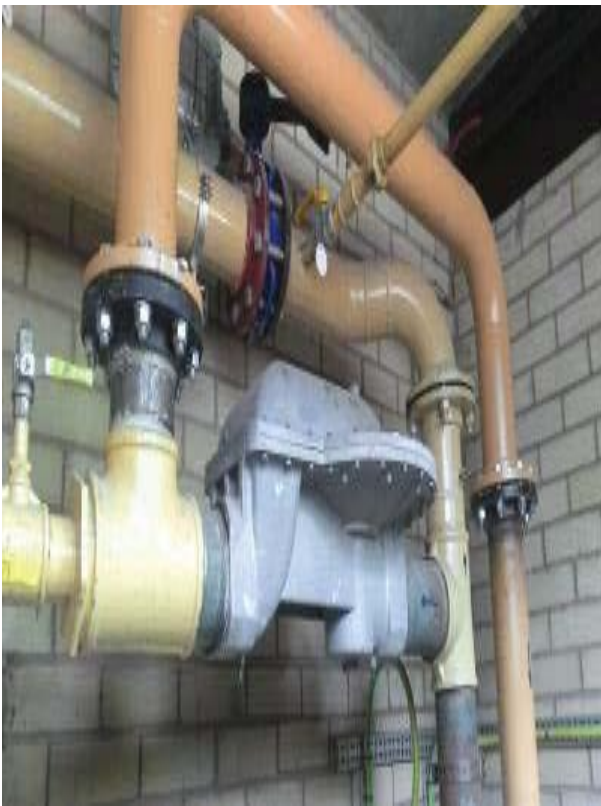
Sample Record Number: J054907PS137

Inspection Date	12/9/2016		
Component:	Gaskets	Sample No.	J054907PS137
Survey Type	Type 2	Surveyor	Richard Farmer
Asbestos type	Chrysotile		
Quantity of Material	9N°

Material	2	Extent of Damage	1
Surface Treatment	1	Asbestos Type	1
Material Assessment Total:	5	C

This material requires no immediate attention. Incorporate ACM into management plan until removal.

Actions Arising	Due Date	Est. Cost
Label & Manage	14-11-2016	£0

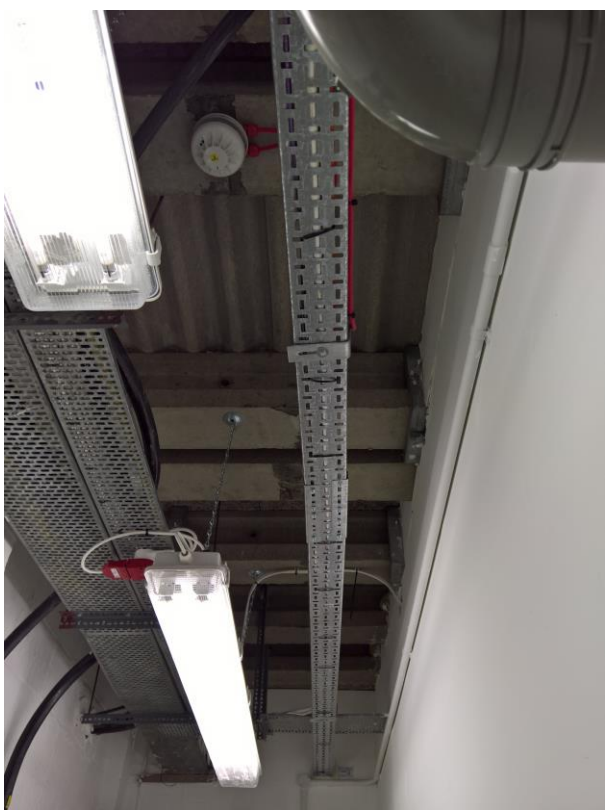
Sample Record Number: VCFU000445-G69

Inspection Date	12/9/2016		
Component:	Profile Cement Shuttering	Sample No.	VCFU000445-G69
Survey Type	Management	Surveyor	Richard Farmer
Asbestos type	Chrysotile		
Quantity of Material	1m²

Material	1	Extent of Damage	1
Surface Treatment	1	Asbestos Type	1
Material Assessment Total:	4	C

Incorporate Asbestos containing materials into management plan until removal.

Actions Arising	Due Date	Est. Cost
Label & Manage	11-11-2016	£0

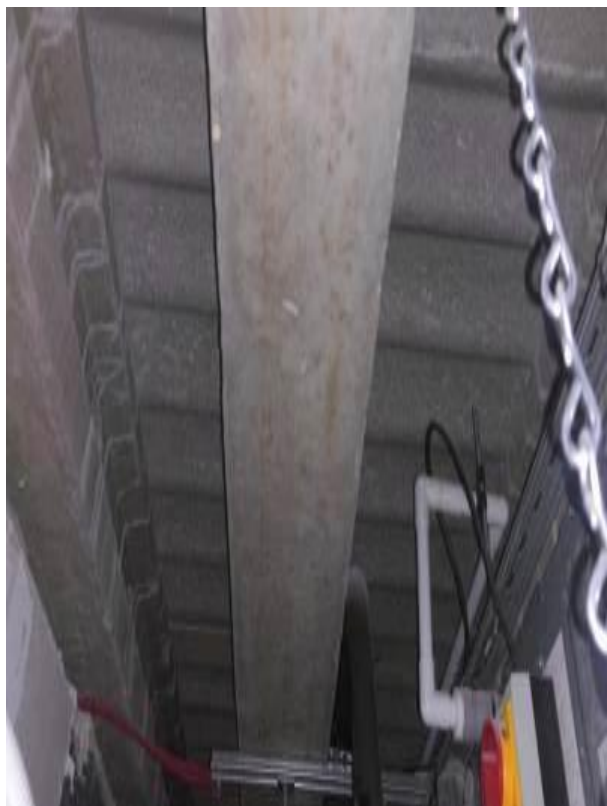
Sample Record Number: FD005297

Inspection Date	12/9/2016		
Component:	Cement Sheet Shuttering	Sample No.	FD005297
Survey Type	Refurbishment	Surveyor	Richard Farmer, RS
Asbestos type	Chrysotile		
Quantity of Material	8m²

Material	1	Extent of Damage	1
Surface Treatment	1	Asbestos Type	1
Material Assessment Total:	4	C

Comments: Incorporate item into management plan.
--

Actions Arising	Due Date	Est. Cost
Label & Manage	11-11-2016	£0

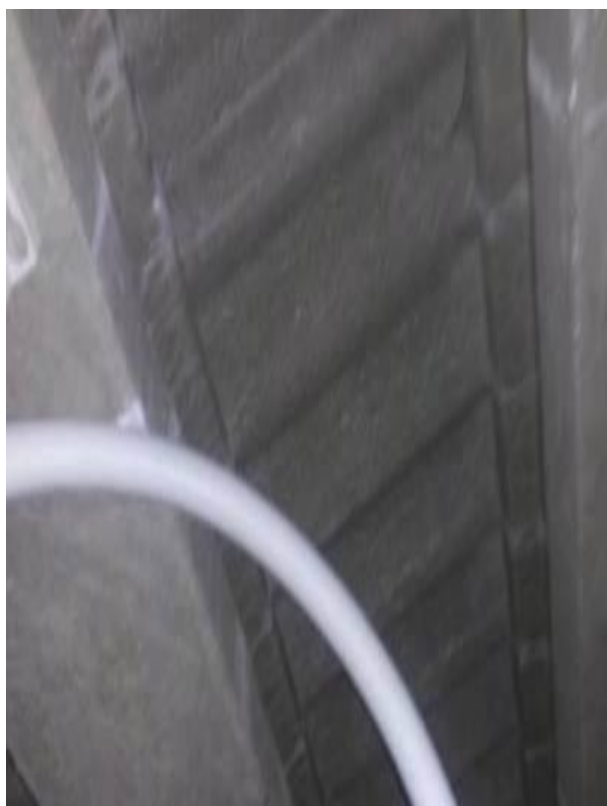
Sample Record Number: VCFD0005297A

Inspection Date	12/9/2016		
Component:	Cement Sheet Shuttering	Sample No.	VCFD0005297A
Survey Type	Refurbishment	Surveyor	Richard Farmer, RS
Asbestos type	Chrysotile		
Quantity of Material	10m²

Material	1	Extent of Damage	1
Surface Treatment	1	Asbestos Type	1
Material Assessment Total:	4	C

Incorporate item into management plan.

Actions Arising	Due Date	Est. Cost
Label & Manage	11-11-2016	£0

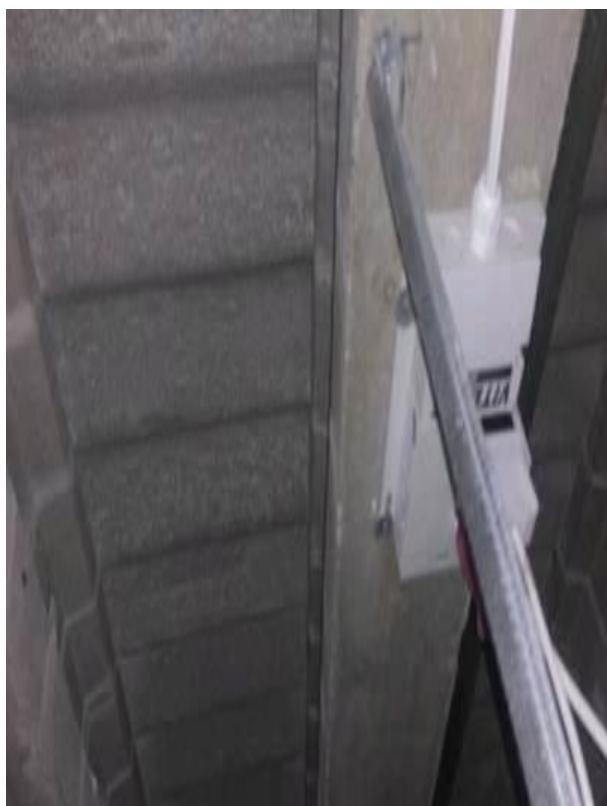
Sample Record Number: VCFD0005297B

Inspection Date	12/9/2016		
Component:	Cement Sheet Shuttering	Sample No.	VCFD0005297B
Survey Type	Refurbishment	Surveyor	Richard Farmer, RS
Asbestos type	Chrysotile		
Quantity of Material	10m²

Material	1	Extent of Damage	1
Surface Treatment	1	Asbestos Type	1
Material Assessment Total:	4	C

Incorporate item into management plan.

Actions Arising	Due Date	Est. Cost
Label & Manage	11-11-2016	£0

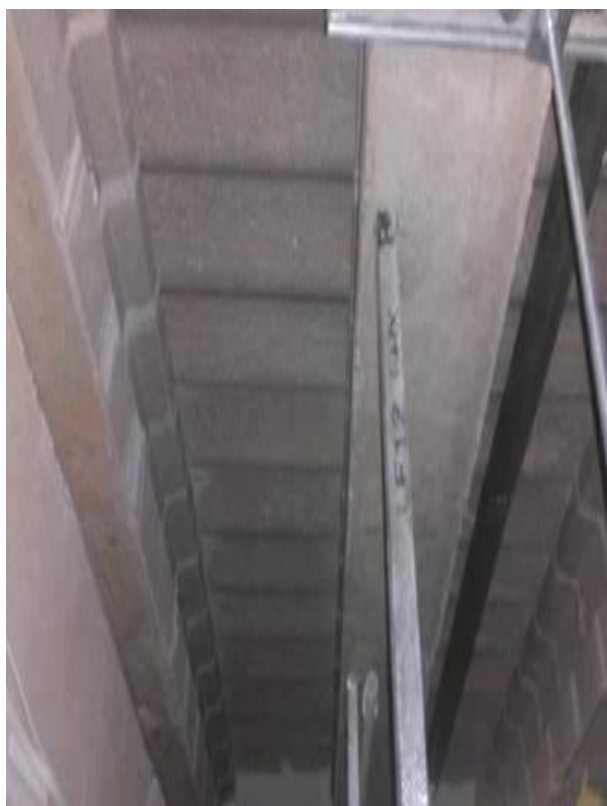
Sample Record Number: VCFD005297C

Inspection Date	12/9/2016		
Component:	Cement Sheet Shuttering	Sample No.	VCFD005297C
Survey Type	Refurbishment	Surveyor	Richard Farmer, RS
Asbestos type	Chrysotile		
Quantity of Material	10m²

Material	1	Extent of Damage	1
Surface Treatment	1	Asbestos Type	1
Material Assessment Total:	4	C

Incorporate item into management plan.

Actions Arising	Due Date	Est. Cost
Label & Manage	11-11-2016	£0

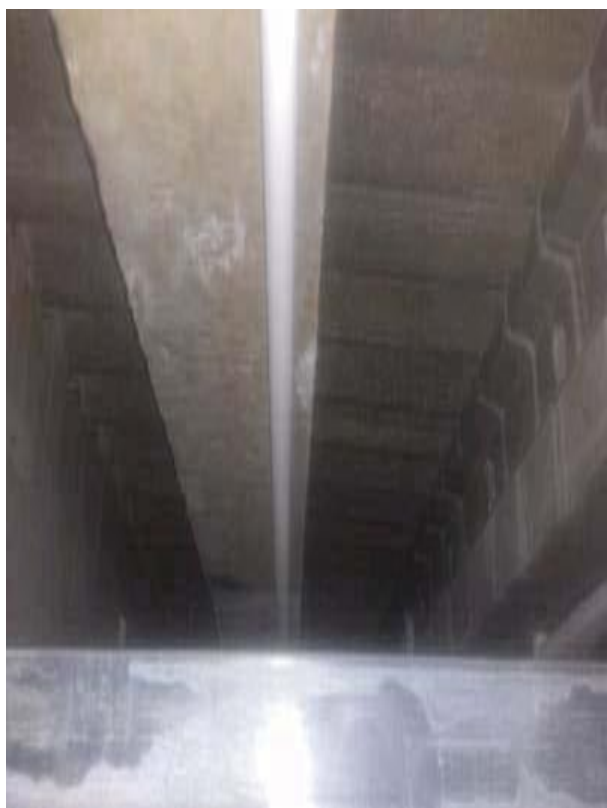
Sample Record Number: VCFU000445-G36

Inspection Date	12/11/2016		
Component:	Cement Profile	Sample No.	VCFU000445-G36
Survey Type	Type 2	Surveyor	Richard Farmer
Asbestos type	Chrysotile		
Quantity of Material	20m²

Material	1	Extent of Damage	1
Surface Treatment	1	Asbestos Type	1
Material Assessment Total:	4	C

Incorporate item into management plan.

Actions Arising	Due Date	Est. Cost
Label & Manage	11-11-2016	£0

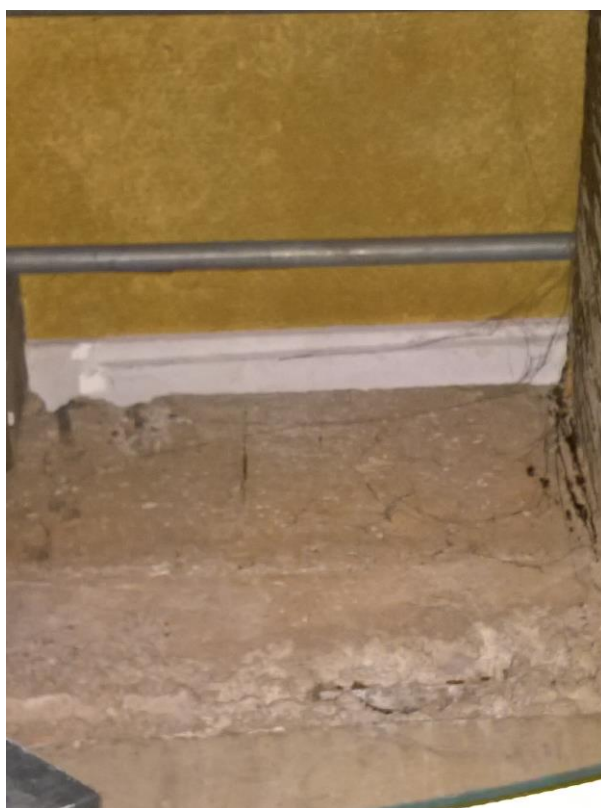
Sample Record Number: FU000446

Inspection Date	12/9/2016		
Component:	Insulating Board Shuttering	Sample No.	FU000446
Survey Type	Type 2	Surveyor	Richard Farmer
Asbestos type	Amosite		
Quantity of Material	0.5lm

Material	2	Extent of Damage	1
Surface Treatment	2	Asbestos Type	2
Material Assessment Total:	7	B

Encapsulate as soon as possible.

Actions Arising	Due Date	Est. Cost
Encapsulate, Label & Manage	11-11-2016	£0

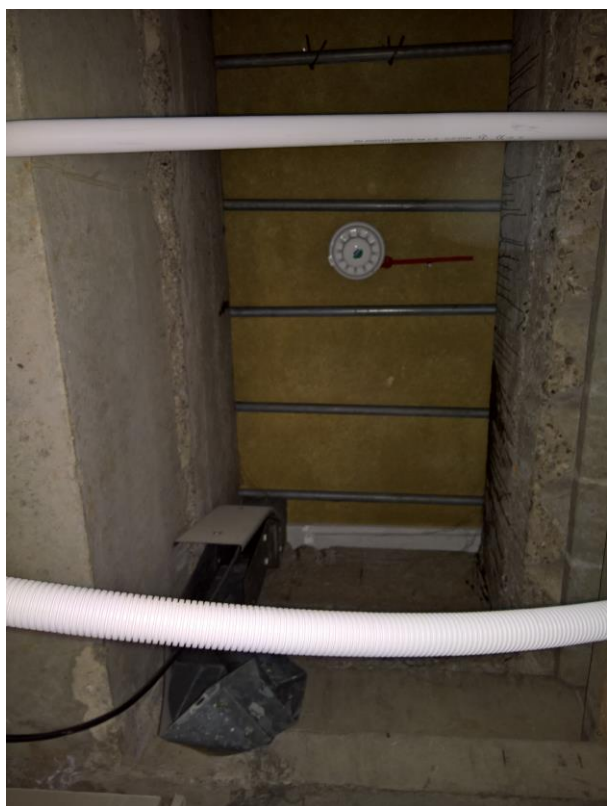
Sample Record Number: FU000447

Inspection Date	12/9/2016		
Component:	Flat cement sheet	Sample No.	FU000447
Survey Type	Type 2	Surveyor	Richard Farmer
Asbestos type	Chrysotile		
Quantity of Material	2m²

Material	1	Extent of Damage	1
Surface Treatment	1	Asbestos Type	1
Material Assessment Total:	4	C

Incorporate into management plan.

Actions Arising	Due Date	Est. Cost
Label & Manage	11-11-2016	£0

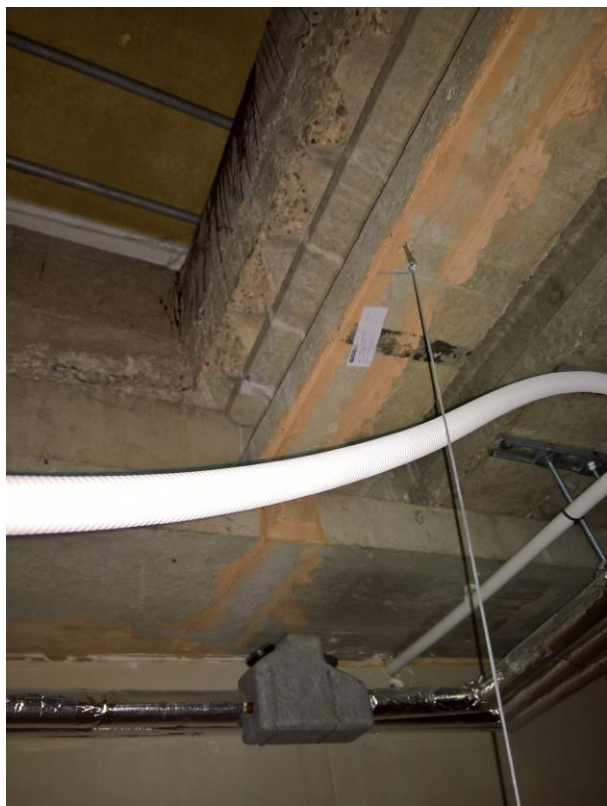
Sample Record Number: VCFU000445-G37

Inspection Date	12/9/2016		
Component:	Profile Cement Sheet	Sample No.	VCFU000445-G37
Survey Type	Type 2	Surveyor	Richard Farmer
Asbestos type	Chrysotile		
Quantity of Material	5m²

Material	1	Extent of Damage	1
Surface Treatment	1	Asbestos Type	1
Material Assessment Total:	4	C

Comments:
Incorporate into management plan.

Actions Arising	Due Date	Est. Cost
Label & Manage	11-11-2016	£0

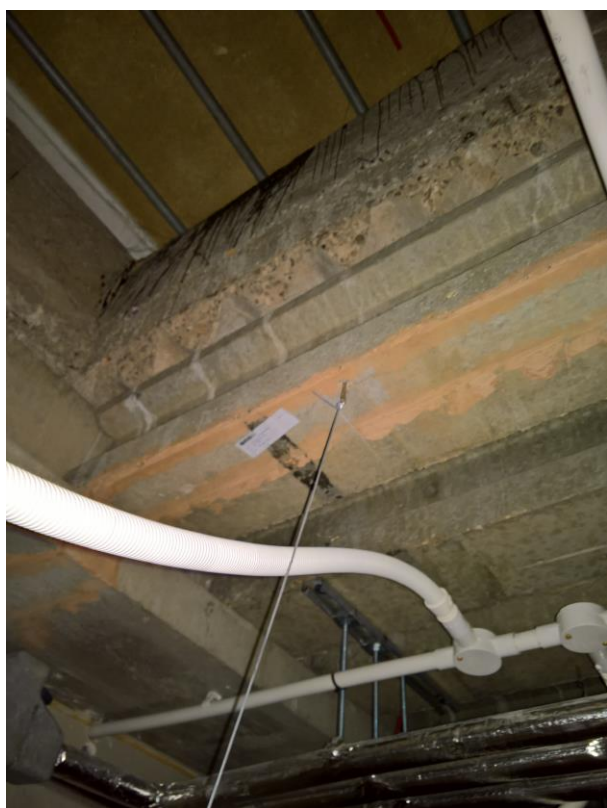
Material	1	Extent of Damage	3
Surface Treatment	1	Asbestos Type	1
Material Assessment Total:	6	C

Remove as soon as possible.

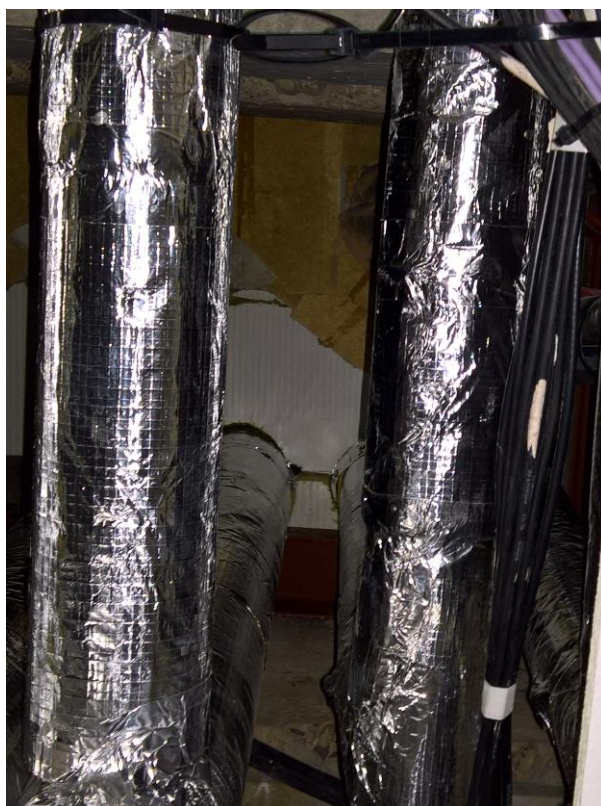
Material	1	Extent of Damage	2
Surface Treatment	1	Asbestos Type	1
Material Assessment Total:	5	C

Repair or remove as soon as possible.

Actions Arising	Due Date	Est. Cost
Repair Damaged Section	11-11-2016	£0
Encapsulate, Label & Manage	11-11-2016	£0

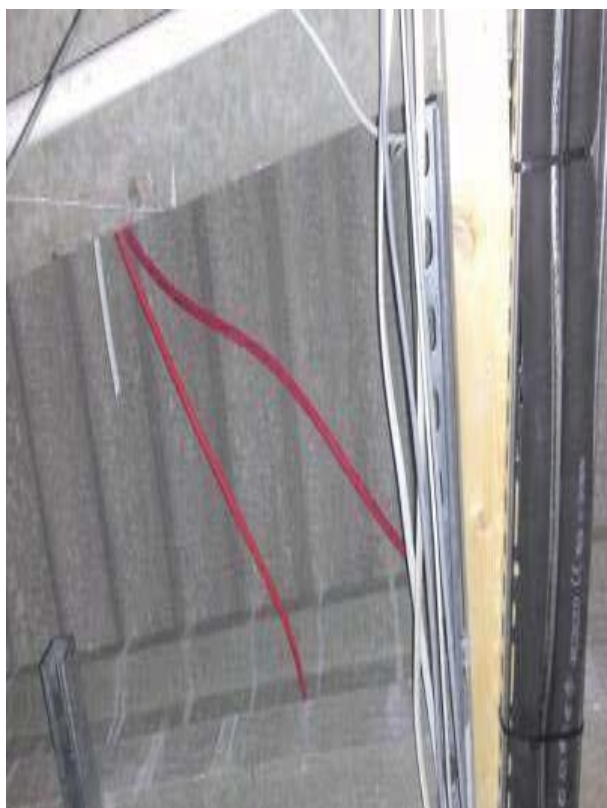
Material	1	Extent of Damage	1
Surface Treatment	1	Asbestos Type	1
Material Assessment Total:	4	C

Incorporate asbestos containing materials into management plan until removal.

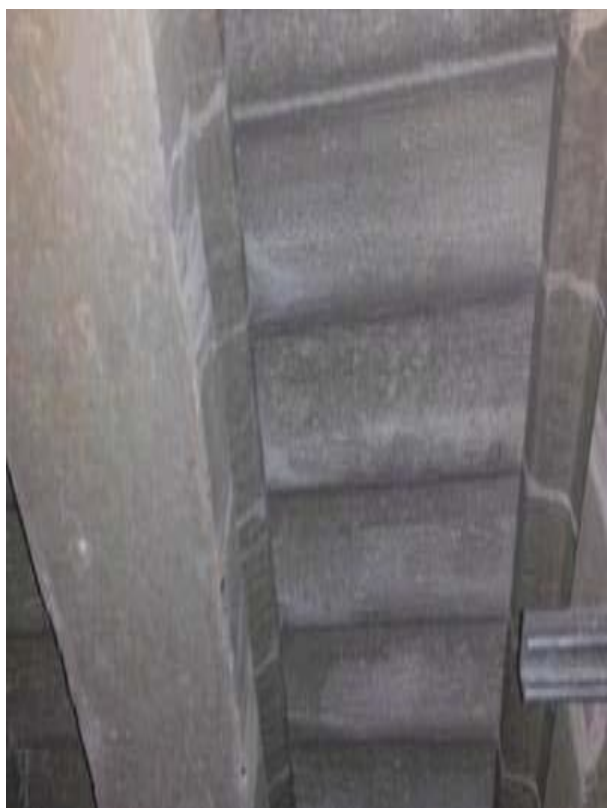
Material	1	Extent of Damage	1
Surface Treatment	1	Asbestos Type	1
Material Assessment Total:	4	C

Incorporate asbestos containing materials into management plan until removal.

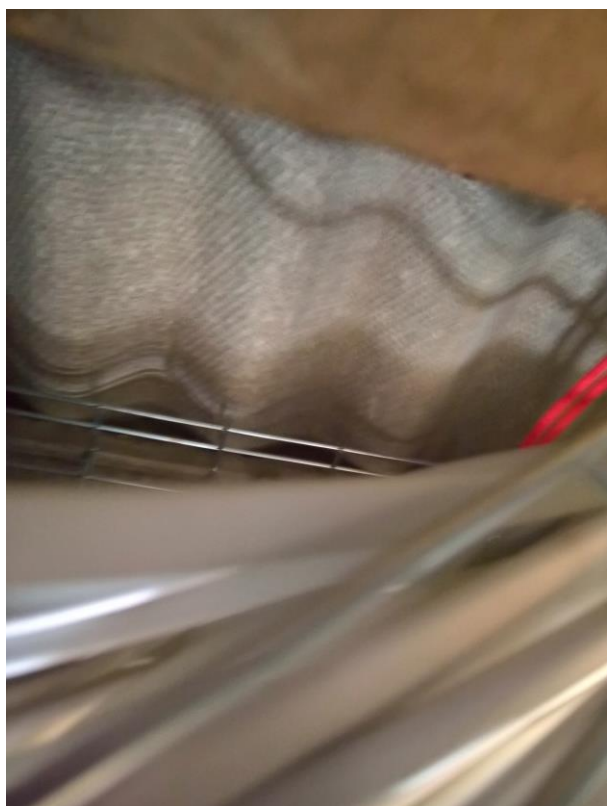
Material	1	Extent of Damage	1
Surface Treatment	1	Asbestos Type	1
Material Assessment Total:	4	C

Incorporate into management plan.

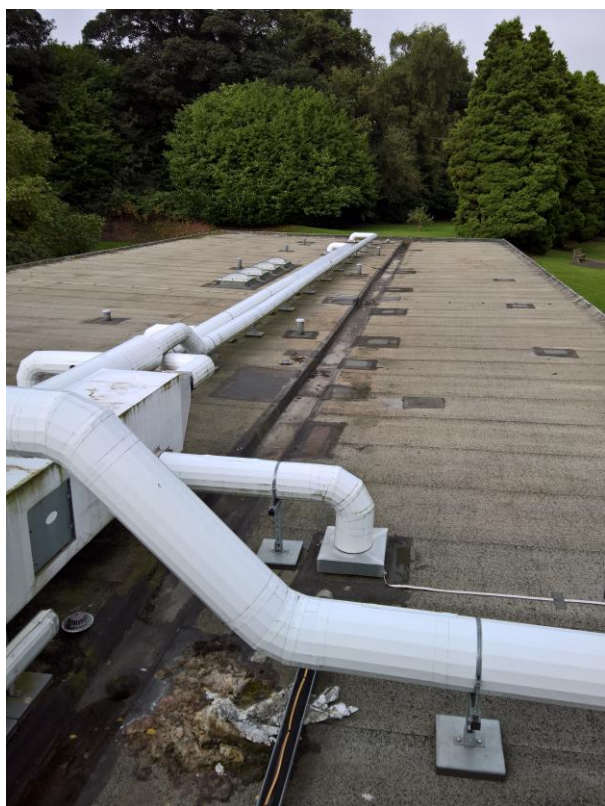
Material	1	Extent of Damage	1
Surface Treatment	0	Asbestos Type	1
Material Assessment Total:	3	D

Located to the roof of therapy corridor. Incorporate item into management plan.

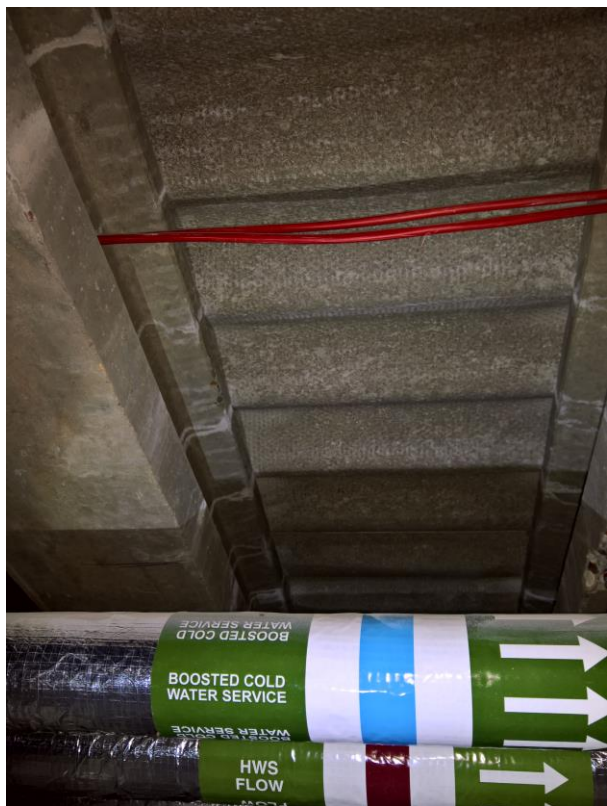
Material	1	Extent of Damage	1
Surface Treatment	1	Asbestos Type	1
Material Assessment Total:	4	C

Comments:
Incorporate item into management plan.

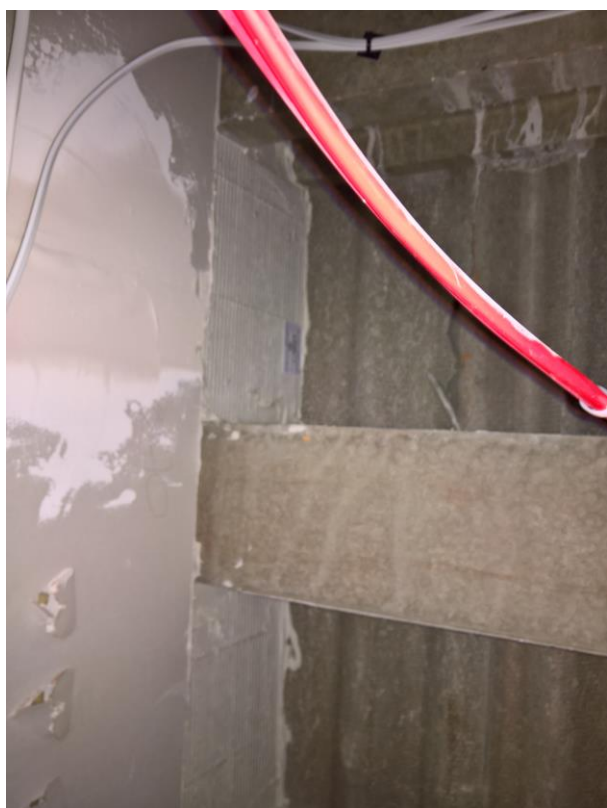
Material	1	Extent of Damage	2
Surface Treatment	1	Asbestos Type	1
Material Assessment Total:	5	C

Repair or remove damaged sections and incorporate ACM into management plan until removal.

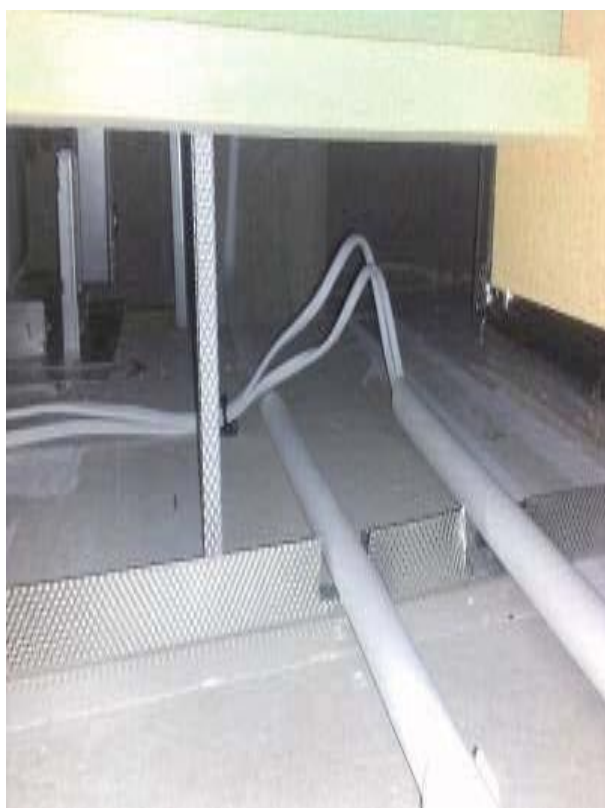
Material	2	Extent of Damage	0
Surface Treatment	1	Asbestos Type	1
Material Assessment Total:	4	C

Incorporate asbestos containing materials into management plan until removal.

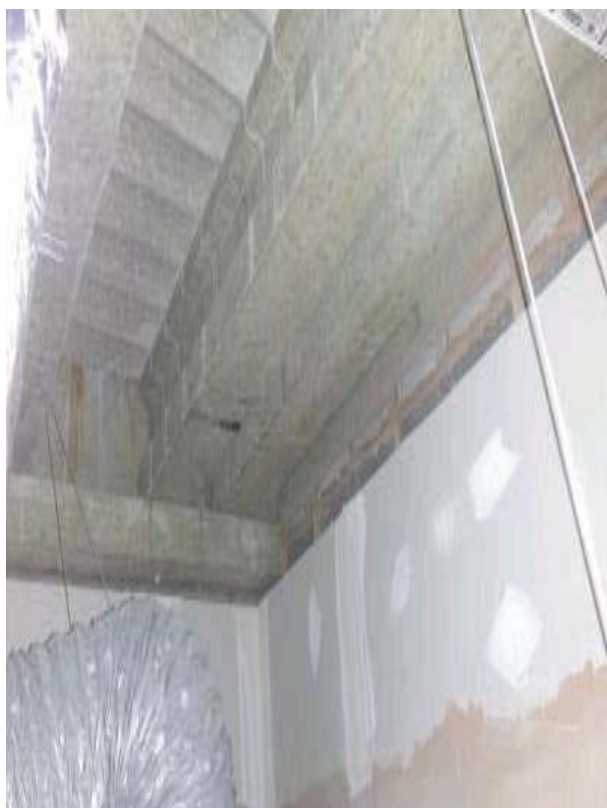
Material	1	Extent of Damage	1
Surface Treatment	1	Asbestos Type	1
Material Assessment Total:	4	C

Incorporate asbestos containing materials into management plan until removal.

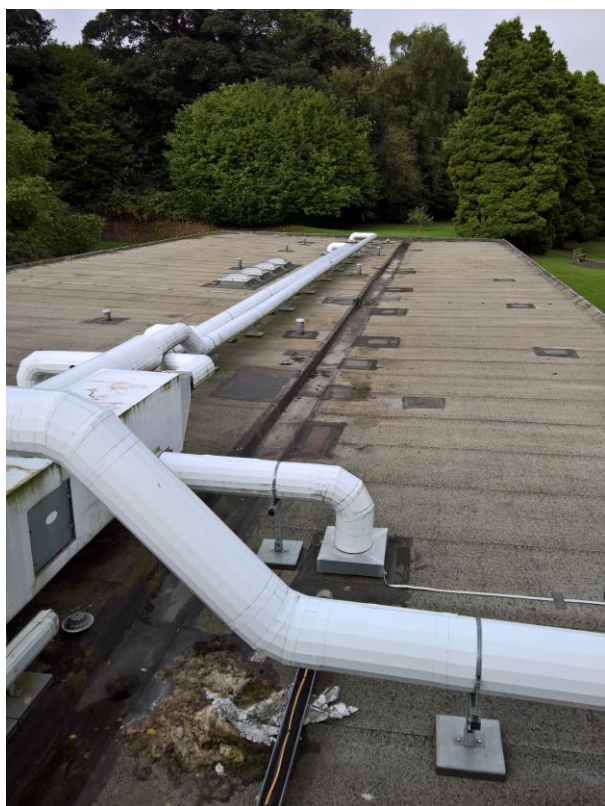
Material	1	Extent of Damage	1
Surface Treatment	0	Asbestos Type	1
Material Assessment Total:	3	D

Visually consistent sample. Label and manage, this material requires no immediate attention.

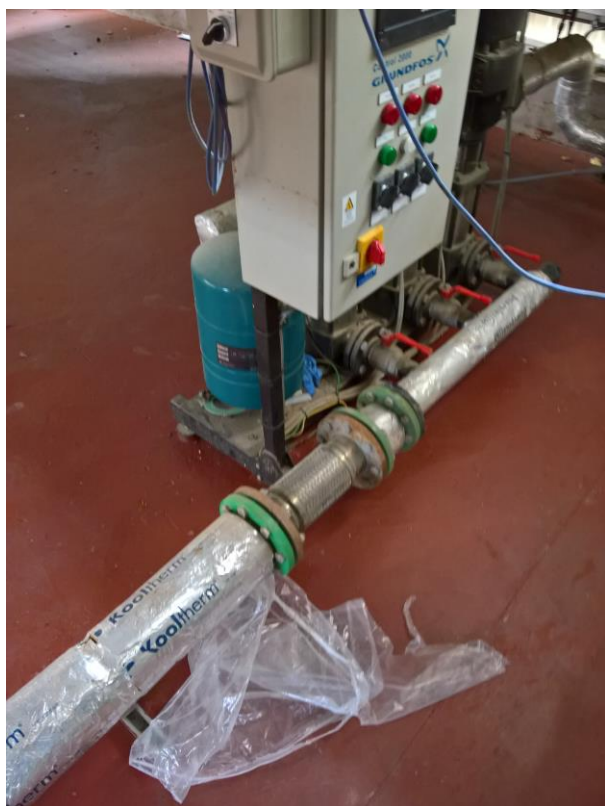
Material	1	Extent of Damage	0
Surface Treatment	0	Asbestos Type	1
Material Assessment Total:	2	D

Label and manage. This material requires no immediate attention.

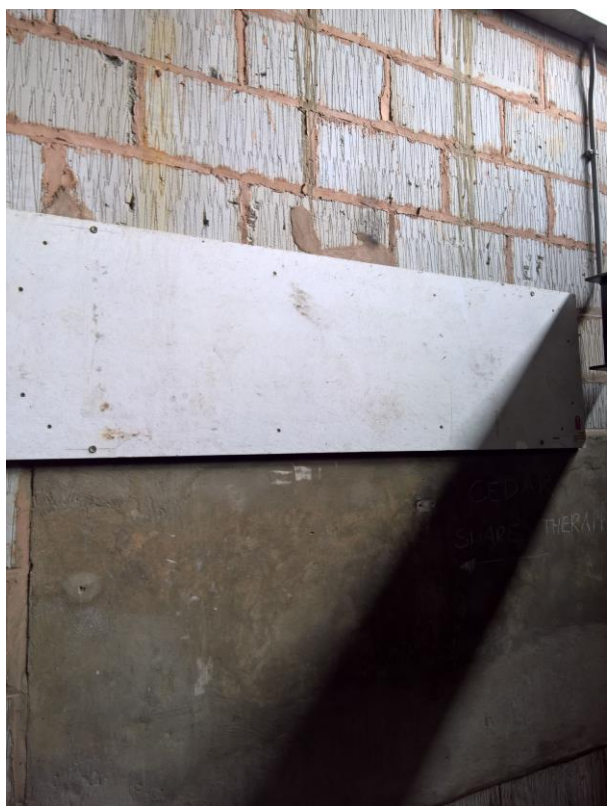
Material	2	Extent of Damage	2
Surface Treatment	2	Asbestos Type	2
Material Assessment Total:	8	B

Encapsulate as soon as is practicable.

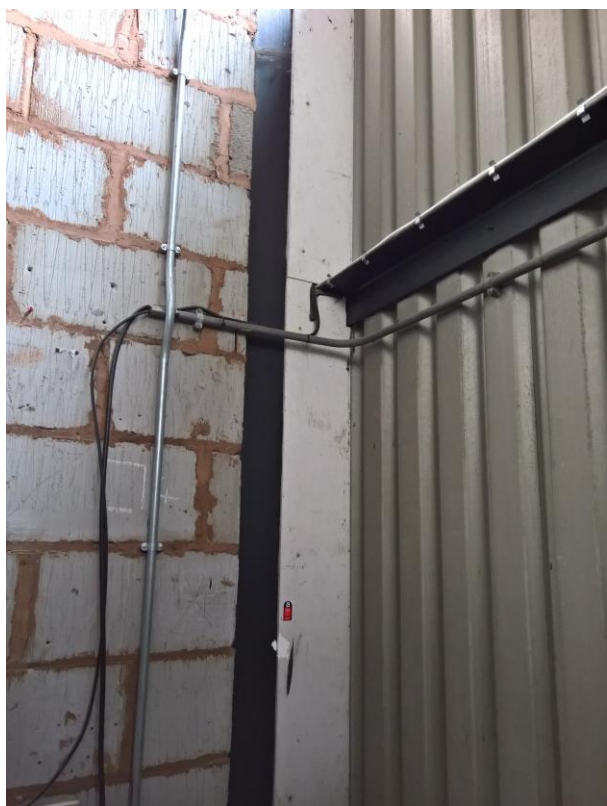
Material	2	Extent of Damage	2
Surface Treatment	2	Asbestos Type	2
Material Assessment Total:	8	B

Encapsulate as soon as is practicable.

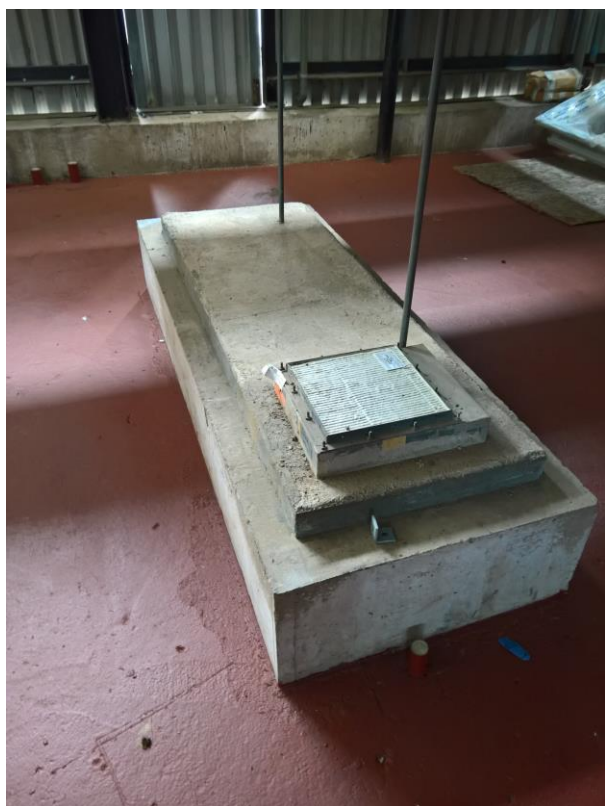
Material	2	Extent of Damage	0
Surface Treatment	2	Asbestos Type	1
Material Assessment Total:	5	C

Label and manage: the material requires no immediate attention.

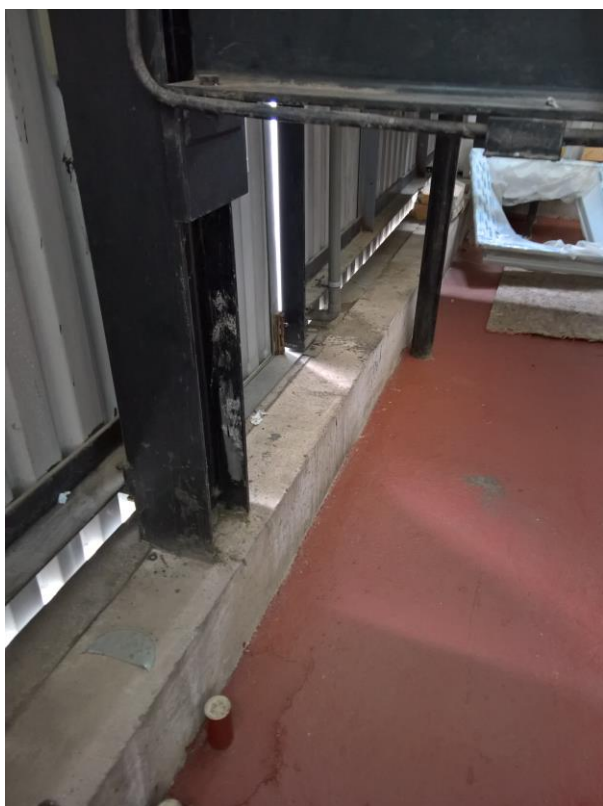
Material	1	Extent of Damage	1
Surface Treatment	0	Asbestos Type	1
Material Assessment Total:	3	D

This material requires no immediate attention.

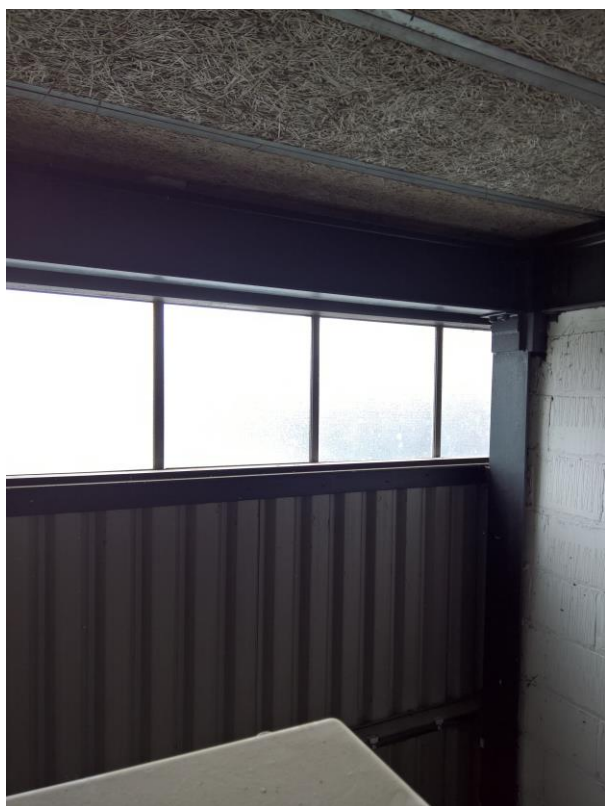
Material	2	Extent of Damage	0
Surface Treatment	1	Asbestos Type	1
Material Assessment Total:	4	C

This material requires no immediate attention. Incorporate ACM into management plan until removal.

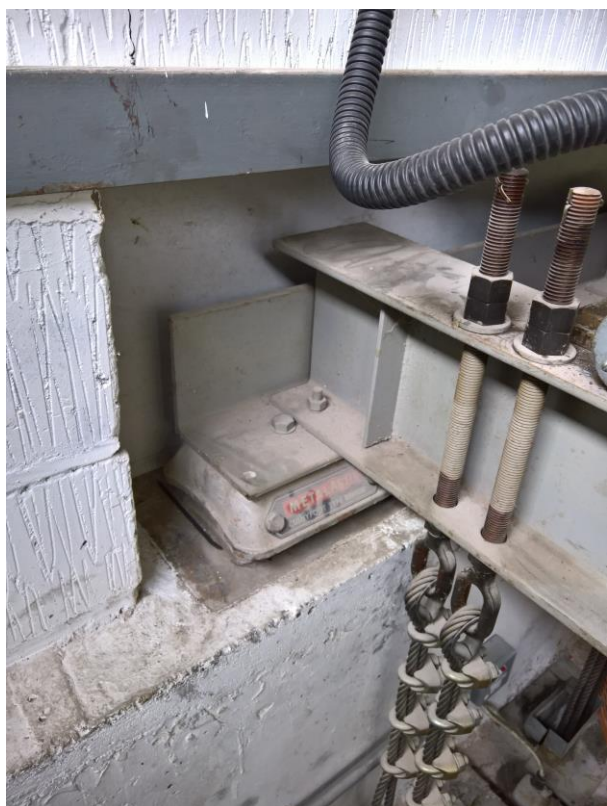
Material	2	Extent of Damage	1
Surface Treatment	2	Asbestos Type	2
Material Assessment Total:	7	B

Encapsulate item as soon as is practicable.

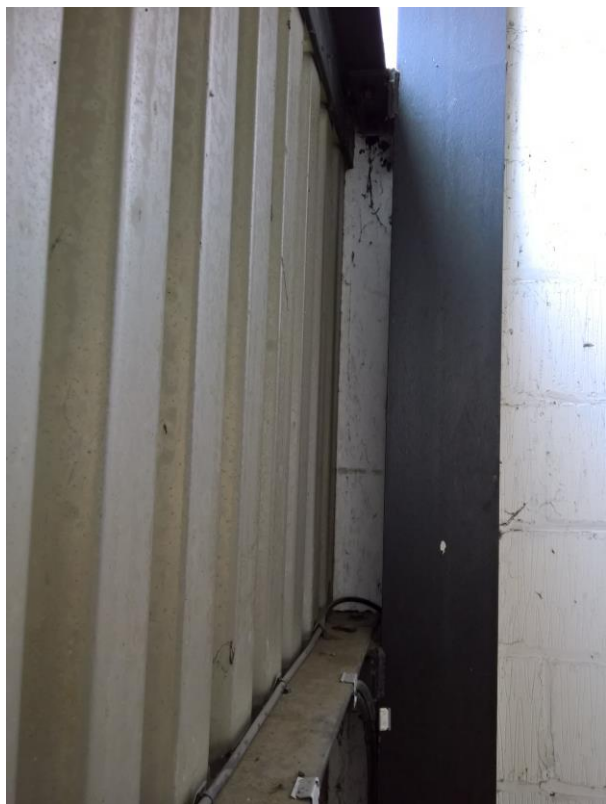
Material	2	Extent of Damage	1
Surface Treatment	2	Asbestos Type	2
Material Assessment Total:	7	B

Comments:
Encapsulate item as soon as is practicable.

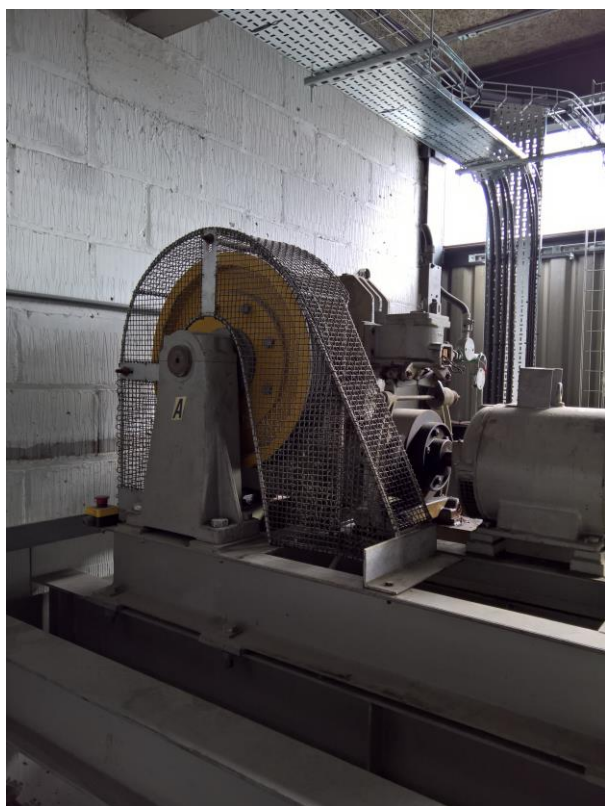
Material	1	Extent of Damage	0
Surface Treatment	0	Asbestos Type	1
Material Assessment Total:	2	D

Incorporate ACM into management plan until removal.

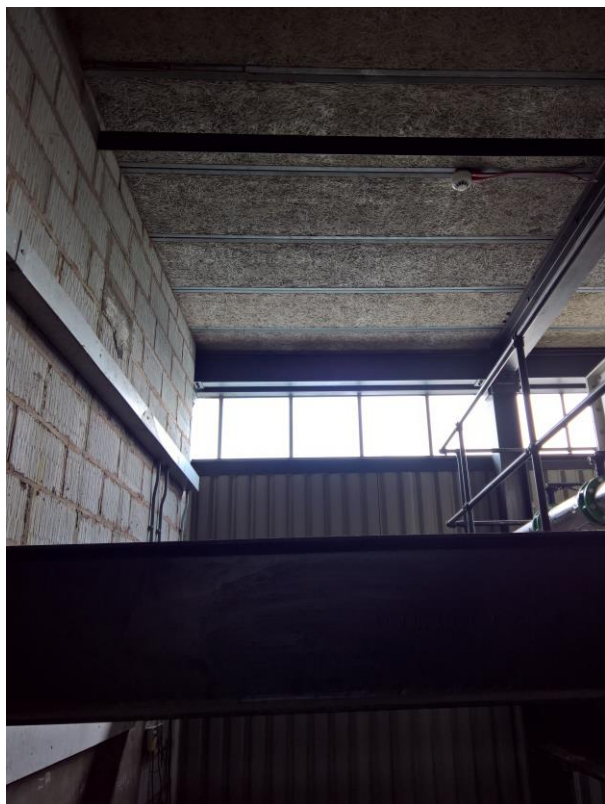
Material	2	Extent of Damage	0
Surface Treatment	1	Asbestos Type	1
Material Assessment Total:	4	C

Incorporate ACM into management until removal.
