**Mixed Management & Refurbishment Asbestos Survey  
Of**

**St Augustine Library  
Queen Mary University  
Church of St Augustine with St Philip  
Newark St  
London  
E1 2AD**

**Report Number: B-30551  
Date of Issue : 20/03/2020**

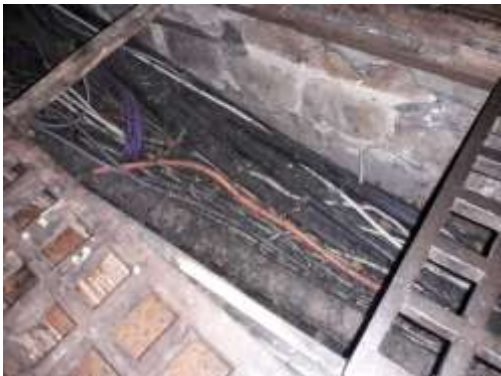
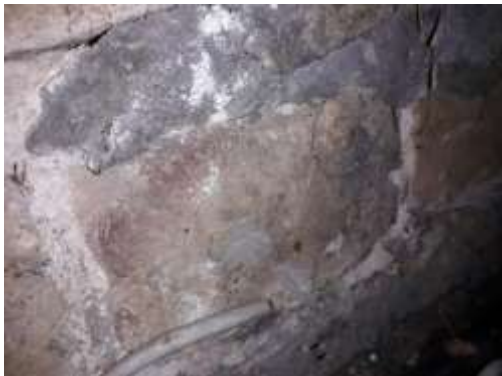
| Sample Inspection Record | | | | | |
|--|---|--|---|---|---|
| Inspection Record: | 859003 | | | | |

| Sample Inspection Record | | | | | |
|--|---|--|---|---|---|
| Description | Trench walls residue - Insulation | | | | |
| Analysis Result | Amosite/Chrysotile | | | | |
| Extent (approximate) | 50 lin m | | | | |
| Extent of Damage | High Damage | 3 | | | |
| Total Score / Risk | High | 11 | | | |

| Sample Inspection Record | | | | | |
|--|---|--|---|---|---|
| Recommendation | Remove | | | | |

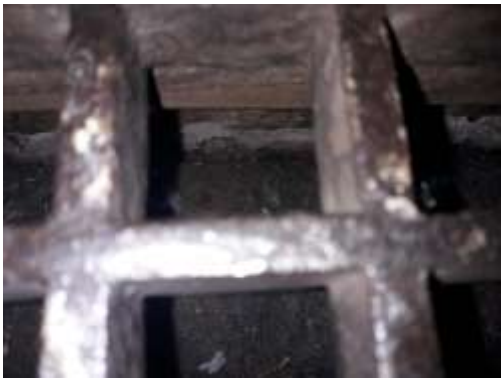
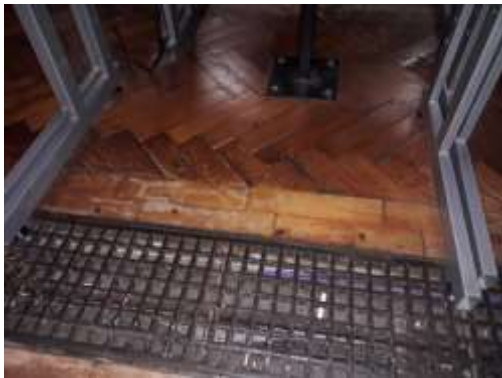
| Sample Inspection Record | | | | | |
|--|--|---|---|---|---|
| Sample Number: | X001 | Inspection Type: | Visually Identified / Strongly Presumed | | |

| Sample Inspection Record | | | | | |
|--|--|---|---|---|---|
| Description | Trench walls residue - Insulation | | | | |
| Extent of Damage | High Damage | 3 | | | |

| Sample Inspection Record | | | | | |
|--|--|---|---|---|---|
| Recommendation | Remove | | | | |

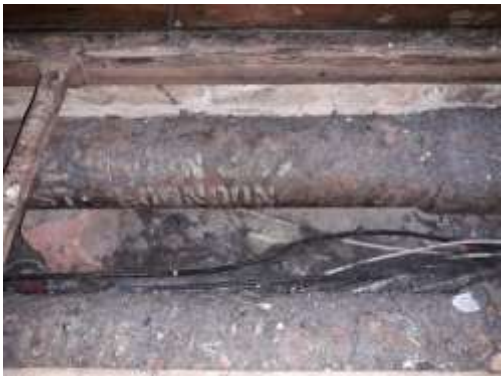
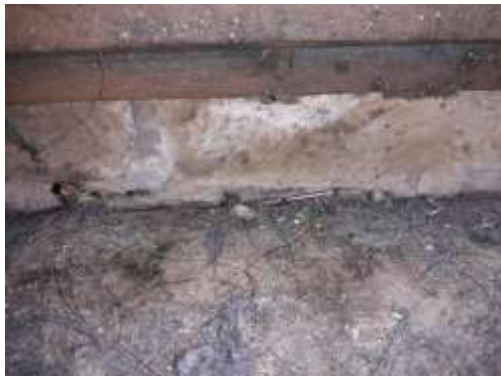
| Sample Inspection Record | | | | | |
|--|---|--|---|---|---|
| Sample Number: | S002 | Inspection Type: | Sampled | | |

| Sample Inspection Record | | | | | |
|--|---|--|---|---|---|
| Description | Trench walls residue - Insulation | | | | |
| Extent of Damage | High Damage | 3 | | | |

| Sample Inspection Record | | | | | |
|--|---|--|---|---|---|
| Recommendation | Remove | | | | |

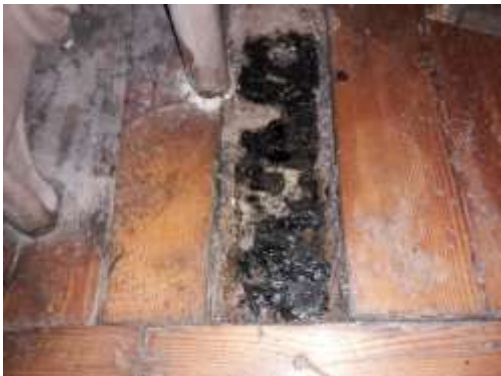
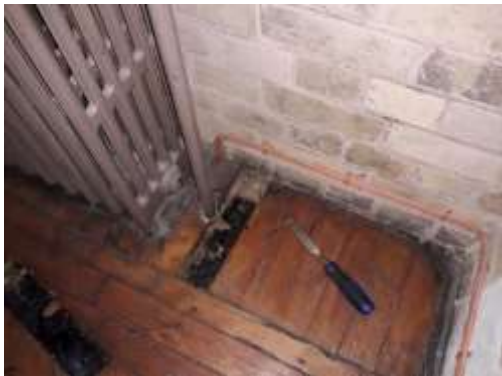
| Sample Inspection Record | | | | | |
|--|---|--|---|---|---|
| Sample Number: | S003 | Inspection Type: | Sampled | | |

| Sample Inspection Record | | | | | |
|--|---|--|---|---|---|
| Description | Adhesive under parquet - Bituminous Product | | | | |

| Sample Inspection Record | | | | | |
|--|---|--|---|---|---|
| Recommendation | No action required | | | | |

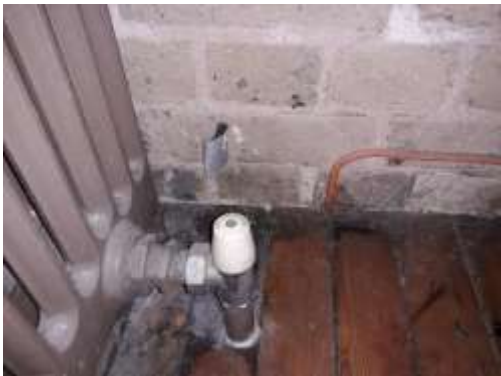
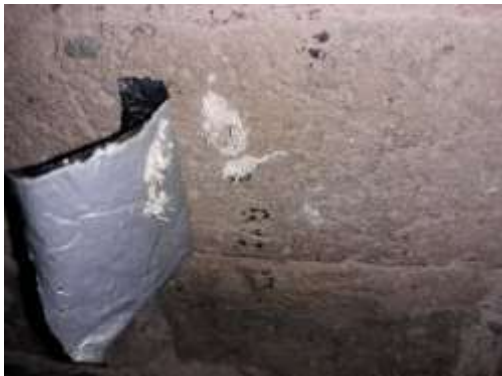
| Sample Inspection Record | | | | | |
|--|---|--|---|---|---|
| Sample Number: | S004 | Inspection Type: | Sampled | | |

| Sample Inspection Record | | | | | |
|--|---|--|---|---|---|
| Description | Wall residue - Insulation | | | | |
| Extent of Damage | High Damage | | | 3 | |

| Sample Inspection Record | | | | | |
|--|---|--|---|---|---|
| Recommendation | Remove | | | | |

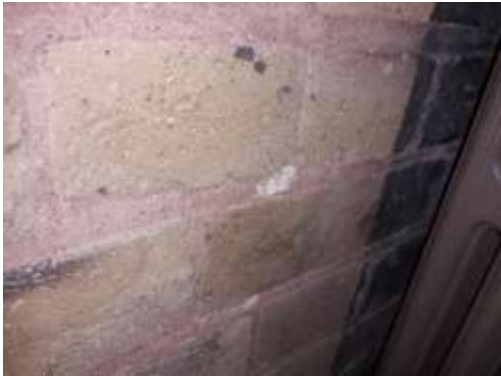
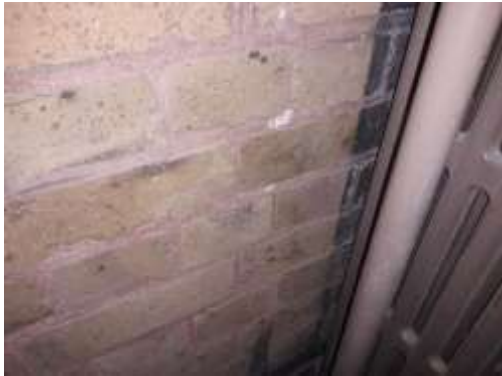
| Sample Inspection Record | | | | | |
|--|--|---|---|---|---|
| Sample Number: | X004 | Inspection Type: | Visually Identified / Strongly Presumed | | |

| Sample Inspection Record | | | | | |
|--|--|---|---|---|---|
| Description | Wall residue - Insulation | | | | |
| Extent of Damage | High Damage | 3 | | | |

| Sample Inspection Record | | | | | |
|--|--|---|---|---|---|
| Recommendation | Remove | | | | |

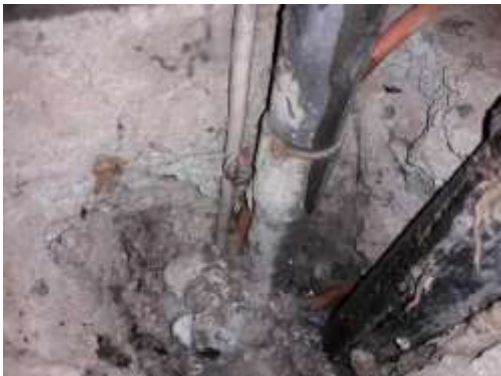
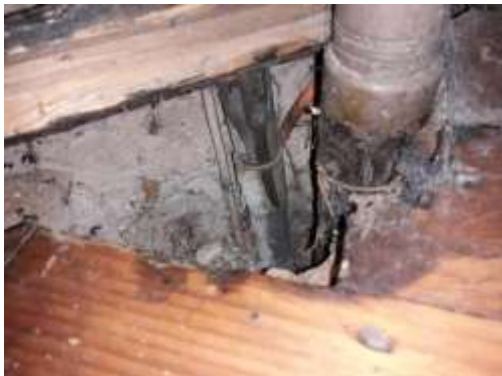
| Sample Inspection Record | | | | | |
|--|---|--|---|---|---|
| Sample Number: | S005 | Inspection Type: | Sampled | | |

| Sample Inspection Record | | | | | |
|--|---|--|---|---|---|
| Description | Floor penetration - Insulation | | | | |

| Sample Inspection Record | | | | | |
|--|---|--|---|---|---|
| Recommendation | No action required | | | | |

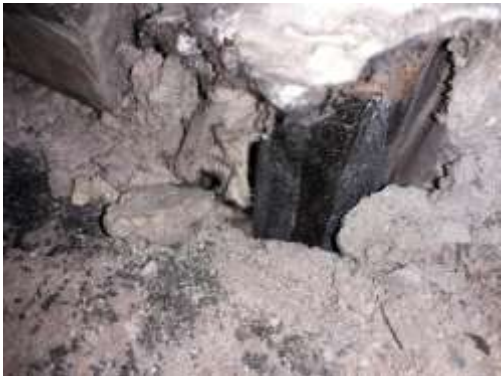
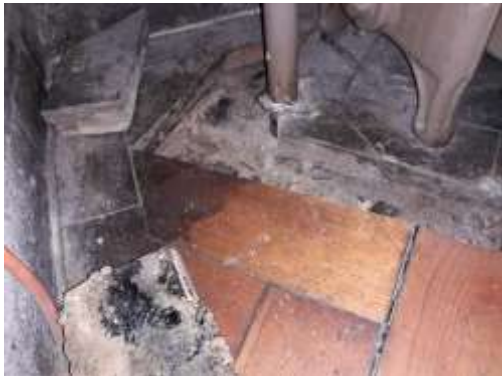
| Sample Inspection Record | | | | | |
|--|---|--|---|---|---|
| Sample Number: | X005 | Inspection Type: | Visually Identified / Strongly Presumed | | |

| Sample Inspection Record | | | | | |
|--|---|--|---|---|---|
| Description | Floor penetration to radiators - Insulation | | | | |
| Sample Notes | Insulation has been presumed to all pipe penetrations through the floors, most were not accessible as they are either concreted over or there was a risk of damaging the copper pipes that wrap around parquet flooring | | | | |

| Sample Inspection Record | | | | | |
|--|---|--|---|---|---|
| Recommendation | No action required | | | | |

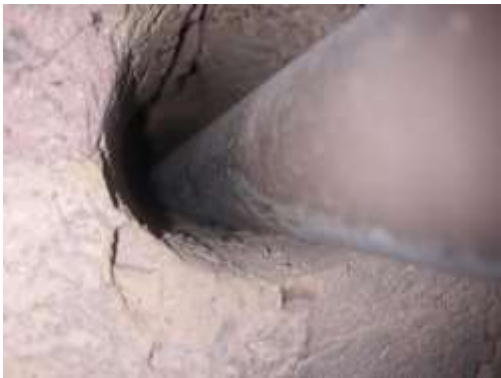
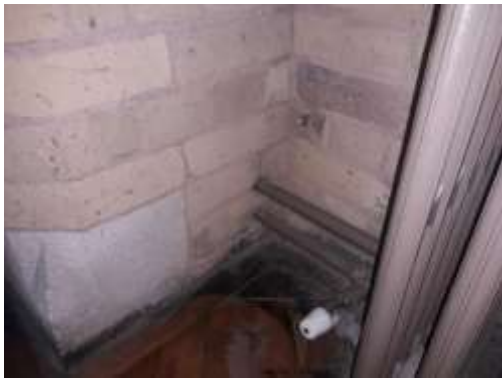
| Sample Inspection Record | | | | | |
|--|---|--|---|---|---|
| Sample Number: | X005 | Inspection Type: | Visually Identified / Strongly Presumed | | |

| Sample Inspection Record | | | | | |
|--|---|--|---|---|---|
| Description | Pipe penetration to wall - Insulation | | | | |
| Sample Notes | Area not fully accessible as close to a wall in a small recession | | | | |

| Sample Inspection Record | | | | | |
|--|---|--|---|---|---|
| Recommendation | No action required | | | | |

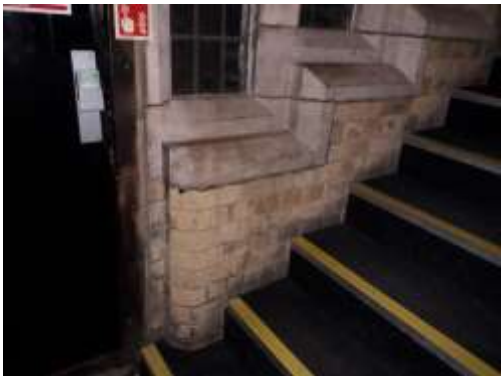
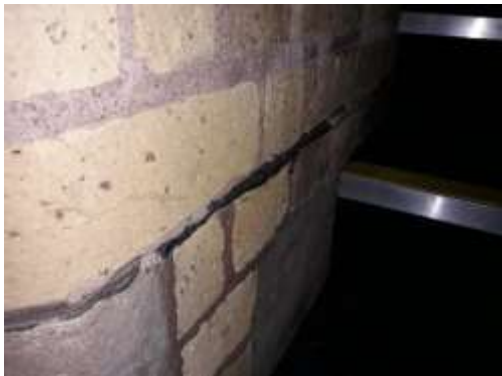
| Sample Inspection Record | | | | | |
|--|--|--|---|---|---|
| Sample Number: | S006 | Inspection Type: | Sampled | | |

| Sample Inspection Record | | | | | |
|--|--|--|---|---|---|
| Description | Damp proof membrane - Bituminous Product | | | | |

| Sample Inspection Record | | | | | |
|--|--|--|---|---|---|
| Recommendation | No action required | | | | |

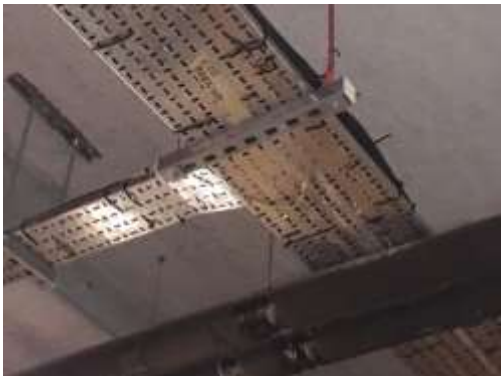
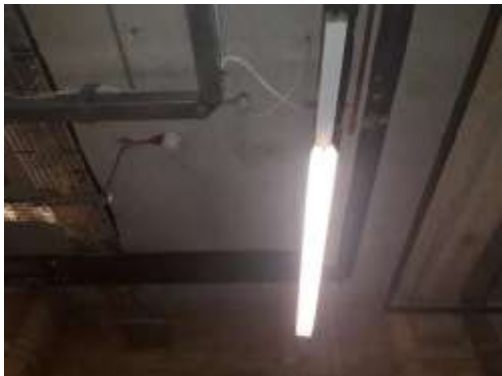
| Sample Inspection Record | | | | | |
|--|---|--|---|---|---|
| Sample Number: | S007 | Inspection Type: | Sampled | | |

| Sample Inspection Record | | | | | |
|--|---|--|---|---|---|
| Description | Ceiling spray coating - Insulation | | | | |

| Sample Inspection Record | | | | | |
|--|---|--|---|---|---|
| Recommendation | No action required | | | | |

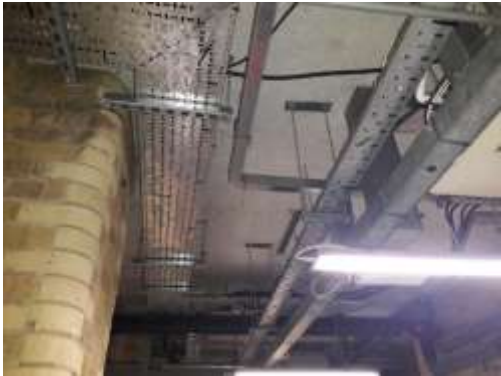
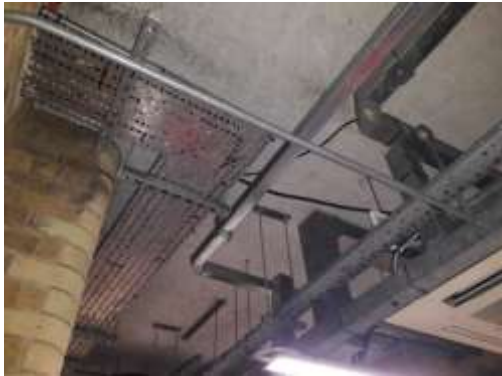
| Sample Inspection Record | | | | | |
|--|---|--|---|---|---|
| Sample Number: | X007 | Inspection Type: | Visually Identified / Strongly Presumed | | |

| Sample Inspection Record | | | | | |
|--|---|--|---|---|---|
| Description | Ceiling spray coating - Insulation | | | | |

| Sample Inspection Record | | | | | |
|--|---|--|---|---|---|
| Recommendation | No action required | | | | |

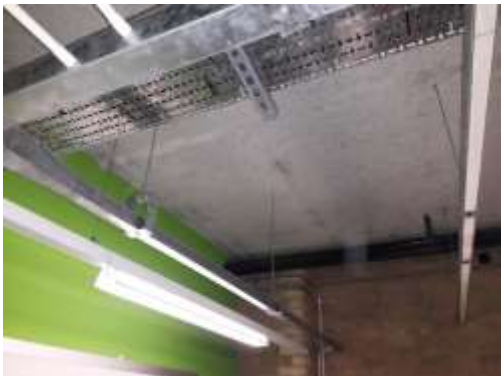
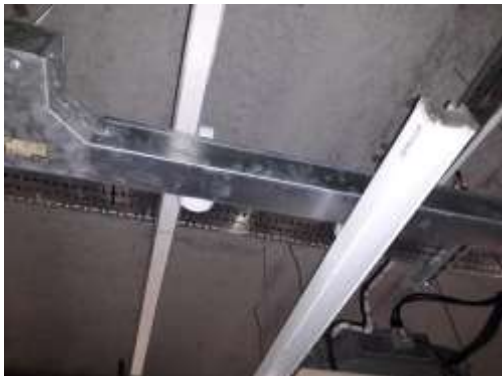
| Sample Inspection Record | | | | | |
|--|---|--|---|---|---|
| Sample Number: | S008 | Inspection Type: | Sampled | | |

| Sample Inspection Record | | | | | |
|--|---|--|---|---|---|
| Description | Ceiling spray coating - Insulation | | | | |

| Sample Inspection Record | | | | | |
|--|---|--|---|---|---|
| Recommendation | No action required | | | | |

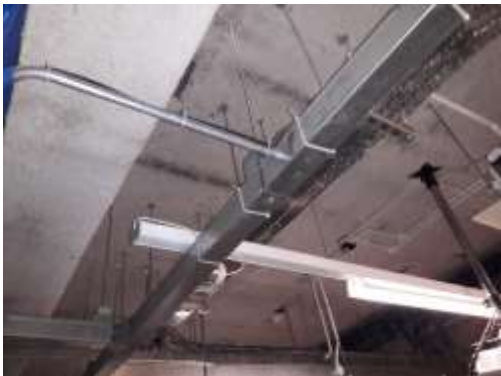
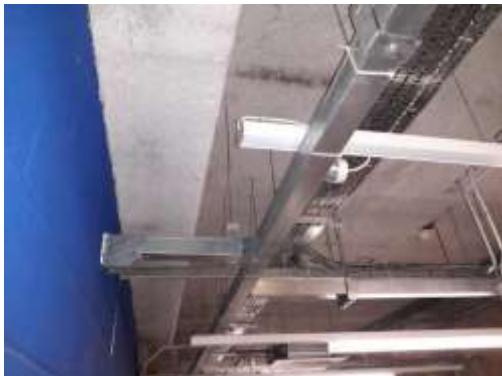
| Sample Inspection Record | | | | | |
|--|---|--|---|---|---|
| Sample Number: | S009 | Inspection Type: | Sampled | | |

| Sample Inspection Record | | | | | |
|--|---|--|---|---|---|
| Description | Ceiling spray coating - Insulation | | | | |

| Sample Inspection Record | | | | | |
|--|---|--|---|---|---|
| Recommendation | No action required | | | | |

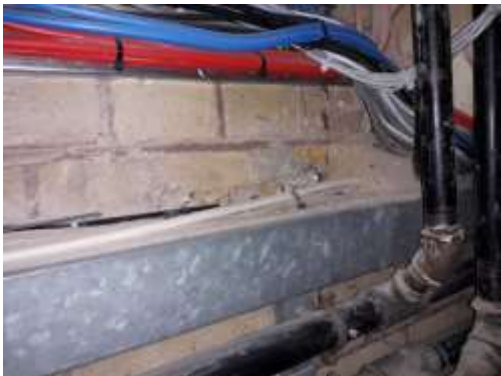
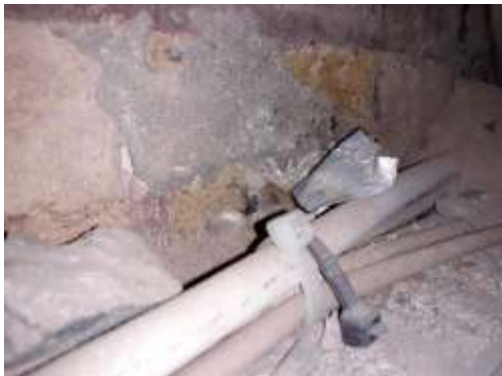
| Sample Inspection Record | | | | | |
|--|---|--|---|---|---|
| Sample Number: | P001 | Inspection Type: | Presumed | | |

| St Augustine Library: | | | | | | | | | | |
|---|---|---|---|---|---|---|---|---|---|---|
| 859099 | Basement | COR01 (007) | Ceiling spray coating - Insulation | 20 m <sup>2</sup> | High Damage | Unsealed lagging or sprays | P001 | Crocidolite | 12 - High | Remove |

| Sample Inspection Record | | | | | |
|--|---|--|---|---|---|
| Description | Ceiling spray coating - Insulation | | | | |
| Extent of Damage | High Damage | 3 | | | |

| Sample Inspection Record | | | | | |
|--|---|--|---|---|---|
| Recommendation | Remove | | | | |

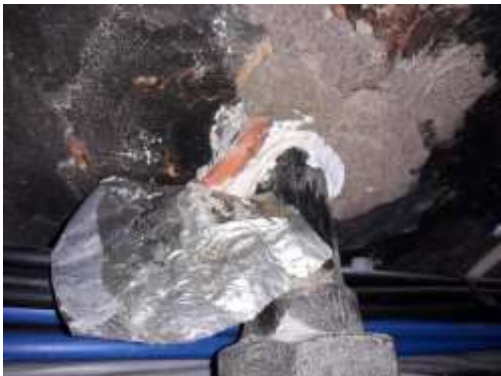
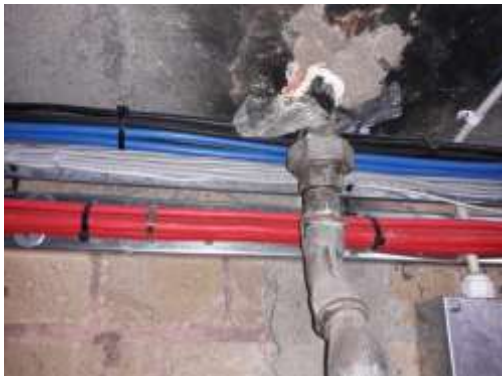
| Sample Inspection Record | | | | | |
|--|---|--|---|---|---|
| Sample Number: | S010 | Inspection Type: | Sampled | | |

| St Augustine Library: | | | | | | | | | | |
|---|---|---|---|---|---|---|---|---|---|---|
| 859093 | Basement | COR01 (007) | Ceiling spray coating - Insulation | 20 m <sup>2</sup> | High Damage | Unsealed lagging or sprays | S010 | Amosite/Chrysotile | 11 - High | Remove |

| Sample Inspection Record | | | | | |
|--|---|--|---|---|---|
| Description | Ceiling spray coating - Insulation | | | | |
| Extent of Damage | High Damage | 3 | | | |

| Sample Inspection Record | | | | | |
|--|---|--|---|---|---|
| Recommendation | Remove | | | | |

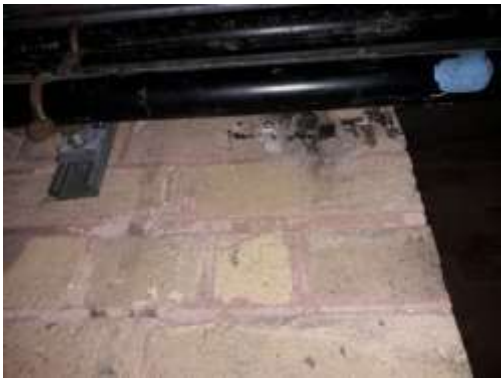
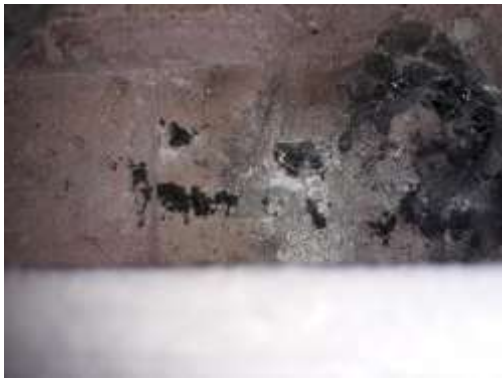
| Sample Inspection Record | | | | | |
|--|--|---|---|---|---|
| Sample Number: | X010 | Inspection Type: | Visually Identified / Strongly Presumed | | |

| Sample Inspection Record | | | | | |
|--|--|---|---|---|---|
| Description | Ceiling spray coating - Insulation | | | | |
| Extent of Damage | High Damage | | | 3 | |

| Sample Inspection Record | | | | | |
|--|--|---|---|---|---|
| Recommendation | Remove | | | | |

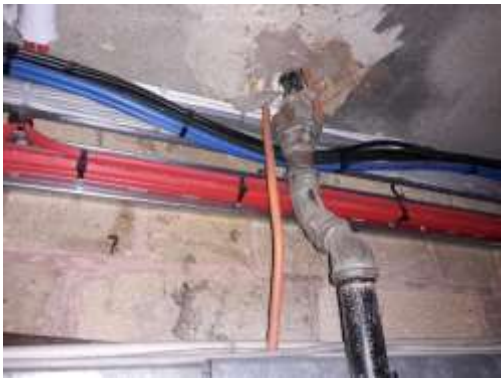
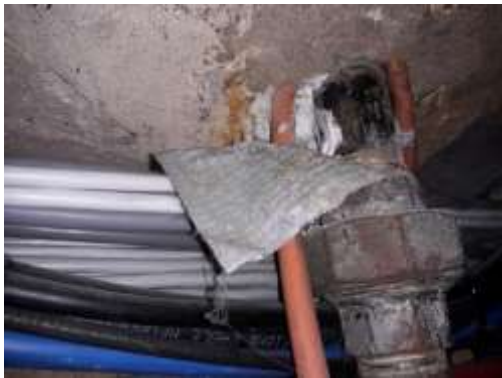
| Sample Inspection Record | | | | | |
|--|--|---|---|---|---|
| Sample Number: | X010 | Inspection Type: | Visually Identified / Strongly Presumed | | |

| Sample Inspection Record | | | | | |
|--|--|---|---|---|---|
| Description | Ceiling spray coating - Insulation | | | | |
| Extent of Damage | High Damage | 3 | | | |

| Sample Inspection Record | | | | | |
|--|--|---|---|---|---|
| Recommendation | Remove | | | | |

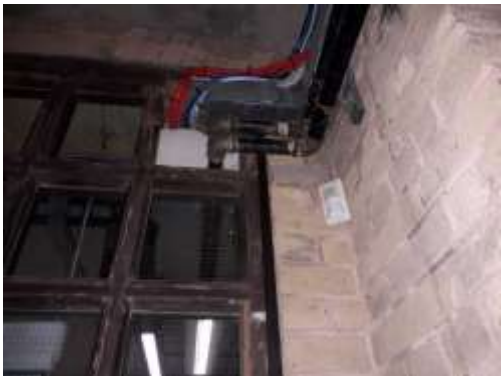
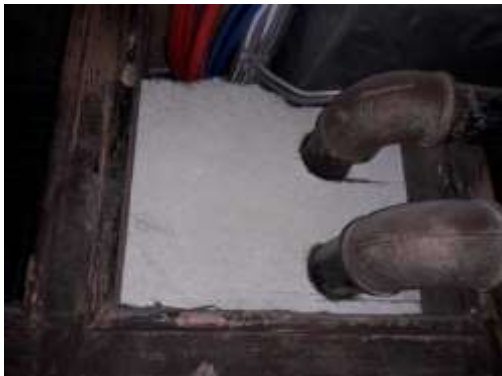
| Sample Inspection Record | | | | | |
|--|---|--|---|---|---|
| Sample Number: | S011 | Inspection Type: | Sampled | | |

| Sample Inspection Record | | | | | |
|--|---|--|---|---|---|
| Description | Door header - Insulating Board | | | | |

| Sample Inspection Record | | | | | |
|--|---|--|---|---|---|
| Recommendation | No action required | | | | |

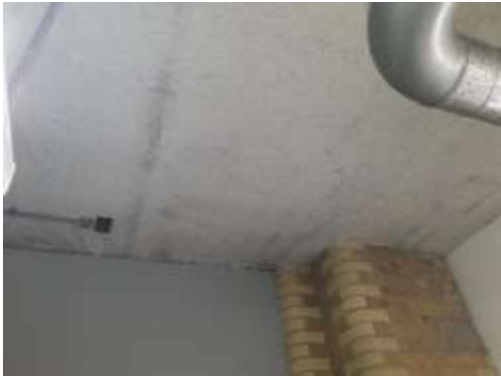
| Sample Inspection Record | | | | | |
|--|--|---|---|---|---|
| Sample Number: | X009 | Inspection Type: | Visually Identified / Strongly Presumed | | |

| Sample Inspection Record | | | | | |
|--|--|---|---|---|---|
| Description | Ceiling spray coating - Insulation | | | | |

| Sample Inspection Record | | | | | |
|--|--|---|---|---|---|
| Recommendation | No action required | | | | |

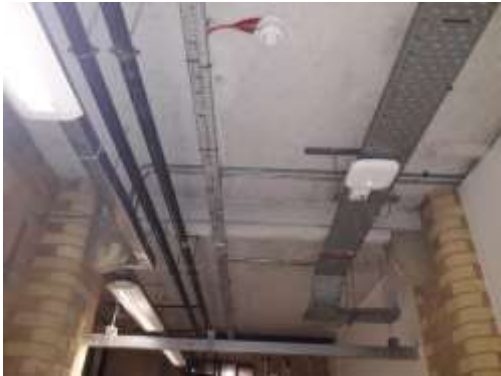
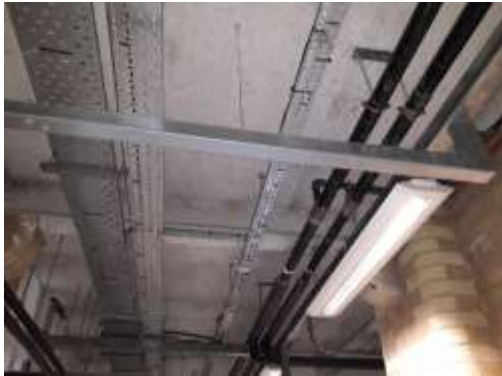
| Sample Inspection Record | | | | | |
|--|---|--|---|---|---|
| Sample Number: | X009 | Inspection Type: | Visually Identified / Strongly Presumed | | |

| Sample Inspection Record | | | | | |
|--|---|--|---|---|---|
| Description | Ceiling spray coating - Insulation | | | | |

| Sample Inspection Record | | | | | |
|--|---|--|---|---|---|
| Recommendation | No action required | | | | |

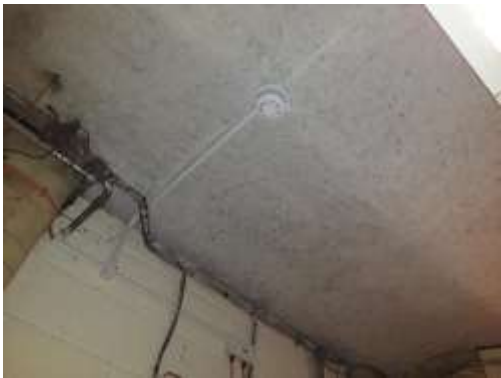
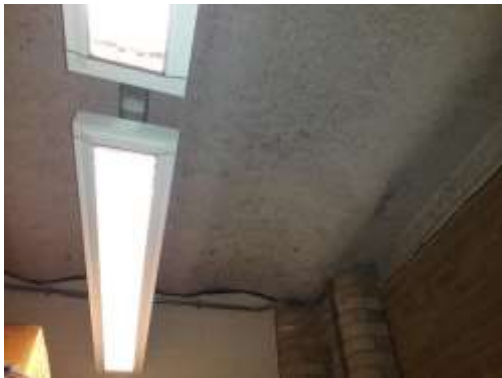
| Sample Inspection Record | | | | | |
|--|---|--|---|---|---|
| Sample Number: | X009 | Inspection Type: | Visually Identified / Strongly Presumed | | |

| Sample Inspection Record | | | | | |
|--|---|--|---|---|---|
| Description | Ceiling spray coating - Insulation | | | | |

| Sample Inspection Record | | | | | |
|--|---|--|---|---|---|
| Recommendation | No action required | | | | |
