TYPE 2
SURVEY, SAMPLING AND ASSESSMENT
OF ASBESTOS CONTAINING
MATERIALS

BRYNMAWR MARKET HALL (CINEMA)
(MO4112) BLOCK 1
MARKET SQUARE
BRYNMAWR
NP23 4AJ

REPORT REFERENCE NUMBER: 1304197 (Block 1) - Issue 2

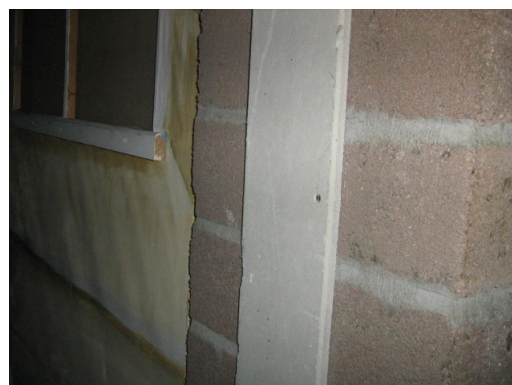
Sample Information		Material Risk Assessment	
Date:	08/07/2008	Product:	2
Surveyor:	Geraint Warlow	Damage/Deterioration:	Low
Building:	Brynmawr Market Hall (Cinema), Block 1	Surface Treatment:	Unsealed Board
Location:	Internal	Asbestos Type:	Amosite
Floor:	0	Material Score:	7
Room/Location:	016	Material Risk:	Medium
Position:	Back wall	Priority Risk Assessment*	
Description:	Grey strip panel	Normal Occupant Activity:	1
Product Type:	Insulating Board	Likelihood of Disturbance:	1
Extent:	=< 10m run	Human Exposure Potential:	1
Identification:	Sampled	Maintenance Activity:	0
Samples Ref:	1304197/0002	Priority Risk/Score:	3
Visually Similar to Sample:		Total Risk:	10

Encapsulate under controlled conditions.
Note that there are 2 instances of the board in this location.

Management Actions	Timescale	Completed	Date of Completion
Management Action - monitor condition of asbestos containing materials	12 Months		
Management Action - inform staff, contractors and tenants	1 Month		
Management Action - label asbestos containing materials with hazard warning stickers	1 Month

Control Actions	Timescale	Completed	Date of Completion
Encapsulate under controlled conditions	1 Months	No

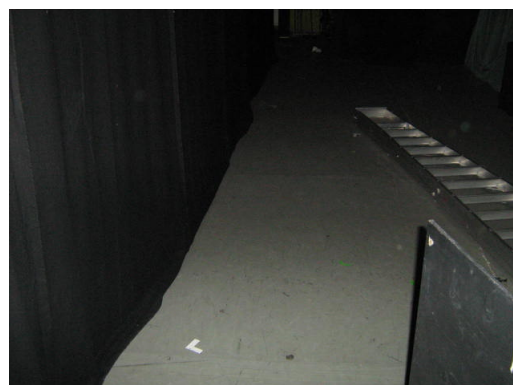
Sample Information		Material Risk Assessment	
Date:	08/07/2008	Product:	1
Surveyor:	Geraint Warlow	Damage/Deterioration:	Low
Building:	Brynmawr Market Hall (Cinema), Block 1	Surface Treatment:	Reinforced Composite Materials
Location:	Internal	Asbestos Type:	Chrysotile
Floor:	0	Material Score:	3
Room/Location:	016	Material Risk:	Very Low
Position:	Floor	Priority Risk Assessment*	
Description:	Grey linoleum and bitumen adhesive	Normal Occupant Activity:	1
Product Type:	Bitumen	Likelihood of Disturbance:	2
Extent:	>= 50 m2	Human Exposure Potential:	1
Identification:	Sampled	Maintenance Activity:	0
Samples Ref:	1304197/0004	Priority Risk/Score:	4
Visually Similar to Sample:		Total Risk:	7

Asbestos detected in bitumen adhesive only.

Management Actions	Timescale	Completed	Date of Completion
Management Action - monitor condition of asbestos containing materials	12 Months		
Management Action - inform staff, contractors and tenants	1 Month		
Management Action - label asbestos containing materials with hazard warning stickers	1 Month

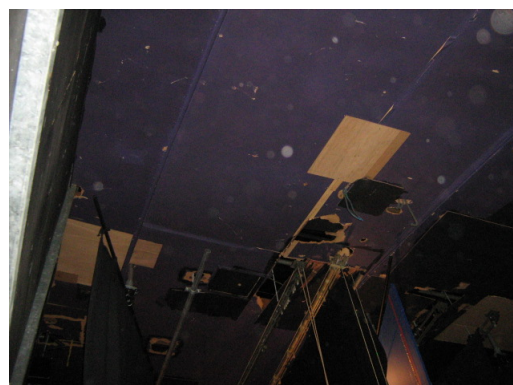
Sample Information		Material Risk Assessment	
Date:	17/04/2009	Product:	2
Surveyor:	Andrew Thomson	Damage/Deterioration:	Medium
Building:	Brynmawr Market Hall (Cinema), Block 1	Surface Treatment:	Painted/Encapsulated Board
Location:	Internal	Asbestos Type:	Non Asbestos
Floor:	0	Material Score:	0
Room/Location:	016	Material Risk:	Non Asbestos
Position:	Ceiling Within Ceiling Void	Priority Risk Assessment*	
Description:	Panels	Normal Occupant Activity:	
Product Type:	Insulating Board	Likelihood of Disturbance:	
Extent:	> 50m2 or > 50m run	Human Exposure Potential:	
Identification:	Str. Presumed	Maintenance Activity:	
Samples Ref:		Priority Risk/Score:	0
Visually Similar to Sample:	1304197/0079	Total Risk:	0

Area now fully accessed using triple ladders.

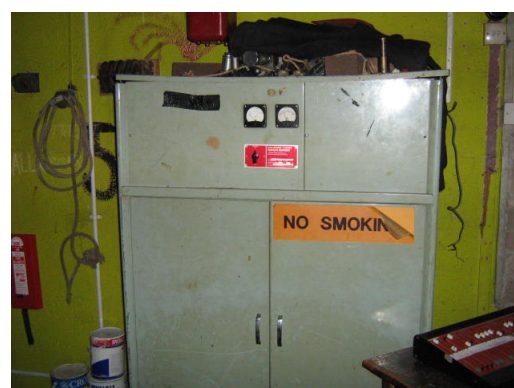
Sample Information Date: 08/07/2008 Surveyor: Geraint Warlow Building: Brynmawr Market Hall (Cinema), Block 1 Location: Internal Floor: 0 Room/Location: 016 Position: Electrics Description: Product Type: Extent: Identification: No Access Samples Ref: Visually Similar to Sample:	Material Risk Assessment Product: Damage/Deterioration: Surface Treatment: Asbestos Type: No Access Material Score: 0 Material Risk: No Access
Priority Risk Assessment* Normal Occupant Activity: Likelihood of Disturbance: Human Exposure Potential: Maintenance Activity: Priority Risk/Score:	
Total Risk: 0

NO ACCESS INTO LIVE ELECTRICTS
 AT TIME OF REINSPECTION
 23/08/2012

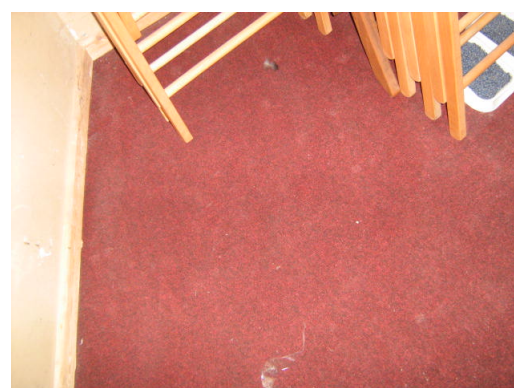
Number: 1304197-0007

Sample Information Date: 08/07/2008 Surveyor: Geraint Warlow Building: Brynmawr Market Hall (Cinema), Block 1 Location: Internal Floor: 0 Room/Location: 019 Position: Beneath fixed carpet Description: Product Type: Extent: Identification: No Access Samples Ref: Visually Similar to Sample:		Material Risk Assessment Product: Damage/Deterioration: Surface Treatment: Asbestos Type: No Access Material Score: 0 Material Risk: No Access	
		Priority Risk Assessment* Normal Occupant Activity: Likelihood of Disturbance: Human Exposure Potential: Maintenance Activity: Priority Risk/Score:	
		Total Risk: 0

TIMBER BELOW CARPET IDENTIFIED
 AT TIME OF REINSPECTION 23/08/2012.
 NO ACCESS BELOW TIMBER.

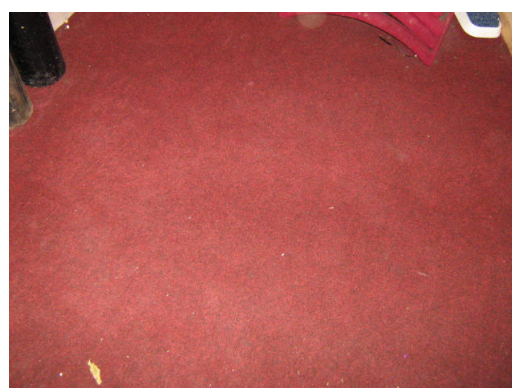
Sample Information Date: 08/07/2008 Surveyor: Geraint Warlow Building: Brynmawr Market Hall (Cinema), Block 1 Location: Internal Floor: 0 Room/Location: 018 Position: Beneath fixed carpet Description: Product Type: Extent: Identification: No Access Samples Ref: Visually Similar to Sample:		Material Risk Assessment Product: Damage/Deterioration: Surface Treatment: Asbestos Type: No Access Material Score: 0 Material Risk: No Access	
		Priority Risk Assessment* Normal Occupant Activity: Likelihood of Disturbance: Human Exposure Potential: Maintenance Activity: Priority Risk/Score:	
		Total Risk: 0

TIMBER BELOW CARPET IDENTIFIED
 AT TIME OF REINSPECTION 23/08/2012.
 NO ACCESS BELOW TIMBER.

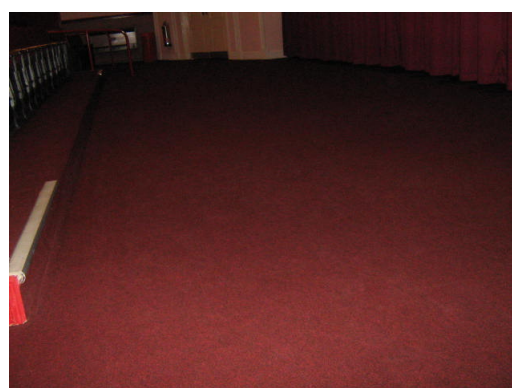
Sample Information Date: 08/07/2008 Surveyor: Geraint Warlow Building: Brynmawr Market Hall (Cinema), Block 1 Location: Internal Floor: 0 Room/Location: 015 Position: Beneath fixed carpet Description: Product Type: Extent: Identification: No Access Samples Ref: Visually Similar to Sample:		Material Risk Assessment Product: Damage/Deterioration: Surface Treatment: Asbestos Type: No Access Material Score: 0 Material Risk: No Access	
		Priority Risk Assessment* Normal Occupant Activity: Likelihood of Disturbance: Human Exposure Potential: Maintenance Activity: Priority Risk/Score:	
		Total Risk: 0

CARPET ACCESSED AND SAMPLE
 TAKEN BY REC LTD.
 12WS219/11/002 FOUND TO CONTAIN
 CHYSOTILE ASBESTOS IN FLOOR TILES AND
 BITUMEN ADHESIVE

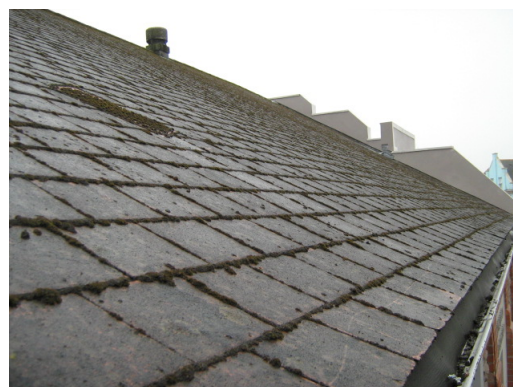
Roof now fully accessed using triple ladders. Present to whole of pitched roof including cement cowl.

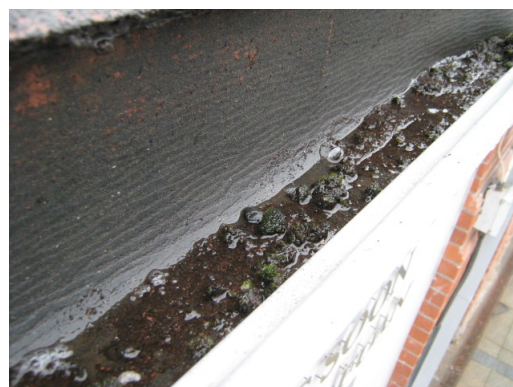
Area now fully access using triple ladder during re-visit. Recommend cleaning of gutterings on a regular basis to prevent accumulation of debris.
