Material Assessment Record

Number: 1304197-0002

| Building: | Brynmawr Market Hall (Cinema), Block 1 | Surface Treatment: | Unsealed Board |

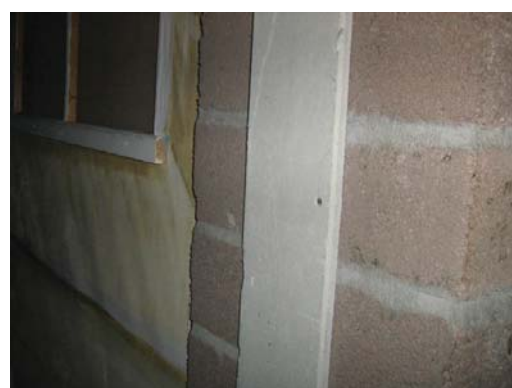
| Surveyor: | Geraint Warlow | Damage/Deterioration: | Low |
| Location: | Internal | Asbestos Type: | Amosite |
| Room/Location: | 016 | Material Risk: | Medium |
| Position: | Back wall | Priority Risk Assessment* | |
| Description: | Grey strip panel | Normal Occupant Activity: | 1 |
| Product Type: | Insulating Board | Likelihood of Disturbance: | 1 |

Encapsulate under controlled conditions.
Note that there are 2 instances of the board in this location.

| Control Actions | Timescale | Completed | Date of Completion |
|---|---|---|---|
| Encapsulate under controlled conditions | 1 Months | No | |
