Material Assessment Record

Floor/	Block 1 and 4-
Area:-	Ground & First Floor

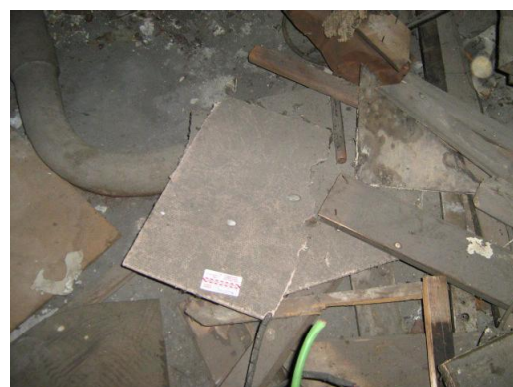
Number: 1304197-0077

Sample Information		Material Risk Assessment	
Date:	17/04/2009	Product:	2
Surveyor:	Andrew Thomson	Damage/Deterioration:	Medium
Building:	Brynmawr Market Hall (Cinema), Block 1	Surface Treatment:	Unsealed Board
Location:	Internal	Asbestos Type:	Amosite
Floor:	1	Material Score:	8
Room/Location:	029	Material Risk:	Medium
Position:	On Floor of Loft Above	Priority Risk Assessment*	
Description:	Loose Panel	Normal Occupant Activity:	0
Product Type:	Insulating Board	Likelihood of Disturbance:	1
Extent:	< 10m2 or < 10m run	Human Exposure Potential:	0
Identification:	Sampled	Maintenance Activity:	1
Samples Ref:	1304197/0077	Priority Risk/Score:	2
Visually Similar to Sample:		Total Risk:	10

Area now fully accessed using triple ladders during re-visit.

Control Actions	Timescale	Completed	Date of Completion
Remove/Dispose as ACM	1 Months	No

ACM TO BE REMOVED AND AREA ENVIRONMENTALLY CLEANED BY A LICENSED ASBESTOS REMOVAL CONTRACTOR.

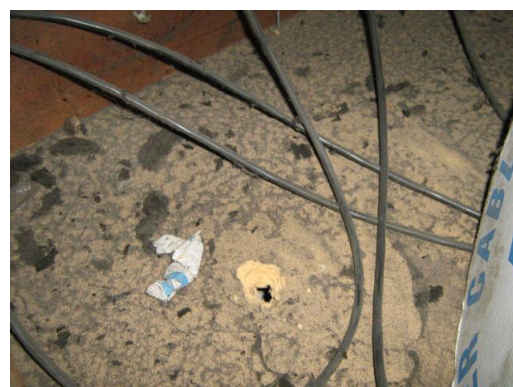
Number: 1304197-0079

Sample Information		Material Risk Assessment	
Date:	17/04/2009	Product:	2
Surveyor:	Andrew Thomson	Damage/Deterioration:	Low
Building:	Brynmawr Market Hall (Cinema), Block 1	Surface Treatment:	Unsealed Board
Location:	Internal	Asbestos Type:	Non Asbestos
Floor:	0	Material Score:	
Room/Location:	015	Material Risk:	Non Asbestos
Position:	Floor Of Roof Void Above	Priority Risk Assessment*	
Description:	Panels	Normal Occupant Activity:	
Product Type:	Insulating Board	Likelihood of Disturbance:	
Extent:	> 50m2 or > 50m run	Human Exposure Potential:	
Identification:	Sampled	Maintenance Activity:	
Samples Ref:	1304197/0079	Priority Risk/Score:	0
Visually Similar to Sample:		Total Risk:	0

Area now fully accessed using triple ladders during re-visit.

ACM TO BE REMOVED AND AREA ENVIRONMENTALLY CLEANED BY A LICENSED ASBESTOS REMOVAL CONTRACTOR.
