Surveyor: [REDACTED]
Date of Survey: 22 September 2008
Report Reference: CH/8/9/596/LW
Date of Report: 25 September 2008
Purpose of Survey: Type 2.
Compliance with
The Control of Asbestos
Regulations 2006.

**Report on Survey of Asbestos Materials
at**

**10 Clawdd Poncen
Corwen**

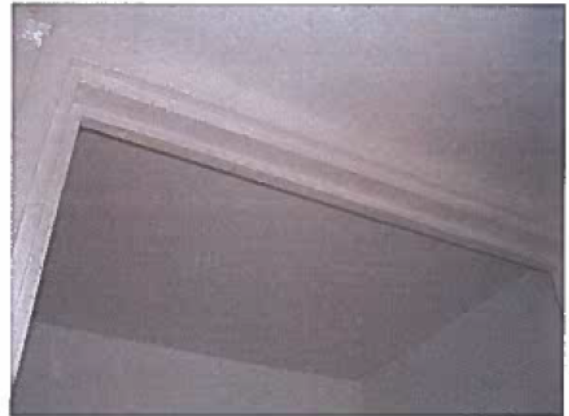
Sample No: 8/9/B/22/GB34.
G.08 Storeroom. Asbestos based ceiling board.

This material should be removed. Removal work should be undertaken only by a **licensed asbestos removal contractor**, working under the guidance of a safe working procedure and in accordance with the requirements of **The Control of Asbestos Regulations 2006** and **The Hazardous Waste Regulations 2005**.

14 Days Notification must be given to The Health and Safety Executive prior to any works being carried out to these materials.

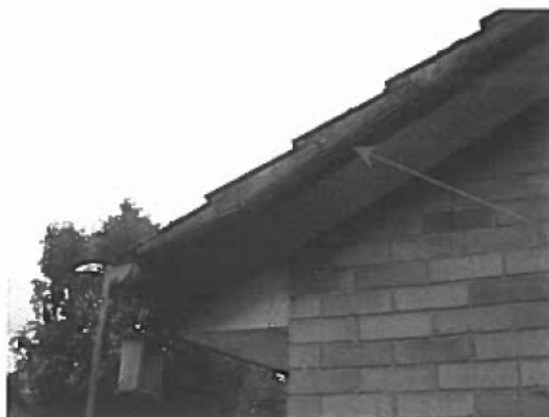
These materials are encapsulated, in a fair condition and are unlikely to generate airborne asbestos fibre during normal occupation and provided undisturbed. We would recommend that these materials are **labeled** for identification purposes, managed and periodically re-inspected as required by **The Control of Asbestos Regulations 2006**. These materials should remain undisturbed and any future remedial or removal works undertaken only by suitably trained personnel, working under the guidance of a safe working procedure and in accordance with the requirements of **The Control of Asbestos Regulations 2006** and **The Hazardous Waste Regulations 2005**.

Sample No: 8/9/B/22/GB35.
External. Asbestos based soffits and canopy.

14 Days Notification must be given to The Health and Safety Executive prior to any works being carried out to these materials.
