Surveyor: [REDACTED]
Date of Survey: 24 September 2008
Report Reference: CH/8/10/690/CH
Date of Report: 27 October 2008
Purpose of Survey: Type 2 Survey

**Report on Survey of Asbestos Materials
at**

**12 Clawdd Poncen
Corwen
Denbighshire**

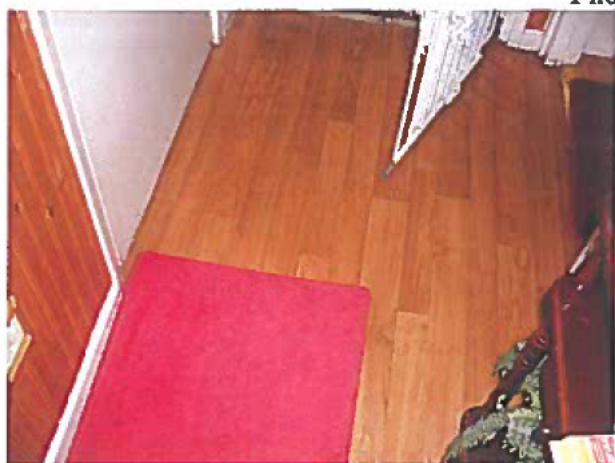
G.08 Bathroom	Ceiling panels (as G.01 Hall)	Refer to Sample 8/9/B/29/KS10	No Asbestos Detected (presume)	-	-	-	-	-	-	-	-	-	-
	Vinyl floor tiles (as G.01 Hall)	Refer to Sample 8/9/B/29/KS11	Chrysotile (strongly presume)	<4m ²	High	Fair	1	1	0	1	3	Manage / Review	12 months

Location: G.01 (also present in G.02, G.06, G.08, G.09, G.10 & G.11)

These materials are in a fair condition and are unlikely to generate airborne asbestos fibre during normal occupation and provided undisturbed. We would recommend that these materials are managed and periodically re-inspected as required by **The Control of Asbestos Regulations 2006**. These materials should remain undisturbed and any future remedial or removal works undertaken only by suitably trained personnel, working under the guidance of a safe working procedure and in accordance with the requirements of **The Control of Asbestos Regulations 2006** and **The Hazardous Waste Regulations 2005**.

8/9/B/24/KS11
G.01 Hall – Vinyl Floor Tiles

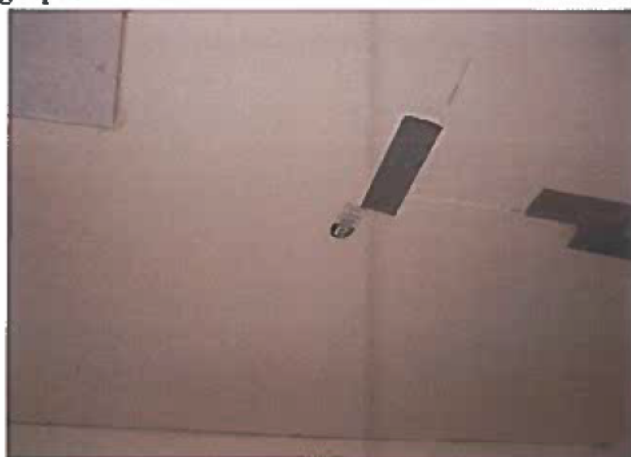
Sample No: 8/9/B/24/KS15 Location: G.07

These materials are not encapsulated, and in a poor condition, therefore are likely to generate airborne asbestos fibre if disturbed. We would recommend that these materials are either removed completely, or repaired and encapsulated to provide a greater level of protection / prevention of fibre release at the earliest possible opportunity. **Labelled** for identification purposes, managed and periodically re-inspected as required by **The Control of Asbestos Regulations 2006**. These materials should remain undisturbed and any future remedial or removal works undertaken only by suitably trained personnel, working under the guidance of a safe working procedure and in accordance with the requirements of **The Control of Asbestos Regulations 2006** and **The Hazardous Waste Regulations 2005**.

8/9/B/24/KS15
G.07 Airing Cupboard – Ceiling Panels

14 Days Notification must be given to The Health and Safety Executive prior to any works being carried out to these materials.

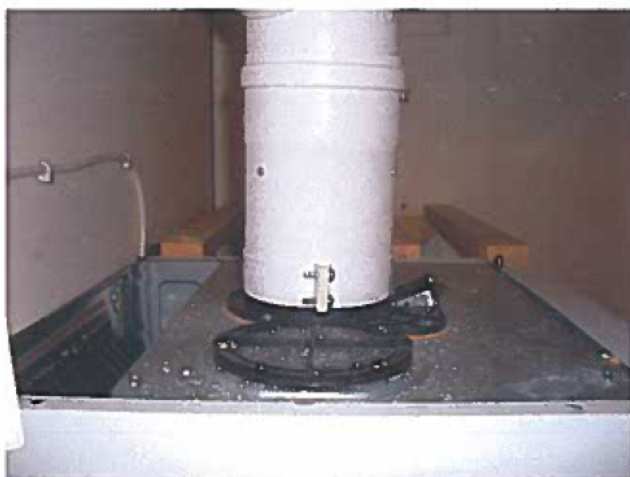
Location (refer to plan)	Material description	Sample Numbers	Asbestos Type ⁴	Quantity ¹	Accessibility ⁶	Condition	Risk Assessment Scores ^{2,5}					Summary Recommendations	Re-inspection Frequency ³
							M	D	ST	AT	Total		
G.05 External Store	Roof – soffit panels (as external)	Refer to Sample 8/9/B/24/KS17	Amosite Chrysotile (strongly presume)	<1m ²	High	Fair	2	1	2	2	7	Label and manage / Review	3 months
G.06 Lobby	Ceiling panels (as G.01 Hall)	Refer to Sample 8/9/B/29/KS10	No Asbestos Detected (presume)	-	-	-	-	-	-	-	-	-	-
	Vinyl floor tiles (as G.01 Hall)	Refer to Sample 8/9/B/29/KS11	Chrysotile (strongly presume)	<3m ²	High	Fair	1	1	0	1	3	Manage / Review	12 months
G.07 Airing Cupboard	Ceiling panels	8/9/B/29/KS15	Amosite Chrysotile	<2m ²	Medium	Poor	2	2	2	2	8	Repair and encapsulate / Remove	-
	Board debris to top of boiler	8/9/B/29/KS16	Amosite Chrysotile	Localised	High	Poor	2	2	2	2	8	Repair and encapsulate / Remove	-

Sample No: 8/9/B/24/KS16 Location: G.07

8/9/B/24/KS16
G.07 Airing Cupboard – Board Debris To Top Of
Boiler

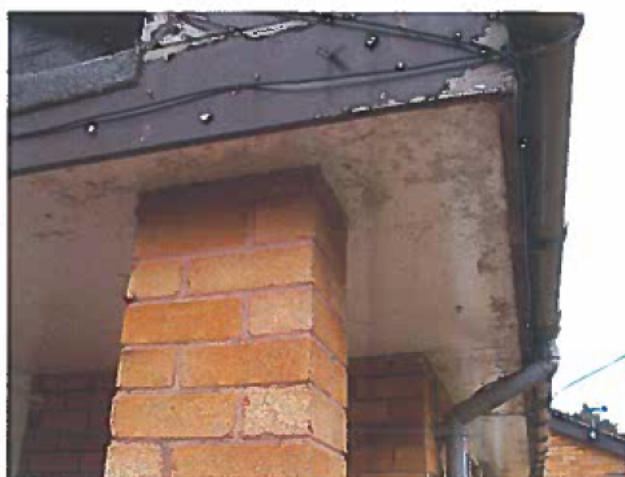
Location (refer to plan)	Material description	Sample Numbers	Asbestos Type ¹	Quantity ¹	Accessibility ⁶	Condition	Risk Assessment Scores ^{2,5}					Summary Recommendations	Re- inspection Frequency ³
							M	D	ST	AT	Total		
External	Roof – soffit panels	8/9/B/24/KS17	Amosite Chrysotile	Site Wide	High	Fair	2	1	1	2	6	Label and manage / Review	6 months
	Verge edging to gable end	8/9/B/24/KS18	Chrysotile	Site Wide	Medium	Fair	1	1	1	1	4	Manage / Review	12 months
	Bitumen damp proof course	8/9/B/24/KS19	No Asbestos Detected	-	-	-	-	-	-	-	-	-	-
	Flat roof – bitumen felt	8/9/B/24/KS20	No Asbestos Detected	-	-	-	-	-	-	-	-	-	-

Sample No: 8/9/B/24/KS17 Location: External

These materials are in a fair condition and are unlikely to generate airborne asbestos fibre during normal occupation and provided undisturbed. We would recommend that these materials are either removed completely, or encapsulated to provide a greater level of protection / prevention of fibre release. **Labelled** for identification purposes, managed and periodically re-inspected as required by **The Control of Asbestos Regulations 2006**. These materials should remain undisturbed and any future remedial or removal works undertaken only by suitably trained personnel, working under the guidance of a safe working procedure and in accordance with the requirements of **The Control of Asbestos Regulations 2006** and **The Hazardous Waste Regulations 2005**.

8/9/B/24/KS17
External Roof – Soffit Panels

14 Days Notification must be given to The Health and Safety Executive prior to any works being carried out to these materials.

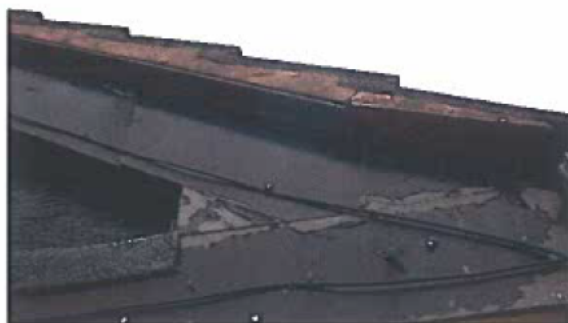
Sample No: 8/9/B/24/KS18 Location: External

These materials are in a fair condition and are unlikely to generate airborne asbestos fibre during normal occupation and provided undisturbed. We would recommend that these materials are managed and periodically re-inspected as required by **The Control of Asbestos Regulations 2006**. These materials should remain undisturbed and any future remedial or removal works undertaken only by suitably trained personnel, working under the guidance of a safe working procedure and in accordance with the requirements of **The Control of Asbestos Regulations 2006** and **The Hazardous Waste Regulations 2005**.

8/9/B/24/KS18
External Roof – Verge Edging To Gable End
