Surveyor: [REDACTED]
Date of Survey: 22 September 2008
Report Reference: CH/8/9/592/LW
Date of Report: 25 September 2008
Purpose of Survey: Type 2.
Compliance with
The Control of Asbestos
Regulations 2006.

**Report on Survey of Asbestos Materials
at**

**14 Clawdd Poncen
Corwen**

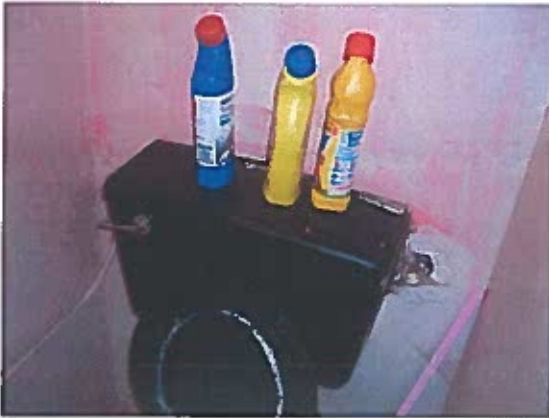
These materials are in a good condition and are unlikely to generate airborne asbestos fibre during normal occupation and provided undisturbed. We would recommend that these materials are managed and periodically re-inspected as required by **The Control of Asbestos Regulations 2006**. These materials should remain undisturbed and any future remedial or removal works undertaken only by suitably trained personnel, working under the guidance of a safe working procedure and in accordance with the requirements of **The Control of Asbestos Regulations 2006** and **The Hazardous Waste Regulations 2005**.

Sample No: 8/9/B/22/GB2.
G.01 WC. Asbestos based toilet cistern.

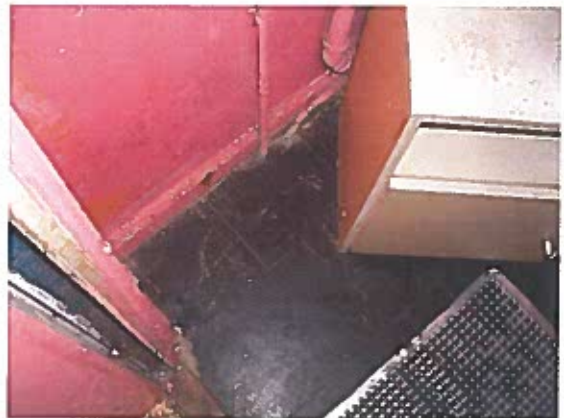
These materials are in a good condition and are unlikely to generate airborne asbestos fibre during normal occupation and provided undisturbed. We would recommend that these materials are labeled for Identification purposes, managed and periodically re-inspected as required by **The Control of Asbestos Regulations 2006**. These materials should remain undisturbed and any future remedial or removal works undertaken only by suitably trained personnel, working under the guidance of a safe working procedure and in accordance with the requirements of **The Control of Asbestos Regulations 2006** and **The Hazardous Waste Regulations 2005**.

Sample No: 8/9/B/22/GB3.
G.01 WC. Asbestos based vinyl floor tiles and
bitumen adhesive.

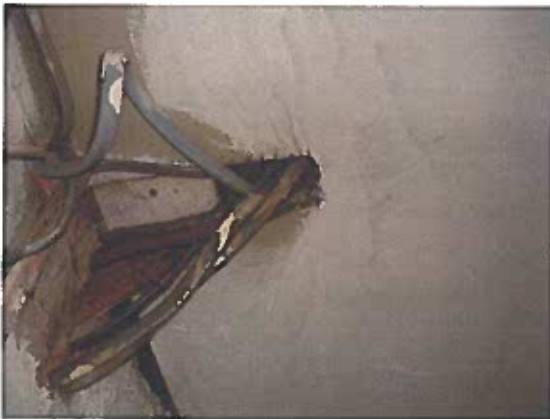
These materials are encapsulated, in a good condition and are unlikely to generate airborne asbestos fibre during normal occupation and provided undisturbed. We would recommend that these materials are **labelled** for identification purposes, managed and periodically re-inspected as required by **The Control of Asbestos Regulations 2006**. These materials should remain undisturbed and any future remedial or removal works undertaken only by suitably trained personnel, working under the guidance of a safe working procedure and in accordance with the requirements of **The Control of Asbestos Regulations 2006** and **The Hazardous Waste Regulations 2005**.

Sample No: 8/9/B/22/GB9.
G.06 Utility Room. Asbestos based ceiling board to
former heater cupboard.

14 Days Notification must be given to The Health and Safety Executive prior to any works being carried out to these materials.

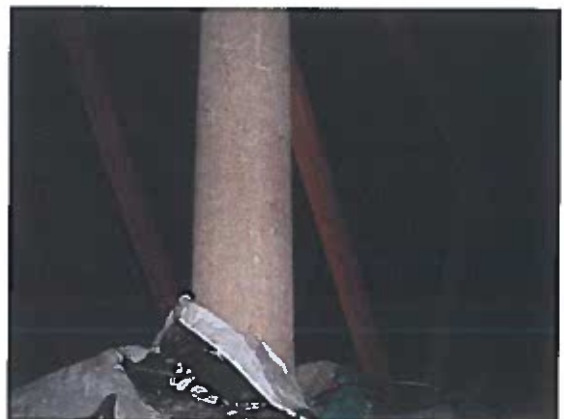
2.01 Roof Space	Flue - Cement	8/9/B/22/GB12	Chrysotile	2 LM	Medium	Fair	1	1	1	1	4	Manage and Review (See Section 1.3)	12 Months

These materials are in a good / fair condition and are unlikely to generate airborne asbestos fibre during normal occupation and unless disturbed. We would recommend that the materials are **labeled** for Identification purposes, managed and periodically re-inspected as required by **The Control of Asbestos Regulations 2006**. These materials should remain undisturbed and any future remedial or removal works undertaken only by suitably trained personnel, working under the guidance of a safe working procedure and in accordance with the requirements of **The Control of Asbestos Regulations 2006** and **The Hazardous Waste Regulations 2005**.

Sample No: 8/9/B/22/GB12.
2.01 Roof Space. Asbestos based cement flue.

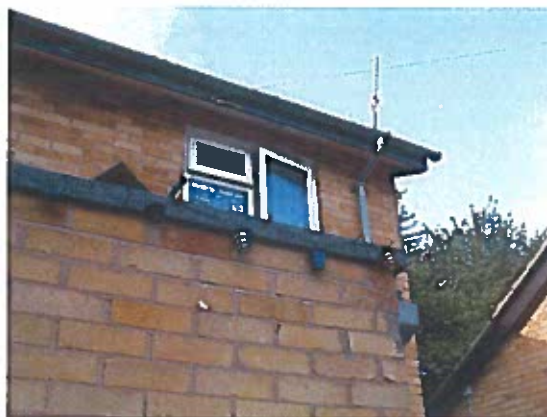
These materials are encapsulated, in a good condition and are unlikely to generate airborne asbestos fibre during normal occupation and provided undisturbed. We would recommend that these materials are **labelled** for identification purposes, managed and periodically re-inspected as required by **The Control of Asbestos Regulations 2006**. These materials should remain undisturbed and any future remedial or removal works undertaken only by suitably trained personnel, working under the guidance of a safe working procedure and in accordance with the requirements of **The Control of Asbestos Regulations 2006** and **The Hazardous Waste Regulations 2005**.

Sample No: 8/9/B/22/GB15.
External. Asbestos based soffits.

14 Days Notification must be given to The Health and Safety Executive prior to any works being carried out to these materials.
