Surveyor: [REDACTED]
Date of Survey: 1 October 2008
Report Reference: CH/8/10/650/CH
Date of Report: 21 October 2008
Purpose of Survey: Type 2.
Compliance with
The Control of Asbestos
Regulations 2006.

**Report on Survey of Asbestos Materials
at**

**30 Clawdd Poncen
Corwen
Denbighshire**

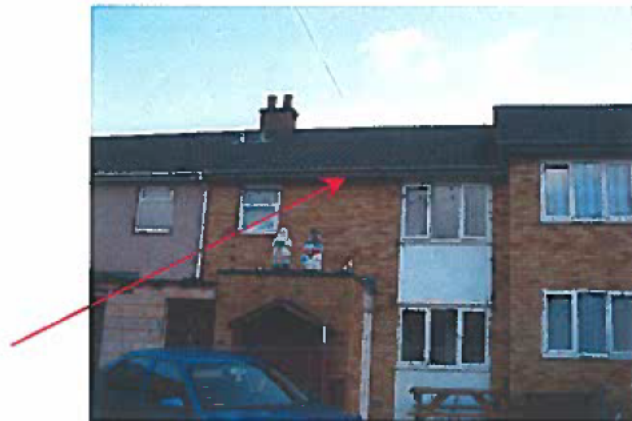
- **Asbestos Insulating Board.**
Sample No: 8/10/B/1/GB26 Location: External

These materials are in a good condition and are unlikely to generate airborne asbestos fibre during normal occupation and provided undisturbed. We would recommend that these materials are either removed completely or labelled for identification purposes, managed and periodically re-inspected as required by **The Control of Asbestos Regulations 2006**. These materials should remain undisturbed and any future remedial or removal works undertaken only by a **licensed asbestos removal contractor**, working under the guidance of a safe working procedure and in accordance with the requirements of **The Control of Asbestos Regulations 2006** and **The Hazardous Waste Regulations 2005**.

8/10/B/1/GB26
External Soffits - Insulating Board

14 Days Notification must be given to The Health and Safety Executive prior to any works being carried out to these materials.
