Surveyor: [REDACTED]
Date of Survey: 1 October 2008
Report Reference: CH/8/10/652/CH
Date of Report: 21 October 2008
Purpose of Survey: Type 2.
Compliance with
The Control of Asbestos
Regulations 2006.

**Report on Survey of Asbestos Materials
at**

**31 Clawdd Poncen
Corwen
Denbighshire**

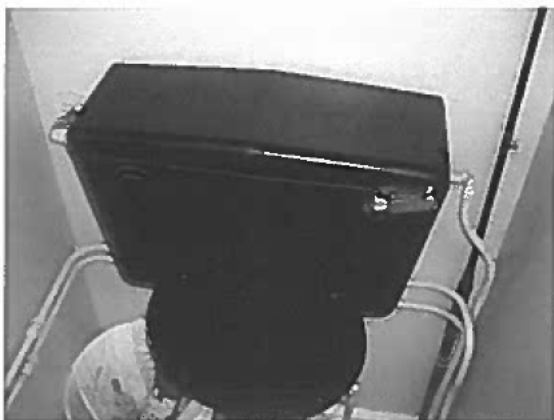
- **Asbestos based thermoplastic toilet cistern .**
Sample No: 8/10/B/1/GB15 Location: G2

These materials are in a good condition and are unlikely to generate airborne asbestos fibre during normal occupation and provided undisturbed. We would recommend that these materials are managed and periodically re-inspected as required by **The Control of Asbestos Regulations 2006**. These materials should remain undisturbed and any future remedial or removal works undertaken only by suitably trained personnel, working under the guidance of a safe working procedure and in accordance with the requirements of **The Control of Asbestos Regulations 2006** and **The Hazardous Waste Regulations 2005**.

8/10/B/1/GB15
G2 WC - Toilet Cistern
