**Surveyor:** [REDACTED]  
**Date of Survey:** 12 January 2009  
**Report Reference:** CH/9/2/112/MP  
**Date of Report:** 09 February 2009  
**Purpose of Survey:** Type 2  
Compliance with  
The Control of Asbestos  
Regulations 2006.

**Report on Survey of Asbestos Materials  
at**

**48 Clawdd Poncen  
Corwen  
Denbighshire**

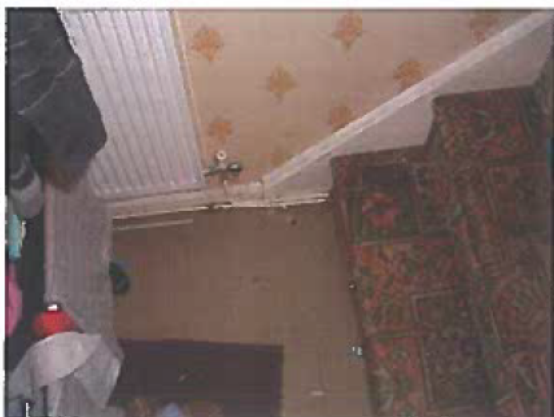
Sample No: 9/1/B/12/GB1.  
G.01 – Front Hall.

| Location<br>(refer to plan) | Material description | Sample Numbers | Asbestos Type <sup>4</sup> | Quantity <sup>1</sup> | Accessibility <sup>6</sup> | Condition | Risk Assessment Scores <sup>2,5</sup> | | | | | Summary Recommendations | Re-inspection Frequency <sup>3</sup> |
|---|--|---|---|---|---|---|---|---|---|---|---|---|---|
| G.01<br>Front Hall | Floor - Vinyl floor tiles and bitumen adhesive | 9/1/B/12/GB1 | Chrysotile | 3m <sup>2</sup> | High | Good | 1 | 0 | 0 | 1 | 2 | Manage & Review<br>(See Section 1.3) | 12 Months |

This material is in a fair condition and is unlikely to generate airborne asbestos fibre during normal occupation and provided undisturbed. We would recommend that this material is managed and periodically re-inspected as required by **The Control of Asbestos Regulations 2006**. This material should remain undisturbed and any future remedial or removal works undertaken only by suitably trained personnel, working under the guidance of a safe working procedure and in accordance with the requirements of **The Control of Asbestos Regulations 2006** and **The Hazardous Waste Regulations 2005**.

Asbestos based vinyl floor tiles & bitumen adhesive.

\*Note that due to the nature / characteristics of the adhesive material, if any future remedial or removal works are undertaken, the **Vinyl Floor Tiles / Covering** to which the adhesive is in contact with should also be treated as an Asbestos containing material and removed and disposed of accordingly, working under the guidance of a safe working procedure and in accordance with the requirements of **The Control of Asbestos Regulations 2006** and **The Hazardous Waste Regulations 2005**.

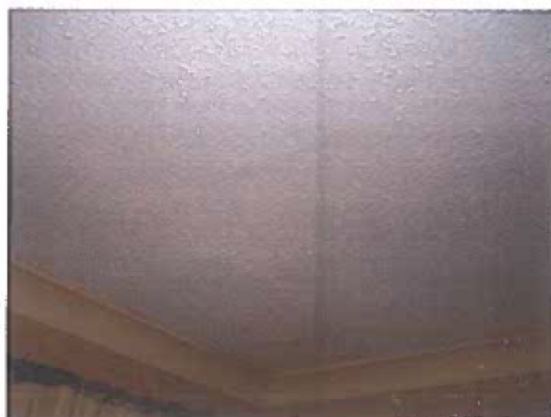
Sample No: 9/1/B/12/GB2.  
G.02 – Living Room.

| Location<br>(refer to plan) | Material description | Sample Numbers | Asbestos Type <sup>4</sup> | Quantity <sup>1</sup> | Accessibility <sup>6</sup> | Condition | Risk Assessment Scores <sup>2,5</sup> | | | | | Summary Recommendations | Re-inspection Frequency <sup>3</sup> |
|---|--|---|---|---|---|---|---|---|---|---|---|---|---|
| G.02<br>Living Room | Ceiling - Textured coating | 9/1/B/12/GB2 | Chrysotile | 21m <sup>2</sup> | High | Good | 1 | 0 | 0 | 1 | 2 | Manage & Review<br>(See Section 1.3) | 12 Months |

These materials are in a good condition and are unlikely to generate airborne asbestos fibre during normal occupation and provided undisturbed. We would recommend that these materials are managed and periodically re-inspected as required by **The Control of Asbestos Regulations 2006**. These materials should remain undisturbed and any future remedial or removal works undertaken only by suitably trained personnel, working under the guidance of a safe working procedure and in accordance with the requirements of **The Control of Asbestos Regulations 2006** and **The Hazardous Waste Regulations 2005**.

Asbestos based textured coating to ceiling.

If these materials are likely to be disturbed during the Refurbishment Works then they should be removed and disposed of prior to these works commencing by suitably trained personnel, working under the guidance of a safe working procedure and in accordance with the requirements of **The Control of Asbestos Regulations 2006** and **The Hazardous Waste Regulations 2005**.

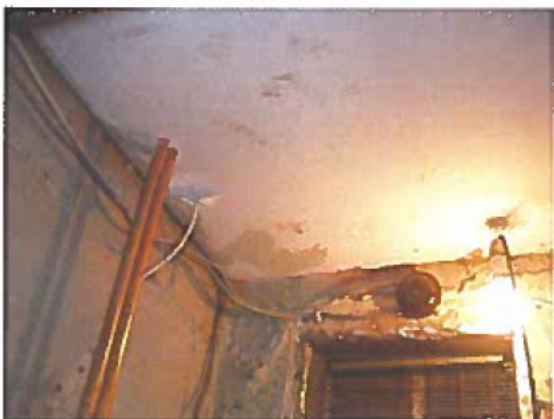
Sample No: 9/1/B/12/GB4.  
G.05 – Heater Cupboard.

| Location<br>(refer to plan) | Material description | Sample Numbers | Asbestos Type <sup>4</sup> | Quantity <sup>1</sup> | Accessibility <sup>6</sup> | Condition | Risk Assessment Scores <sup>2,5</sup> | | | | | Summary Recommendations | Re-inspection Frequency <sup>3</sup> |
|---|--|---|---|---|---|---|---|---|---|---|---|---|---|
| G.05<br>Heater Cupboard | Ceiling - Insulating board | 9/1/B/12/GB4 | Amosite | 1m <sup>2</sup> | High | Very Poor | 2 | 3 | 2 | 2 | 10 | Remove & Dispose (See Section 1.3) | - |

These materials are in a poor condition, therefore are likely to generate airborne asbestos fibre if disturbed. We would recommend that these materials are either removed completely, or repaired and encapsulated to provide a greater level of protection / prevention of fibre release at the earliest possible opportunity. We would also recommend that these materials are managed and periodically re-inspected as required by **The Control of Asbestos Regulations 2006**. These materials should remain undisturbed and any future remedial or removal works undertaken only by suitably trained personnel, working under the guidance of a safe working procedure and in accordance with the requirements of **The Control of Asbestos Regulations 2006** and **The Hazardous Waste Regulations 2005**.

Asbestos based insulation board forming ceiling.

If these materials are likely to be disturbed during the Refurbishment Works then they should be removed and disposed of prior to these works commencing by suitably trained personnel, working under the guidance of a safe working procedure and in accordance with the requirements of **The Control of Asbestos Regulations 2006** and **The Hazardous Waste Regulations 2005**.

**14 Days Notification must be given to The Health and Safety Executive prior to any works being carried out to these materials.**

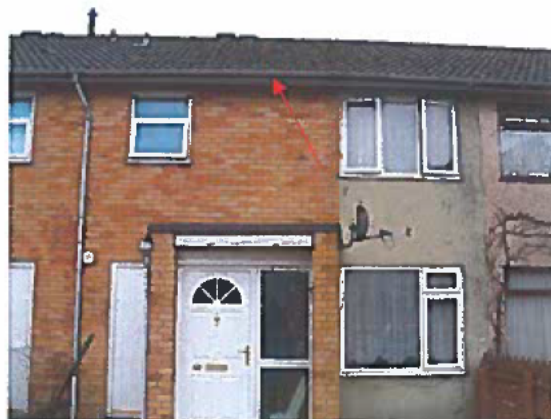
Sample No: 9/1/B/12/GB7.  
Exterior.

| Location<br>(refer to plan) | Material description | Sample Numbers | Asbestos Type <sup>4</sup> | Quantity <sup>1</sup> | Accessibility <sup>6</sup> | Condition | Risk Assessment Scores <sup>2,5</sup> | | | | | Summary Recommendations | Re-inspection Frequency <sup>3</sup> |
|---|--|---|---|---|---|---|---|---|---|---|---|---|---|
| External | Soffits - Insulation board | 9/1/B/12/GB7 | Amosite | Through out | Medium | Fair | 2 | 1 | 1 | 2 | 6 | Manage & Review<br>(See Section 1.3) | 6 Months |

These materials are encapsulated, in a fair condition and are unlikely to generate airborne asbestos fibre during normal occupation and provided undisturbed. We would recommend that these materials are managed and periodically re-inspected as required by **The Control of Asbestos Regulations 2006**. These materials should remain undisturbed and any future remedial or removal works undertaken only by suitably trained personnel, working under the guidance of a safe working procedure and in accordance with the requirements of **The Control of Asbestos Regulations 2006** and **The Hazardous Waste Regulations 2005**.

Asbestos based insulating board forming soffits.

If these materials are likely to be disturbed during the Refurbishment Works then they should be removed and disposed of prior to these works commencing by suitably trained personnel, working under the guidance of a safe working procedure and in accordance with the requirements of **The Control of Asbestos Regulations 2006** and **The Hazardous Waste Regulations 2005**.

**14 Days Notification must be given to The Health and Safety Executive prior to any works being carried out to these materials.**

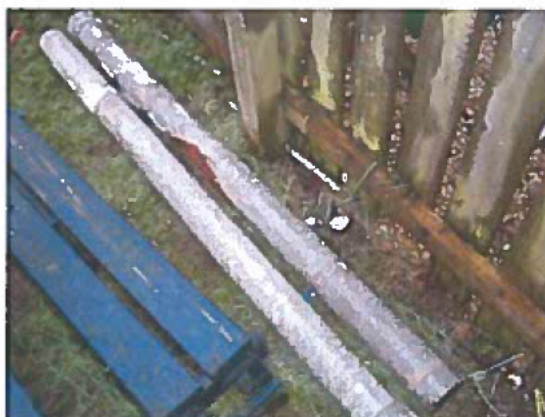
| Location<br>(refer to plan) | Material description | Sample Numbers | Asbestos Type <sup>4</sup> | Quantity <sup>1</sup> | Accessibility <sup>6</sup> | Condition | Risk Assessment Scores <sup>2,5</sup> | | | | | Summary Recommendations | Re-inspection Frequency <sup>3</sup> |
|---|--|---|---|---|---|---|---|---|---|---|---|---|---|
| | Redundant flue & elbow to garden - Cement | 9/1/B/12/GB8 | Chrysotile | 3.5LM | High | Fair | 1 | 1 | 1 | 1 | 4 | Remove & Dispose<br>(See Section 1.3) | - |

These materials are in a poor condition and could cause fibre release if disturbed. These materials should be removed and disposed of by suitably trained personnel, working under the guidance of a safe working procedure and in accordance with the requirements of **The Control of Asbestos Regulations 2006** and **The Hazardous Waste (England and Wales) (Amendment) Regulations 2009**

Sample No: 9/1/B/12/GB8.  
Exterior. Asbestos based redundant cement flue & elbow in garden.
