Chichester Station

Management Survey Asbestos Report - Copy 1

September 2010

N-29773 / B070909NA1 / Issue No. 02

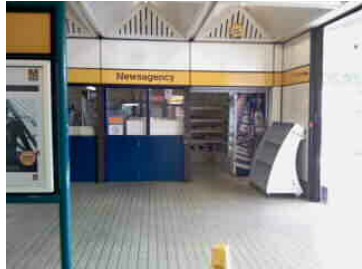
No access has been gained into the following locations:			
Building	Location	Comments	Photograph
Chichester Metro Station	First Floor; Location ID:007-Newsagent Kiosk (Whole location)	Outside scope of works

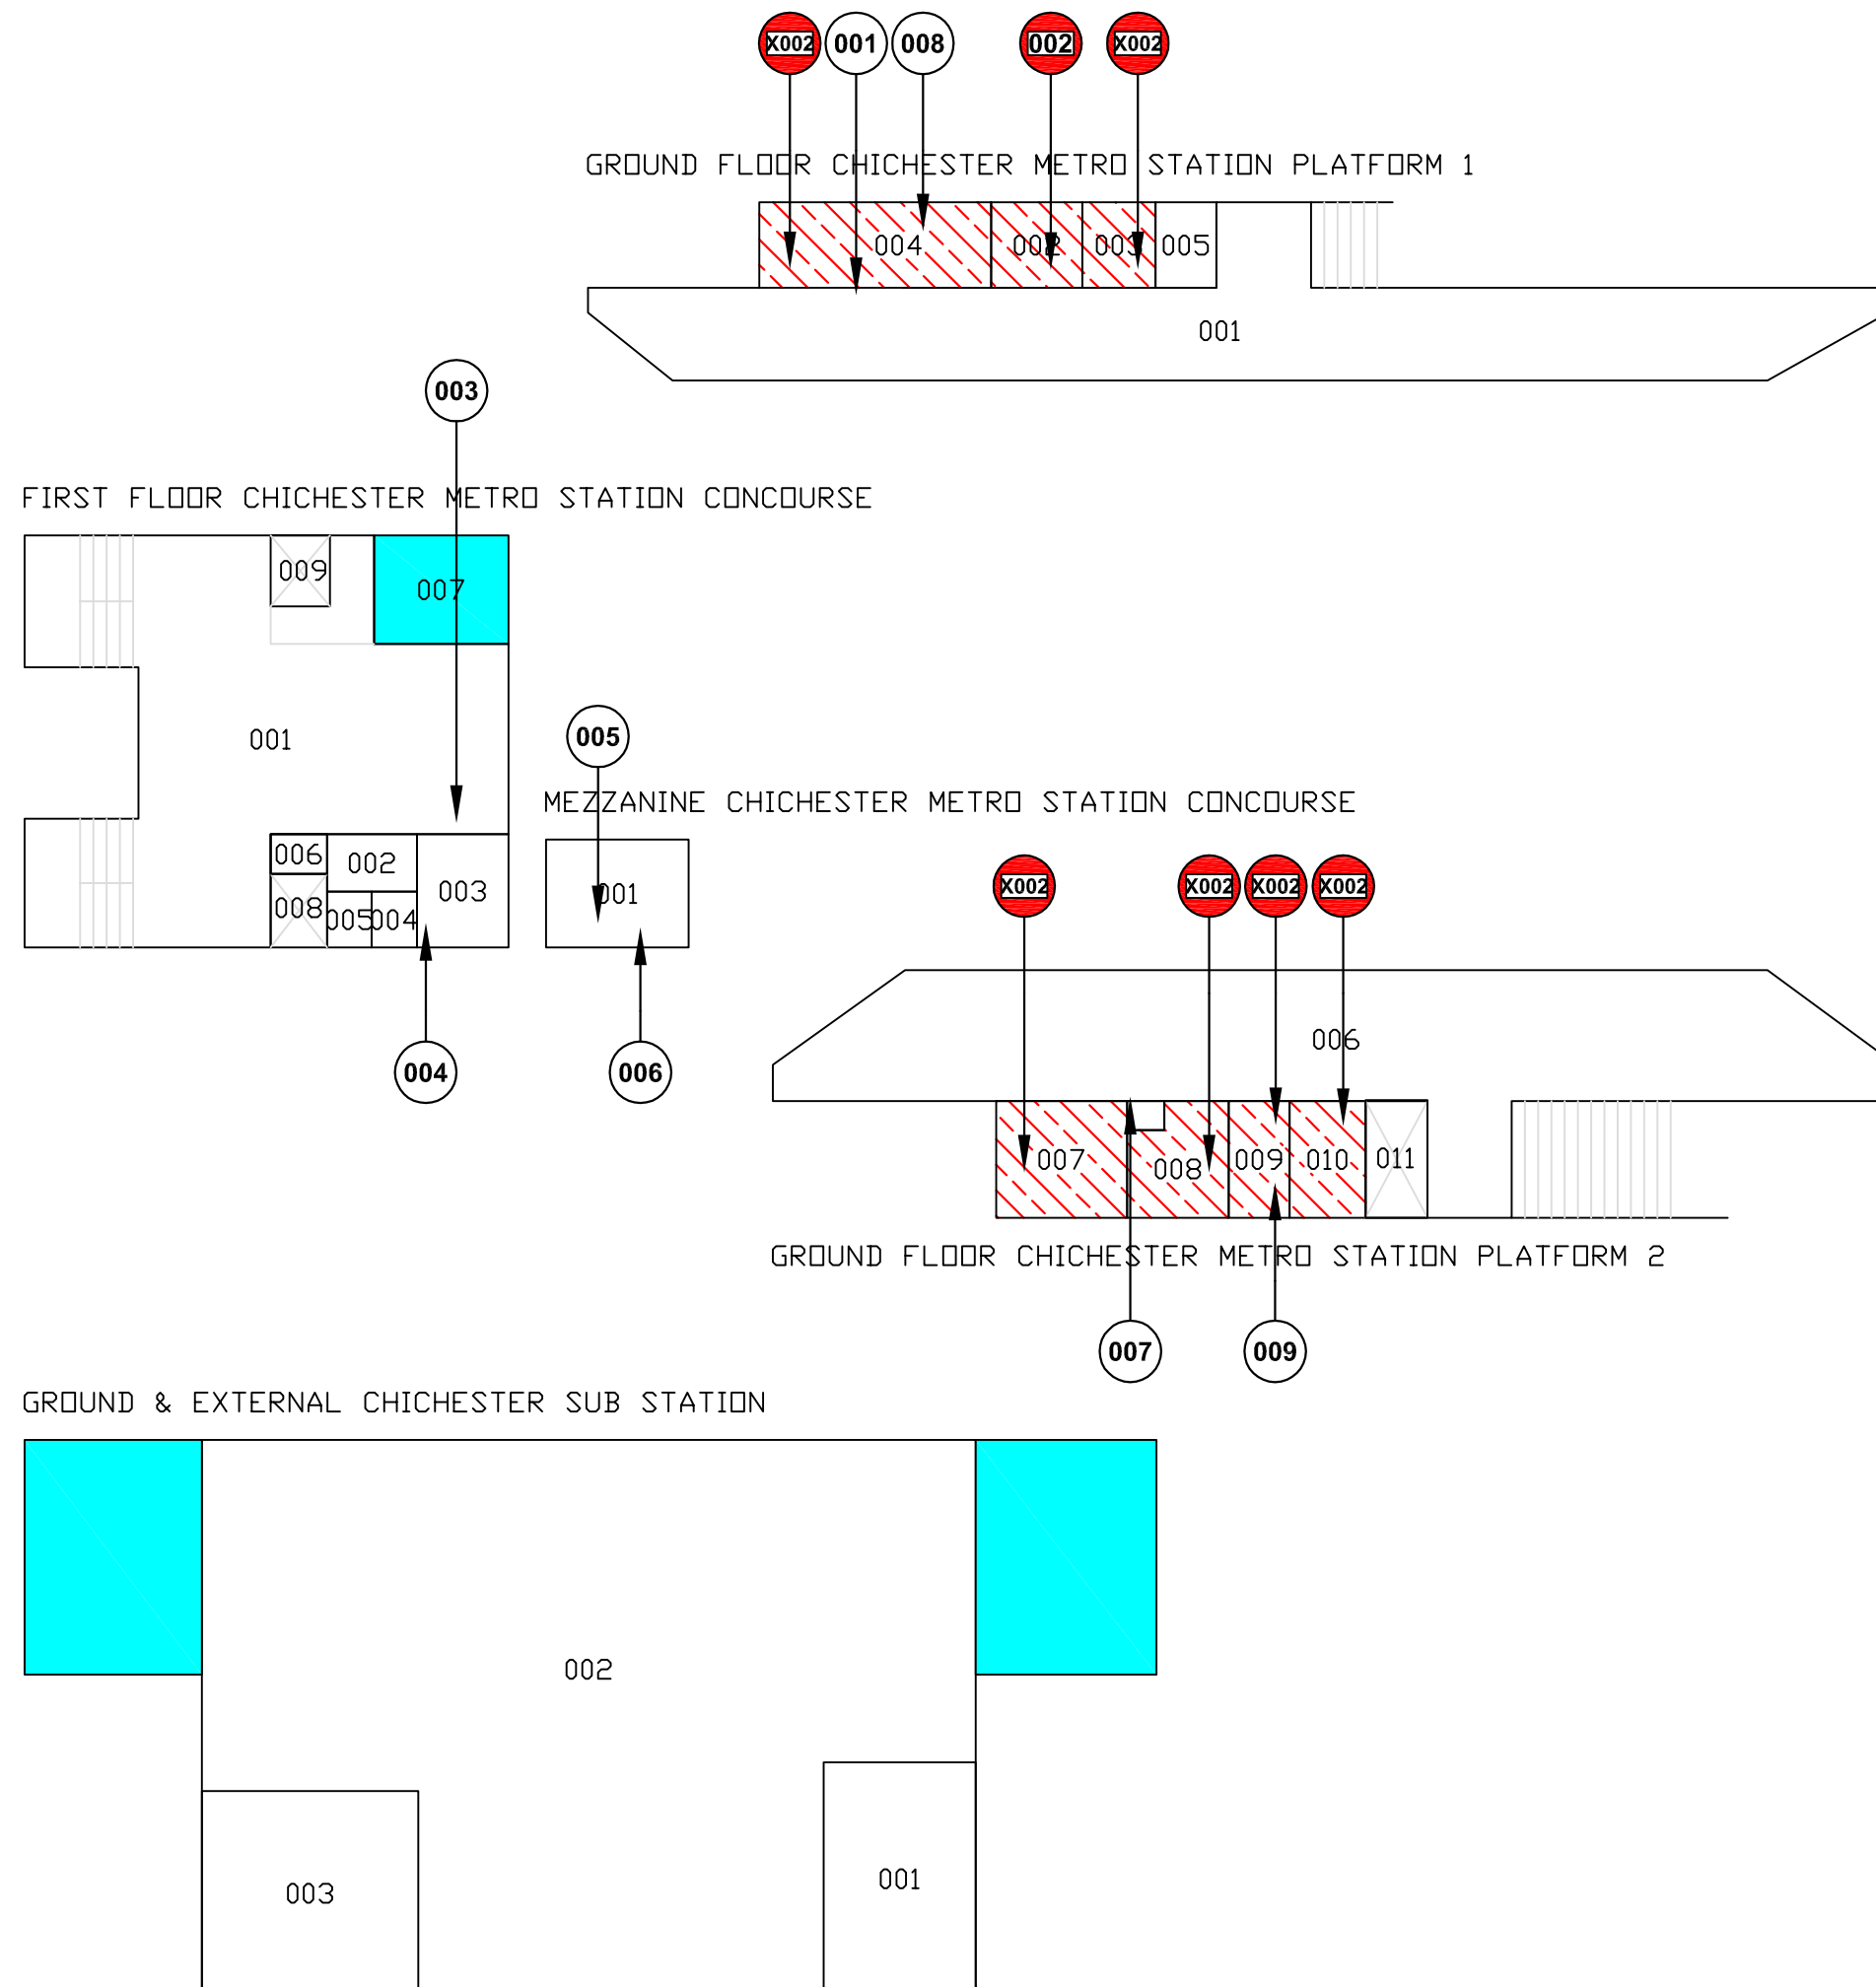
Reference	B070909NA1
Job Number	N-29773
Building	Chichester Metro Station Chichester Sub Station
Floor	Ground, First & Mezzanine
Page	1 of 1
Drawn By	MG
Issue	2

Building	Floor	Location	Item Description	Risk Assessment Score	Recommendation
Chichester Metro Station	Ground Floor	Location ID:007: Relay Room	Floor tiles	10	Manage
Chichester Metro Station	Ground Floor	Location ID:008: LV Room	Floor tiles	10	Manage
Chichester Metro Station	Ground Floor	Location ID:002: Lift Motor Room Lobby	Floor tiles	9	Manage
Chichester Metro Station	Ground Floor	Location ID:004: C & S Room	Floor tiles	9	Manage
Chichester Metro Station	Ground Floor	Location ID:009: Lobby Area	Floor tiles	8	Manage
Chichester Metro Station	Ground Floor	Location ID:010: Lift Machine Room	Floor tiles	8	Manage
Chichester Metro Station	First Floor	Location ID:001: Station Concourse	VE panels	7	Manage
Chichester Metro Station	Ground Floor	Location ID:006: Station Platform 2	VE Panels	7	Manage
Chichester Metro Station	Ground Floor	Location ID:001: Station Platform 1	VE panels	6	Manage
Chichester Metro Station	Ground Floor	Location ID:003: Lift Motor Room	Floor tiles	6	Manage
