**Report No: AR/09/3388 (update 02)**

**CRAGSIDE PRIMARY SCHOOL,  
WEST LOCK ROAD,  
CRAMLINGTON, NE23 6LW  
MANAGEMENT ASBESTOS SURVEY**

**UPDATED ASBESTOS REGISTER FROM VEGA REPORT  
AR/09/3388**

**Issue Date: 09 July 2015**

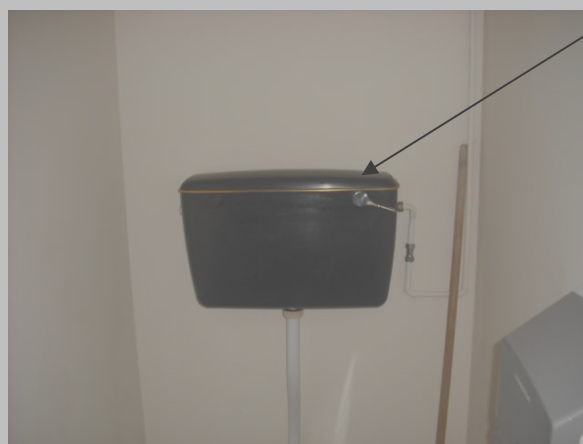
Kitchen Staff Room & Toilet - toilet cistern is an asbestos containing material (ACM sample BS/01). It is in good condition and recommended it be left undisturbed and monitored.

**REMOVED AUGUST 2014**

Level of ID	Sample ID	Extent (m/m <sup>2</sup> /m <sup>3</sup> )	Product Type (1,2,3)	Condition (0,1,2,3)	Surface Treatment (0,1,2,3)	Asbestos Type (1,2,3)	Score	Access (IA,OA,EA)	Action (A1,A2,A3)
ID	BS/01	<0.5m <sup>2</sup>	1	0	0	2	3	EA	A3

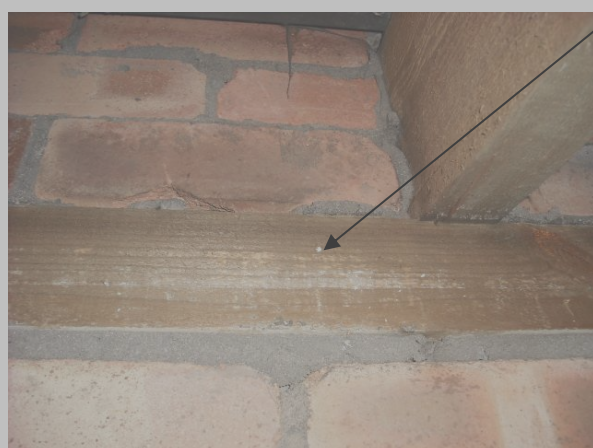
Boiler Room - residual debris to roof joists is an ACM (as BS/02). It is recommended that the roof joists are cleaned and decontaminated by a licenced asbestos removal contractor.

**REMOVED FEB 2010**

Level of ID	Sample ID	Extent (m/m <sup>2</sup> /m <sup>3</sup> )	Product Type (1,2,3)	Condition (0,1,2,3)	Surface Treatment (0,1,2,3)	Asbestos Type (1,2,3)	Score	Access (IA,OA,EA)	Action (A1,A2,A3)
SP	As BS/02	49m <sup>2</sup>	2	3	2	2	9	IA	REMOVED FEB 2010

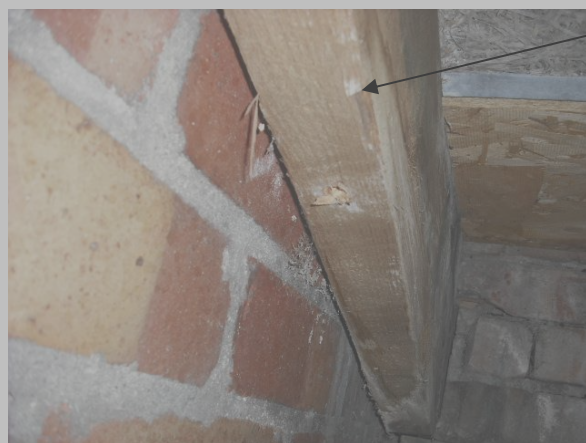
Tank Room - residual debris to roof joists is an ACM (as BS/02). It is recommended that the roof joists are cleaned and decontaminated by a licenced asbestos removal contractor.

**REMOVED FEB 2010**

Level of ID	Sample ID	Extent (m/m <sup>2</sup> /m <sup>3</sup> )	Product Type (1,2,3)	Condition (0,1,2,3)	Surface Treatment (0,1,2,3)	Asbestos Type (1,2,3)	Score	Access (IA,OA,EA)	Action (A1,A2,A3)
SP	As BS/02	14m <sup>2</sup>	2	3	2	2	9	IA	REMOVED FEB 2010

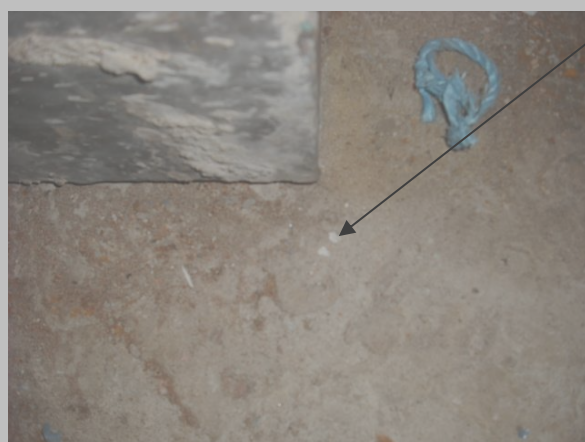
Tank Room - floor debris is an ACM (sample BS/02). It is recommended that the floor space is cleaned and decontaminated by a licenced asbestos removal contractor.

**REMOVED FEB 2010**

Level of ID	Sample ID	Extent (m/m <sup>2</sup> /m <sup>3</sup> )	Product Type (1,2,3)	Condition (0,1,2,3)	Surface Treatment (0,1,2,3)	Asbestos Type (1,2,3)	Score	Access (IA,OA,EA)	Action (A1,A2,A3)
ID	BS/02	14m <sup>2</sup>	2	3	2	2	9	EA	REMOVED FEB 2010

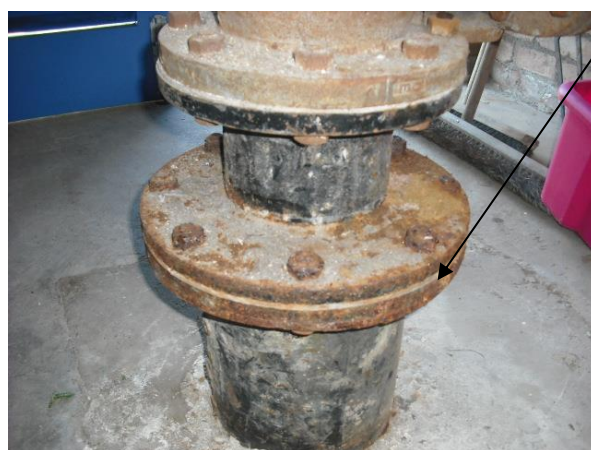
Gas Cupboard - pipe flange gaskets are an ACM (sample BS/03). They are in good condition and recommended they be left undisturbed and monitored.

Level of ID	Sample ID	Extent (m/m <sup>2</sup> /m <sup>3</sup> )	Product Type (1,2,3)	Condition (0,1,2,3)	Surface Treatment (0,1,2,3)	Asbestos Type (1,2,3)	Score	Access (IA,OA,EA)	Action (A1,A2,A3)
ID	BS/03	<0.5m <sup>2</sup>	1	0	0	1	2	EA	A3

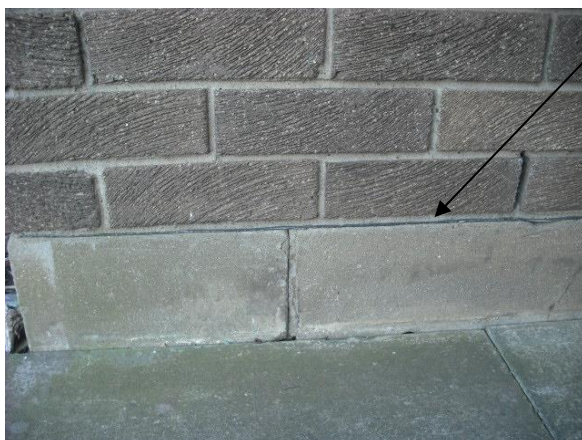
Exterior - damp proof course is an ACM (BS/04). It is in good condition and recommended it be left undisturbed and monitored.

Level of ID	Sample ID	Extent (m/m <sup>2</sup> /m <sup>3</sup> )	Product Type (1,2,3)	Condition (0,1,2,3)	Surface Treatment (0,1,2,3)	Asbestos Type (1,2,3)	Score	Access (IA,OA,EA)	Action (A1,A2,A3)
ID	BS/04	210m	1	0	0	1	2	OA	A3
