**Report No: AR/04/1677 (Update 06)**

**CRAMLINGTON HILLCREST SCHOOL,  
EAST VIEW AVENUE  
CRAMLINGTON, NE23 9DY**

**UPDATED ASBESTOS REGISTER FROM VEGA REPORT  
AR/04/1677  
UPDATED BY ASBESTOS MANAGER – RON BROWN  
UPDATE NUMBER 06**

**ASBESTOS SURVEY REPORT**

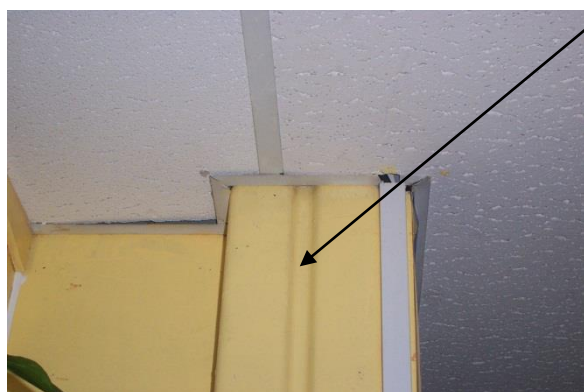
**Entrance Lobby** – metal columns were inaccessible, therefore, we must presume they contain asbestos. It is recommended a closer inspection be undertaken prior to invasive maintenance works. Surveying experience of similar building constructions has identified AIB material inside these metal columns. Often this material cannot easily be found until demolition or major refurbishment works.

Similar metal columns can be found in Corridors 1 and 2, Head Masters' Office, Store Cupboard 1, Office 1, Male and Female Staff Toilets, Staff Room, Foyer, Hall, Classrooms 18, 22, 23, 25, 29, 35, 36 and 39, Store Rooms 19, 20, 24, 26, 33, 34, 37, 38 and 40, Hall Store, Changing Room, Changing Room Toilet, Shower Rooms 1 and 2, Photocopier Room, Quiet Room, Library, Kitchen, Vegetable Store, Staff Office, Larder, Exit Lobby and Room 11.

Level of ID	Sample ID	Extent (m <sup>2</sup> /m <sup>3</sup> )	Product Type (1,2,3)	Condition (0,1,2,3)	Surface Treatment (0,1,2,3)	Asbestos Type (1,2,3)	Score	Access (IA,OA,EA)	Action (A1,A2,A3)
P	-	<1m <sup>2</sup>	2	0	0	2	4	IA	A3

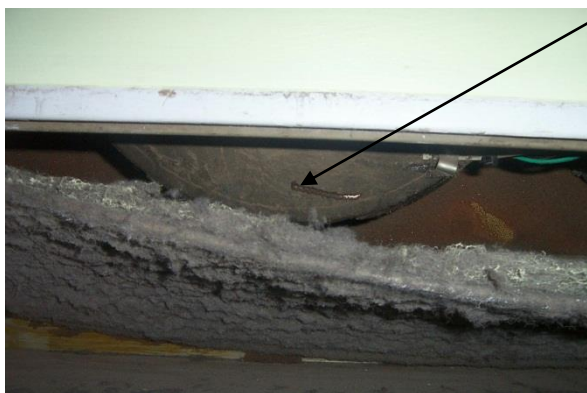
Corridor 2 – wall mounted heater, bitumen coating to motor is an asbestos containing material (ACM sample BS/02). It is in good condition and recommended it be left undisturbed and monitored. Similar wall mounted heaters can be found in the Hall, Foyer and Corridor 1.

Still 1 heater in changing room

Level of ID	Sample ID	Extent (m/m <sup>2</sup> /m <sup>3</sup> )	Product Type (1,2,3)	Condition (0,1,2,3)	Surface Treatment (0,1,2,3)	Asbestos Type (1,2,3)	Score	Access (IA,OA,EA)	Action (A1,A2,A3)
ID	BS/02	<0.25m <sup>2</sup>	1	0	0	1	2	OA	A3

**ALL ABOVE REMOVED FEB 2015**

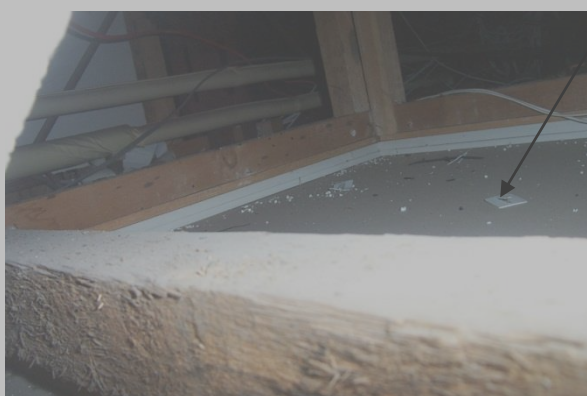
Void Above Corridor 2 – Skylight AIB debris. Removal is recommended as soon as possible.

Level of ID	Sample ID	Extent (m/m <sup>2</sup> /m <sup>3</sup> )	Product Type (1,2,3)	Condition (0,1,2,3)	Surface Treatment (0,1,2,3)	Asbestos Type (1,2,3)	Score	Access (IA,OA,EA)	Action (A1,A2,A3)
ID	BS/15	80 m <sup>2</sup>	2	3	2	2	9	IA	REMOVED 2005

**REMOVED 2005**

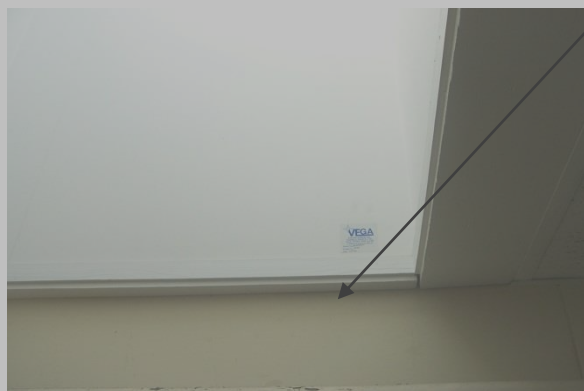
Male Staff Toilet – Skylight panel is an ACM (sample BS/04). It is in good condition and recommended it be left undisturbed and monitored. Similar skylight panels can be found in the Female Staff Toilet, Changing Room, Library, Boys' and Girls' Toilets, Classroom 34, Kitchen, Vegetable Store, Staff Office, Larder and Entrance to Tank Room. Similar panels can also be found to the pipe riser in Larder.

Level of ID	Sample ID	Extent (m/m <sup>2</sup> /m <sup>3</sup> )	Product Type (1,2,3)	Condition (0,1,2,3)	Surface Treatment (0,1,2,3)	Asbestos Type (1,2,3)	Score	Access (IA,OA,EA)	Action (A1,A2,A3)
ID	BS/04	4m <sup>2</sup>	2	0	1	2	5	OA	REMOVED 2005

**REMOVED 2005**

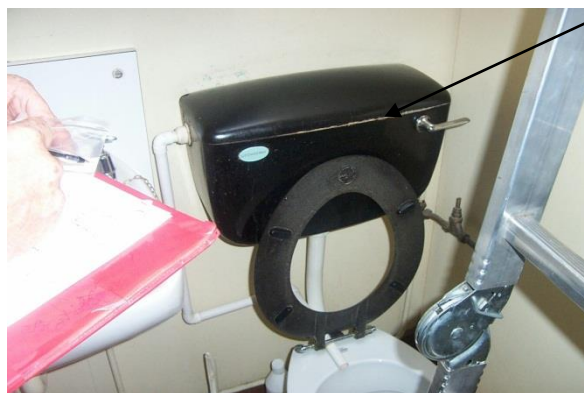
Staff Toilet– toilet cistern is an ACM (sample BS/05). It is in good condition and recommended it be left undisturbed and monitored.

Level of ID	Sample ID	Extent (m/m <sup>2</sup> /m <sup>3</sup> )	Product Type (1,2,3)	Condition (0,1,2,3)	Surface Treatment (0,1,2,3)	Asbestos Type (1,2,3)	Score	Access (IA,OA,EA)	Action (A1,A2,A3)
ID	BS/05	<0.5m <sup>2</sup>	1	0	0	2	3	EA	A3

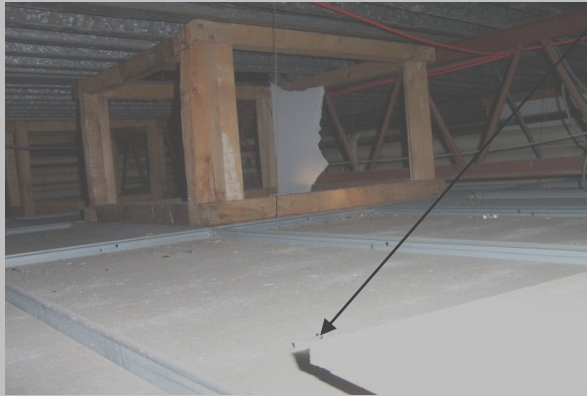
Void Above Male Staff Toilet – debris from broken skylight panels to back of ceiling is an ACM (sample As BS/04). Removal is recommended as soon as possible. Similar debris from broken skylight panels to back of ceiling can be found in the Voids Above Female Staff Toilet, Foyer, Changing Room Toilet, Classrooms 22, 25, 29, 36 and 39, Girls' and Boys' Toilet, Girls' Changing Room, and Staff Office.

**REMOVED 2005**

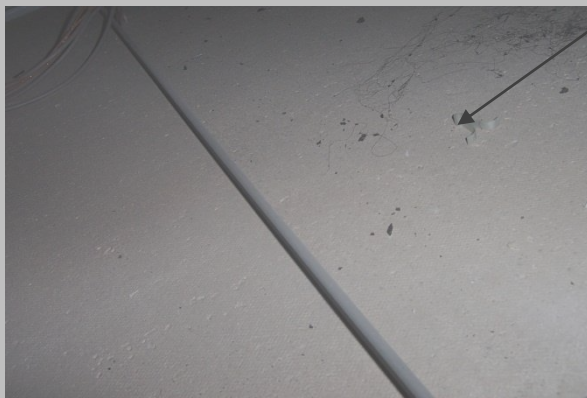
Void Above Classroom 22 – AIB debris on top of tiles.

Level of ID	Sample ID	Extent (m/m <sup>2</sup> /m <sup>3</sup> )	Product Type (1,2,3)	Condition (0,1,2,3)	Surface Treatment (0,1,2,3)	Asbestos Type (1,2,3)	Score	Access (IA,OA,EA)	Action (A1,A2,A3)
SP	As BS/04	<0.5m <sup>2</sup>	2	2	3	2	9	OA	REMOVED 2005

**REMOVED 2005**

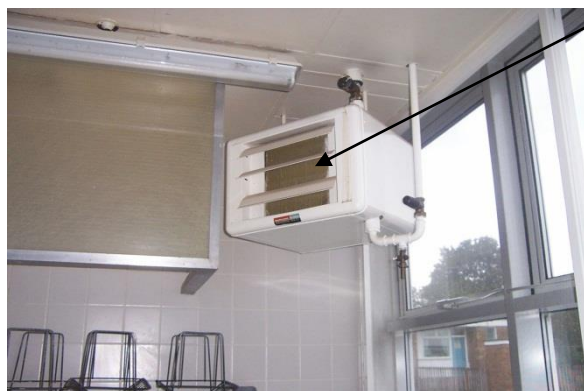
Kitchen – heaters were inaccessible, therefore, we must presume they contains asbestos. It is recommended a closer inspection be undertaken prior to invasive maintenance works.

Level of ID	Sample ID	Extent (m/m <sup>2</sup> /m <sup>3</sup> )	Product Type (1,2,3)	Condition (0,1,2,3)	Surface Treatment (0,1,2,3)	Asbestos Type (1,2,3)	Score	Access (IA,OA,EA)	Action (A1,A2,A3)
<i>P</i>	-	<i>&lt;0.5m<sup>2</sup></i>	<i>2</i>	<i>0</i>	<i>2</i>	<i>2</i>	<i>6</i>	<i>IA</i>	<i>A3</i>

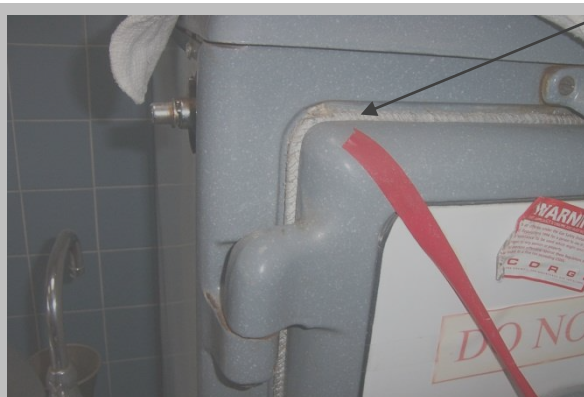
Kitchen – steam heated oven, rope gasket to door is and ACM (sample BS/14). Although the material assessment is low, consideration should be given to replacement with a non asbestos material.

Level of ID	Sample ID	Extent (m/m <sup>2</sup> /m <sup>3</sup> )	Product Type (1,2,3)	Condition (0,1,2,3)	Surface Treatment (0,1,2,3)	Asbestos Type (1,2,3)	Score	Access (IA,OA,EA)	Action (A1,A2,A3)
<i>ID</i>	<i>BS/14</i>	<i>1m</i>	<i>2</i>	<i>0</i>	<i>2</i>	<i>1</i>	<i>5</i>	<i>EA</i>	<i>A2</i>

**REMOVED AUGUST 2006**

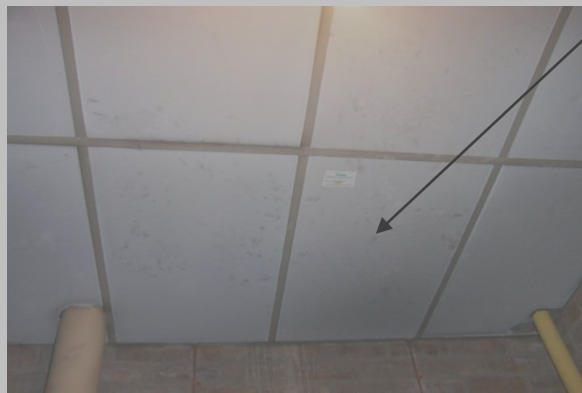
Boiler Room – ceiling panels are an ACM (sample BS/18). They are in fair condition and recommended they be left undisturbed and monitored.

Level of ID	Sample ID	Extent (m/m <sup>2</sup> /m <sup>3</sup> )	Product Type (1,2,3)	Condition (0,1,2,3)	Surface Treatment (0,1,2,3)	Asbestos Type (1,2,3)	Score	Access (IA,OA,EA)	Action (A1,A2,A3)
ID	BS/18	22m <sup>2</sup>	2	2	1	2	4	OA	REMOVED 2005

**REMOVED 2005**

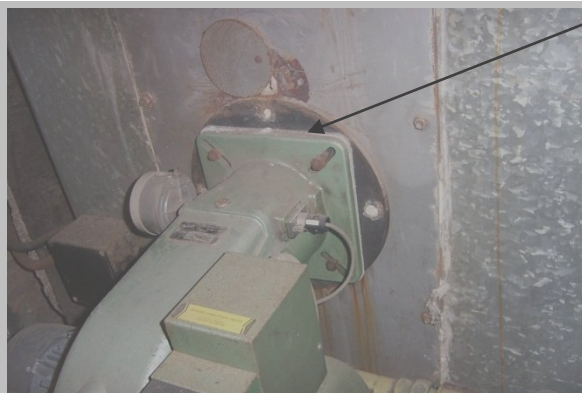
Boiler Room – burner gasket is an ACM (sample BS/19). It is in good condition and recommended it be left undisturbed and monitored.

Level of ID	Sample ID	Extent (m/m <sup>2</sup> /m <sup>3</sup> )	Product Type (1,2,3)	Condition (0,1,2,3)	Surface Treatment (0,1,2,3)	Asbestos Type (1,2,3)	Score	Access (IA,OA,EA)	Action (A1,A2,A3)
ID	BS/19	0.25m <sup>2</sup>	1	0	0	1	2	EA	A3

**REMOVED SUMMER 2010**

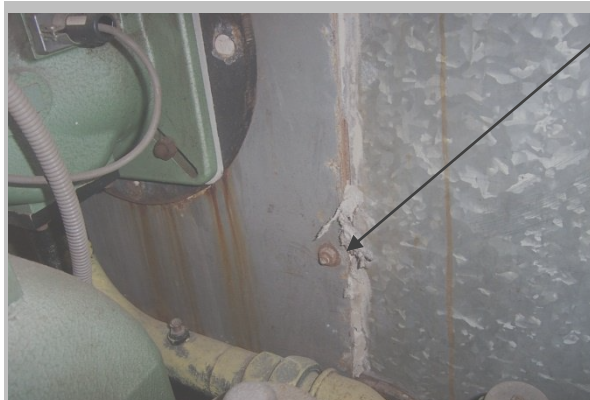
Boiler Room – boiler front rope gasket is an ACM (sample BS/20). This material should be paint sealed for it to remain in place. Similar rope gasket can be found in the, flue pipe penetration, through to boiler housing.

Level of ID	Sample ID	Extent (m/m <sup>2</sup> /m <sup>3</sup> )	Product Type (1,2,3)	Condition (0,1,2,3)	Surface Treatment (0,1,2,3)	Asbestos Type (1,2,3)	Score	Access (IA,OA,EA)	Action (A1,A2,A3)
ID	BS/20	1m	2	1	2	1	6	EA	A2

REMOVED SUMMER 2010

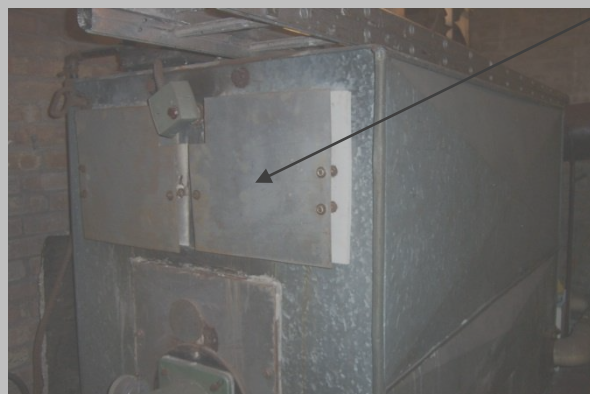
Boiler Room - boiler internal segments were inaccessible, therefore, we must presume they contain asbestos. It is recommended a closer inspection be undertaken prior to invasive maintenance works.

Level of ID	Sample ID	Extent (m/m <sup>2</sup> /m <sup>3</sup> )	Product Type (1,2,3)	Condition (0,1,2,3)	Surface Treatment (0,1,2,3)	Asbestos Type (1,2,3)	Score	Access (IA,OA,EA)	Action (A1,A2,A3)
P	-	<0.25m <sup>2</sup>	2	0	1	1	4	IA	A3

REMOVED SUMMER 2010

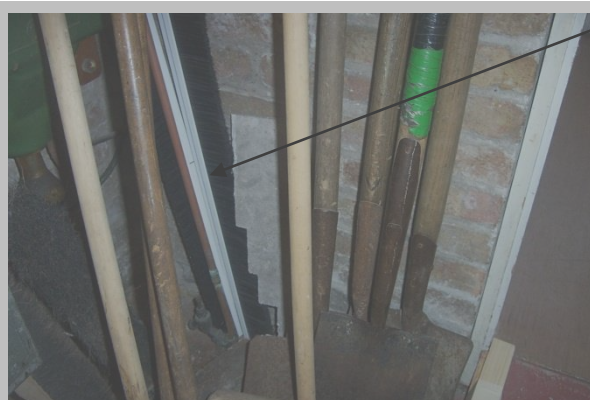
Boiler Room – redundant panel adjacent doorway is an ACM (as sample BS/18). Removal is recommended as soon as possible.

Level of ID	Sample ID	Extent (m/m <sup>2</sup> /m <sup>3</sup> )	Product Type (1,2,3)	Condition (0,1,2,3)	Surface Treatment (0,1,2,3)	Asbestos Type (1,2,3)	Score	Access (IA,OA,EA)	Action (A1,A2,A3)
SP	As BS/18	<0.5m <sup>2</sup>	2	1	2	2	7	EA	REMOVED 2005

**REMOVED 2005**

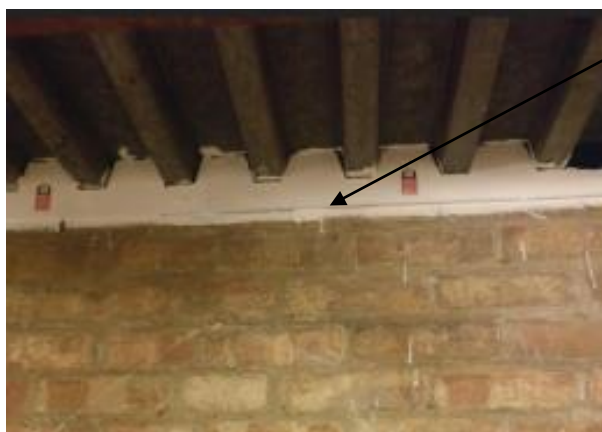
Caretaker's Office – insulation board panel to wall is an ACM (as sample BS/04). It is in good condition and recommended it be left undisturbed and monitored.

Level of ID	Sample ID	Extent (m/m <sup>2</sup> /m <sup>3</sup> )	Product Type (1,2,3)	Condition (0,1,2,3)	Surface Treatment (0,1,2,3)	Asbestos Type (1,2,3)	Score	Access (IA,OA,EA)	Action (A1,A2,A3)
ID	BS/04	1.5m <sup>2</sup>	2	0	1	2	5	OA	A3
