Report No: AR/10/00215

**SEAFIELD TOILETS
SEAHOUSES
TYPE 2 ASBESTOS SURVEY**

Survey to identify asbestos based materials
carried out on behalf of Northumberland County Council

Issue Date: 6 February 2010

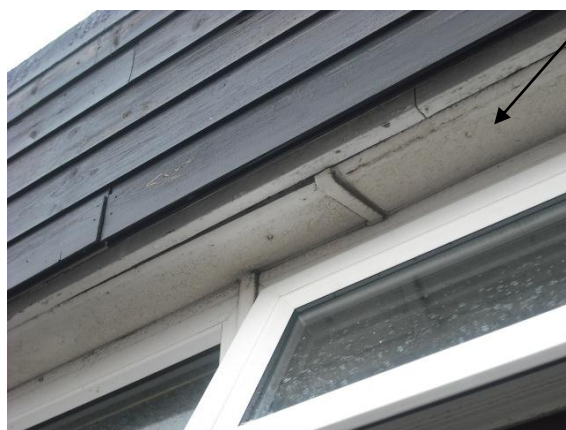
Seafield Toilets - Exterior

Exterior - insulation board (under UPVC) is an asbestos containing material (ACM BS/02). It is in good condition and recommended it be left undisturbed and monitored.

Level of ID	Sample ID	Extent (m/m ² /m ³)	Product Type (1,2,3)	Condition (0,1,2,3)	Surface Treatment (0,1,2,3)	Asbestos Type (1,2,3)	Score	Access (IA,OA,EA)	Action (A1,A2,A3)
ID	BS/02	18m	1	0	1	1	3	OA	A3

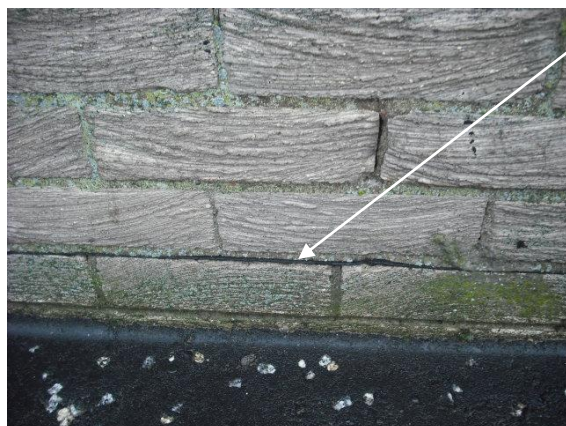
Seafield Toilets - Exterior

Exterior - damp proof course is an ACM (sample BS/03). It is in good condition and recommended it be left undisturbed and monitored.

Level of ID	Sample ID	Extent (m/m ² /m ³)	Product Type (1,2,3)	Condition (0,1,2,3)	Surface Treatment (0,1,2,3)	Asbestos Type (1,2,3)	Score	Access (IA,OA,EA)	Action (A1,A2,A3)
ID	BS/03	40m	1	0	0	1	2	EA	A3
