Report No: AR/04/1629 (update 06)

**SS PETER AND PAULS CATHOLIC PRIMARY
ACADEMY, NORTHUMBRIAN ROAD,
CRAMLINGTON, NORTHUMBERLAND**

**UPDATED ASBESTOS REGISTER FROM VEGA REPORT
AR/04/1629
UPDATED BY ASBESTOS MANAGER – RON BROWN
UPDATE NUMBER 06**

ASBESTOS SURVEY REPORT

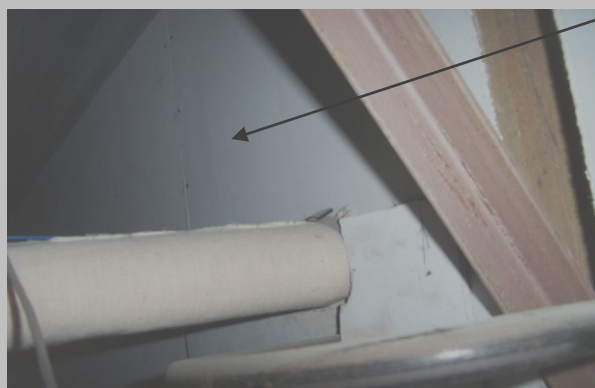
Cloakroom 1 – panel above door is an asbestos containing material (ACM as sample BS/10). It is in good condition and recommended it be left undisturbed and monitored. Similar panels can be found in the Void above Cloakroom 1, Art and Craft Room, Void above Art and Craft Room, Voids above Boys' and Girls' Toilets 1 and 2.

Level of ID	Sample ID	Extent (m/m ² /m ³)	Product Type (1,2,3)	Condition (0,1,2,3)	Surface Treatment (0,1,2,3)	Asbestos Type (1,2,3)	Score	Access (IA,OA,EA)	Action (A1,A2,A3)
SP	As BS/10	5m ²	2	0	1	2	5	OA	REMOVED FEB 2005

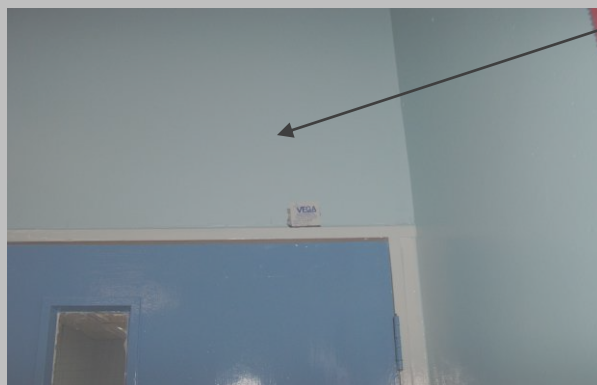
Cloakroom 1 – panel above door is an ACM (as sample BS/09). It is in good condition and recommended it be left undisturbed and monitored. Similar panels can be found in I.T. and Cookery, Cloakroom 2,

Level of ID	Sample ID	Extent (m/m ² /m ³)	Product Type (1,2,3)	Condition (0,1,2,3)	Surface Treatment (0,1,2,3)	Asbestos Type (1,2,3)	Score	Access (IA,OA,EA)	Action (A1,A2,A3)
ID	BS09	4m ²	2	0	1	2	5	OA	REMOVED FEB 2005

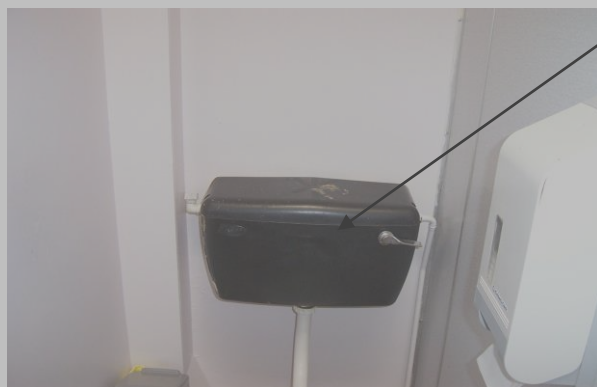
Boys' Toilet 1 – toilet cisterns are an ACM (sample BS/04). They are in good condition and recommended they be left undisturbed and monitored. Similar cisterns can be found in Girls' Toilet 2 and Boys' Toilet 2.

Level of ID	Sample ID	Extent (m/m ² /m ³)	Product Type (1,2,3)	Condition (0,1,2,3)	Surface Treatment (0,1,2,3)	Asbestos Type (1,2,3)	Score	Access (IA,OA,EA)	Action (A1,A2,A3)
ID	BS/04	0.25m ²	1	0	0	2	3	EA	A3

Girls & Boys Toilet 2: REMOVED 2016

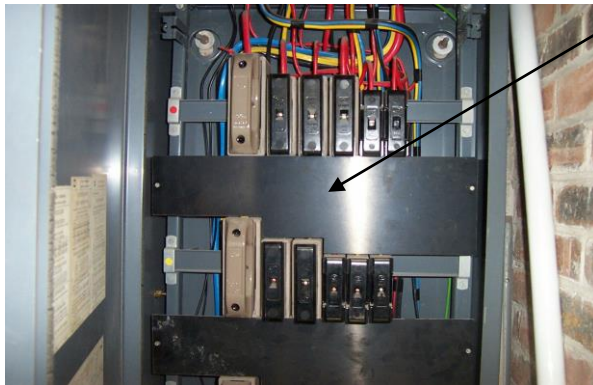
Electricity Cupboard – electrical equipment was inaccessible, therefore, we must presume it contains asbestos. It is recommended a closer inspection be undertaken prior to any invasive maintenance works. Similar electrical equipment can be found in Store 2.

Level of ID	Sample ID	Extent (m/m ² /m ³)	Product Type (1,2,3)	Condition (0,1,2,3)	Surface Treatment (0,1,2,3)	Asbestos Type (1,2,3)	Score	Access (IA,OA,EA)	Action (A1,A2,A3)
P	-	<0.25m ²	2	0	1	1	4	IA	A3

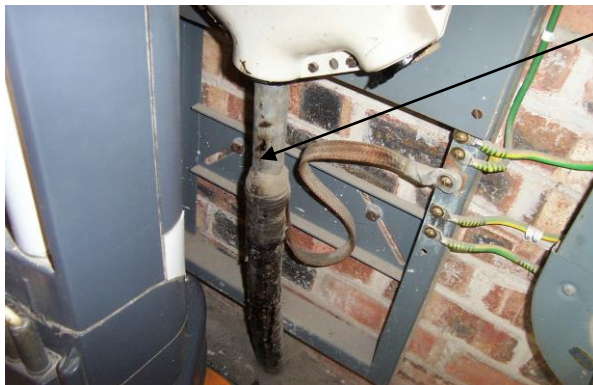
Electricity Cupboard – main cable sheath was inaccessible, therefore, we must presume it contains asbestos. It is recommended a closer inspection be undertaken prior to any invasive maintenance works.

Level of ID	Sample ID	Extent (m/m ² /m ³)	Product Type (1,2,3)	Condition (0,1,2,3)	Surface Treatment (0,1,2,3)	Asbestos Type (1,2,3)	Score	Access (IA,OA,EA)	Action (A1,A2,A3)
P	-	<0.25m ²	1	0	0	1	2	IA	A3

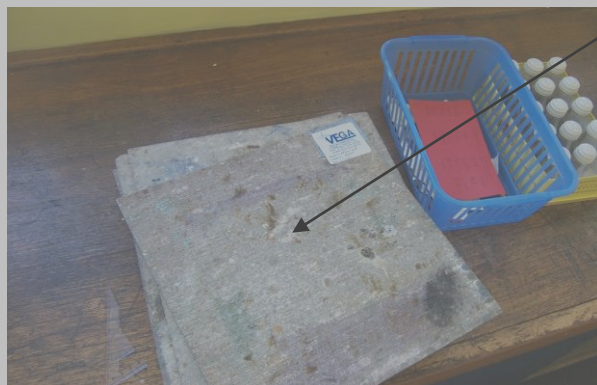
G.P. Area – heat pads are an ACM (sample BS/08). Although they are in good condition, it is recommended they be replaced with a non asbestos material.

Level of ID	Sample ID	Extent (m/m ² /m ³)	Product Type (1,2,3)	Condition (0,1,2,3)	Surface Treatment (0,1,2,3)	Asbestos Type (1,2,3)	Score	Access (IA,OA,EA)	Action (A1,A2,A3)
ID	BS/08	4m ²	1	0	1	1	3	EA	REMOVED JAN 2005

REMOVED JAN 2005

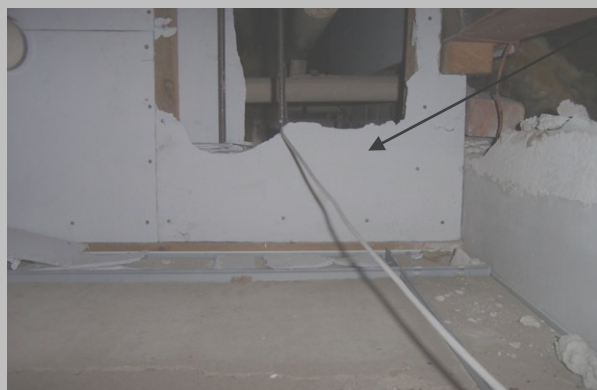
Void above Cloakroom 2 – firebreak panels above door are an ACM (as sample BS/10). They are in poor condition and recommended they be repaired and encapsulated as soon as possible. Similar panels can be found in Void above Classroom 4.

Level of ID	Sample ID	Extent (m/m ² /m ³)	Product Type (1,2,3)	Condition (0,1,2,3)	Surface Treatment (0,1,2,3)	Asbestos Type (1,2,3)	Score	Access (IA,OA,EA)	Action (A1,A2,A3)
SP	As BS/10	5m ²	2	3	2	2	9	OA	REMOVED FEB 2005

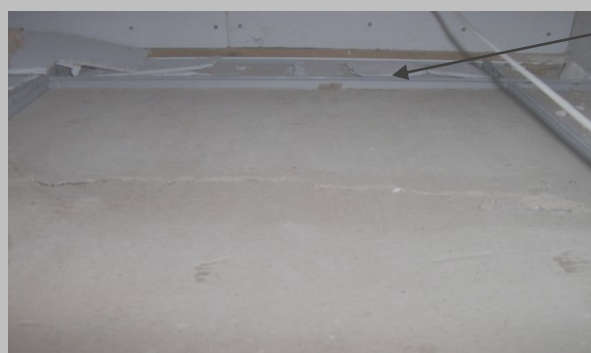
Void above Cloakroom 2 – debris on tiles is an ACM (as sample BS/10). Removal is recommended as soon as possible. Similar debris can be found in I.T. Cookery.

Level of ID	Sample ID	Extent (m/m ² /m ³)	Product Type (1,2,3)	Condition (0,1,2,3)	Surface Treatment (0,1,2,3)	Asbestos Type (1,2,3)	Score	Access (IA,OA,EA)	Action (A1,A2,A3)
SP	As BS/10	1m ²	2	0	2	2	6	OA	REMOVED FEB 2005

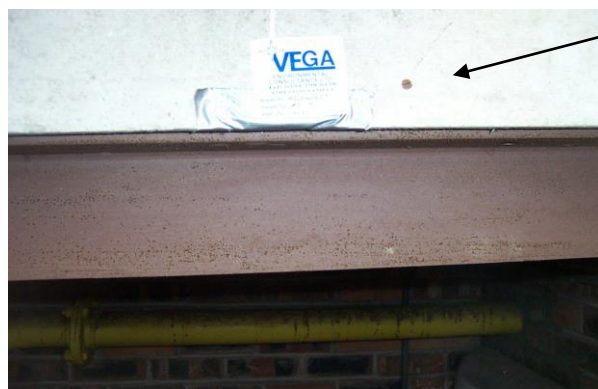
Boiler Room – panels surrounding skylight are an ACM (sample BS/16). They are in fair condition and recommended they be paint sealed as soon as possible.

Level of ID	Sample ID	Extent (m/m ² /m ³)	Product Type (1,2,3)	Condition (0,1,2,3)	Surface Treatment (0,1,2,3)	Asbestos Type (1,2,3)	Score	Access (IA,OA,EA)	Action (A1,A2,A3)
ID	BS/16	10m ²	2	1	2	2	7	OA	A2

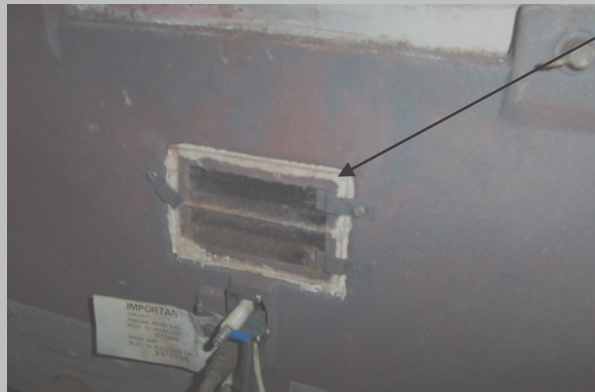
Boiler Room – gasket to boiler inspection cover is an ACM (sample BS/20). It is in good condition and recommended it be left undisturbed and monitored.

Level of ID	Sample ID	Extent (m/m ² /m ³)	Product Type (1,2,3)	Condition (0,1,2,3)	Surface Treatment (0,1,2,3)	Asbestos Type (1,2,3)	Score	Access (IA,OA,EA)	Action (A1,A2,A3)
ID	BS/20	<0.25m	2	0	1	1	4	OA	A3

REMOVED 2019

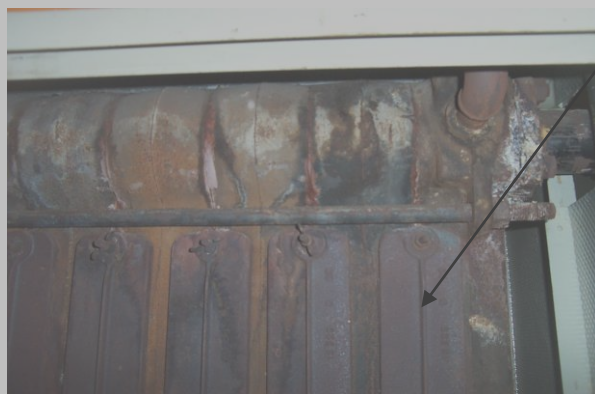
Boiler Room – boiler internal segments were inaccessible, therefore, we must presume they contain asbestos. It is recommended a closer inspection be undertaken prior to any invasive maintenance works.

Level of ID	Sample ID	Extent (m/m ² /m ³)	Product Type (1,2,3)	Condition (0,1,2,3)	Surface Treatment (0,1,2,3)	Asbestos Type (1,2,3)	Score	Access (IA,OA,EA)	Action (A1,A2,A3)
P	-	<0.25m ²	2	0	1	1	4	IA	A3

REMOVED 2019

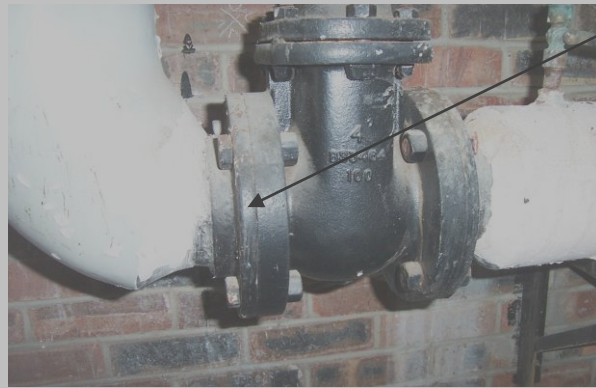
Boiler Room – flange gaskets were inaccessible, therefore, we must presume they contain asbestos. It is recommended a closer inspection be undertaken prior to any invasive maintenance works.

Level of ID	Sample ID	Extent (m/m ² /m ³)	Product Type (1,2,3)	Condition (0,1,2,3)	Surface Treatment (0,1,2,3)	Asbestos Type (1,2,3)	Score	Access (IA,OA,EA)	Action (A1,A2,A3)
P	-	<1m ²	1	0	0	1	2	IA	A3

REMOVED 2019
