**Report No: AR/10/01568 (update 01)**

**BURNSIDE PRIMARY SCHOOL  
CRAMLINGTON  
MANAGEMENT ASBESTOS SURVEY**

Survey to identify asbestos based materials  
carried out on behalf of Northumberland County Council

Issue Date: 19 February 2020

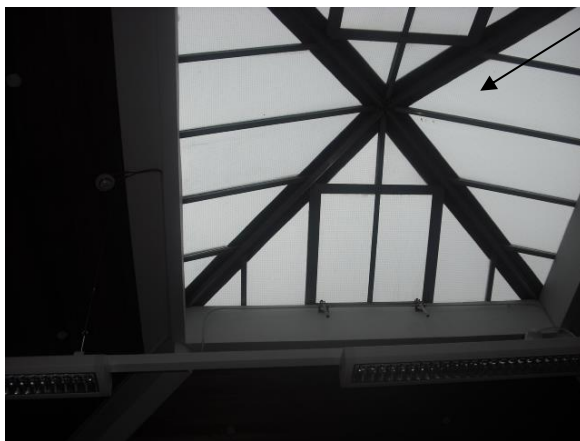
✓ Hall - Skylights were not accessed due to height, therefore we must presume they contain asbestos. It is recommended an inspection take place prior to any refurbishment work.

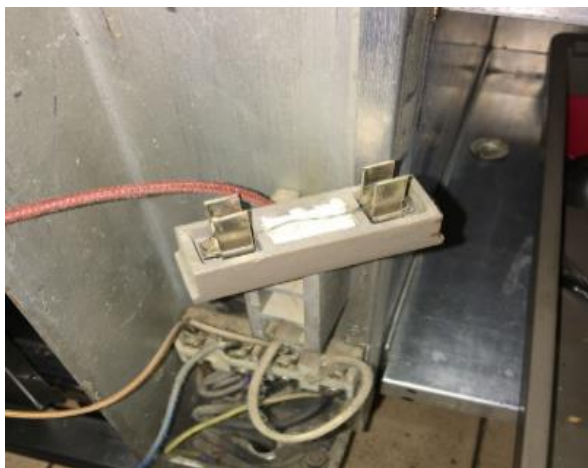
Main Kitchen – flash guard within hot cupboard 3 (identified during fixed wiring test), therefore we must presume it to contain asbestos. It is recommended an inspection take place prior to any refurbishment work.
