Report No: AR/10/01469

**EAST LEA PRIMARY SCHOOL
CRAMLINGTON
MANAGEMENT ASBESTOS SURVEY**

**Survey to identify asbestos based materials
carried out on behalf of Northumberland County Council**

Issue Date: 20 July 2010

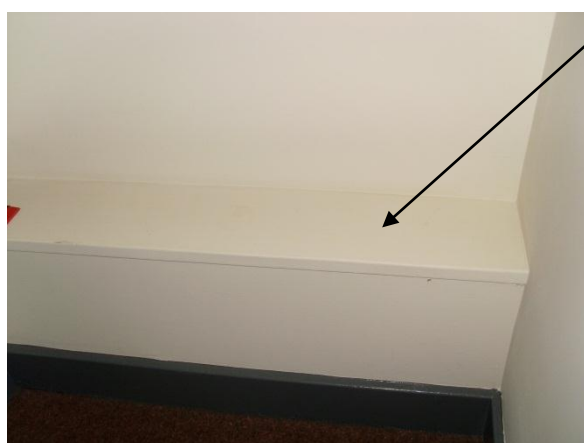
Ground Floor

Corridor 1 - Void Behind Low Level Boxing - was not accessed (without causing damage), therefore we must presume it contains asbestos. It is recommended an inspection be carried out prior to any refurbishment work.

Level of ID	Sample ID	Extent (m/m ² /m ³)	Product Type (1,2,3)	Condition (0,1,2,3)	Surface Treatment (0,1,2,3)	Asbestos Type (1,2,3)	Score	Access (DA,OA,EA)	Action (A1,A2,A3)
P	-	-	-	-	-	-	-	DA	A3

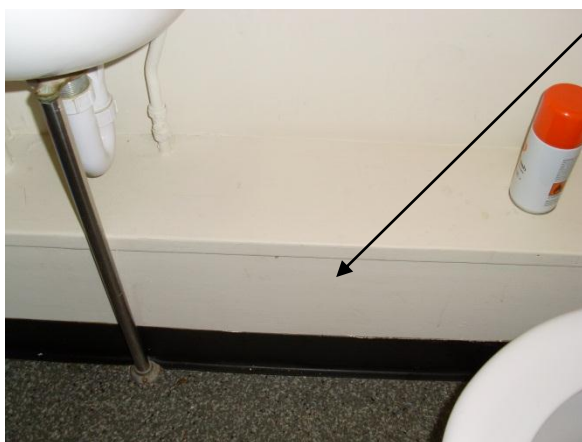
Ground Floor

Disabled Toilet - Void Behind Low Level Boxing - was not accessed (without causing damage), therefore we must presume it contains asbestos. It is recommended an inspection be carried out prior to any refurbishment work.

Level of ID	Sample ID	Extent (m/m ² /m ³)	Product Type (1,2,3)	Condition (0,1,2,3)	Surface Treatment (0,1,2,3)	Asbestos Type (1,2,3)	Score	Access (DA,OA,EA)	Action (A1,A2,A3)
P	-	-	-	-	-	-	-	DA	A3

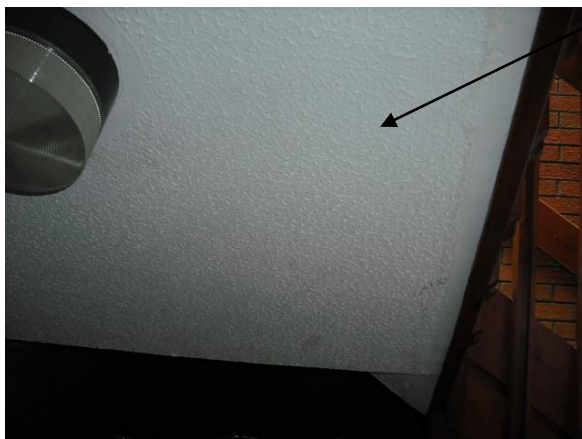
First Floor

Stair Lobby 1 - textured coating to ceiling is an asbestos containing material (ACM sample BS/02). It is in good condition and recommended it be left undisturbed and monitored.

Similar textured coating can be found on the ceiling of stair lobby 2 and stair lobby 1 on the first floor. Refer to Asbestos Register Page 4.

Level of ID	Sample ID	Extent (m/m ² /m ³)	Product Type (1,2,3)	Condition (0,1,2,3)	Surface Treatment (0,1,2,3)	Asbestos Type (1,2,3)	Score	Access (DA,OA,EA)	Action (A1,A2,A3)
ID	BS/02	10m ²	1	0	0	1	2	EA	A3

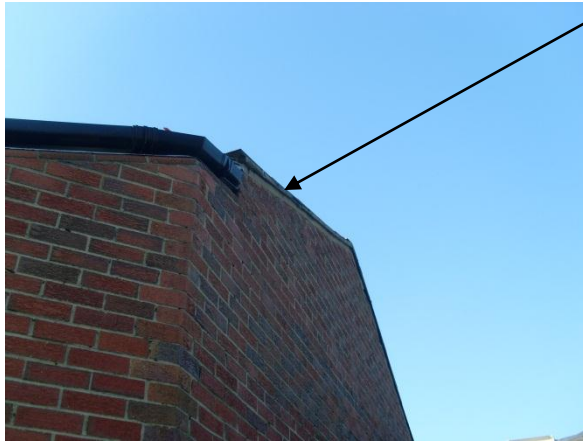
Exterior - undercloaking is an ACM (sample BS/05). It is in good condition and recommended it be left undisturbed and monitored.

Level of ID	Sample ID	Extent (m/m ² /m ³)	Product Type (1,2,3)	Condition (0,1,2,3)	Surface Treatment (0,1,2,3)	Asbestos Type (1,2,3)	Score	Access (DA,OA,EA)	Action (A1,A2,A3)
ID	BS/05	12m	1	0	1	1	3	OA	A3

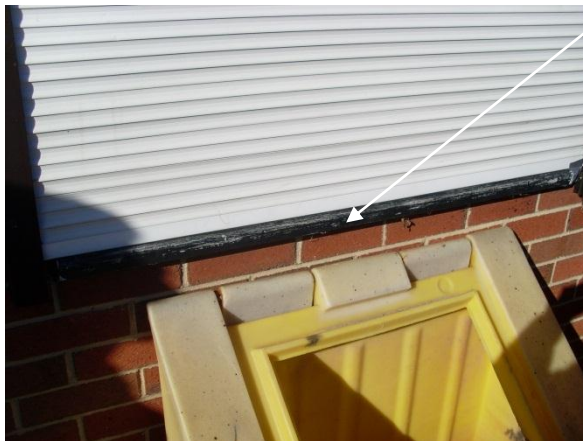
Exterior - cement to window sills is an ACM (sample BS/03). It is in good condition and recommended it be left undisturbed and monitored.

Level of ID	Sample ID	Extent (m/m ² /m ³)	Product Type (1,2,3)	Condition (0,1,2,3)	Surface Treatment (0,1,2,3)	Asbestos Type (1,2,3)	Score	Access (DA,OA,EA)	Action (A1,A2,A3)
ID	BS/03	60m	1	0	1	1	3	EA	A3

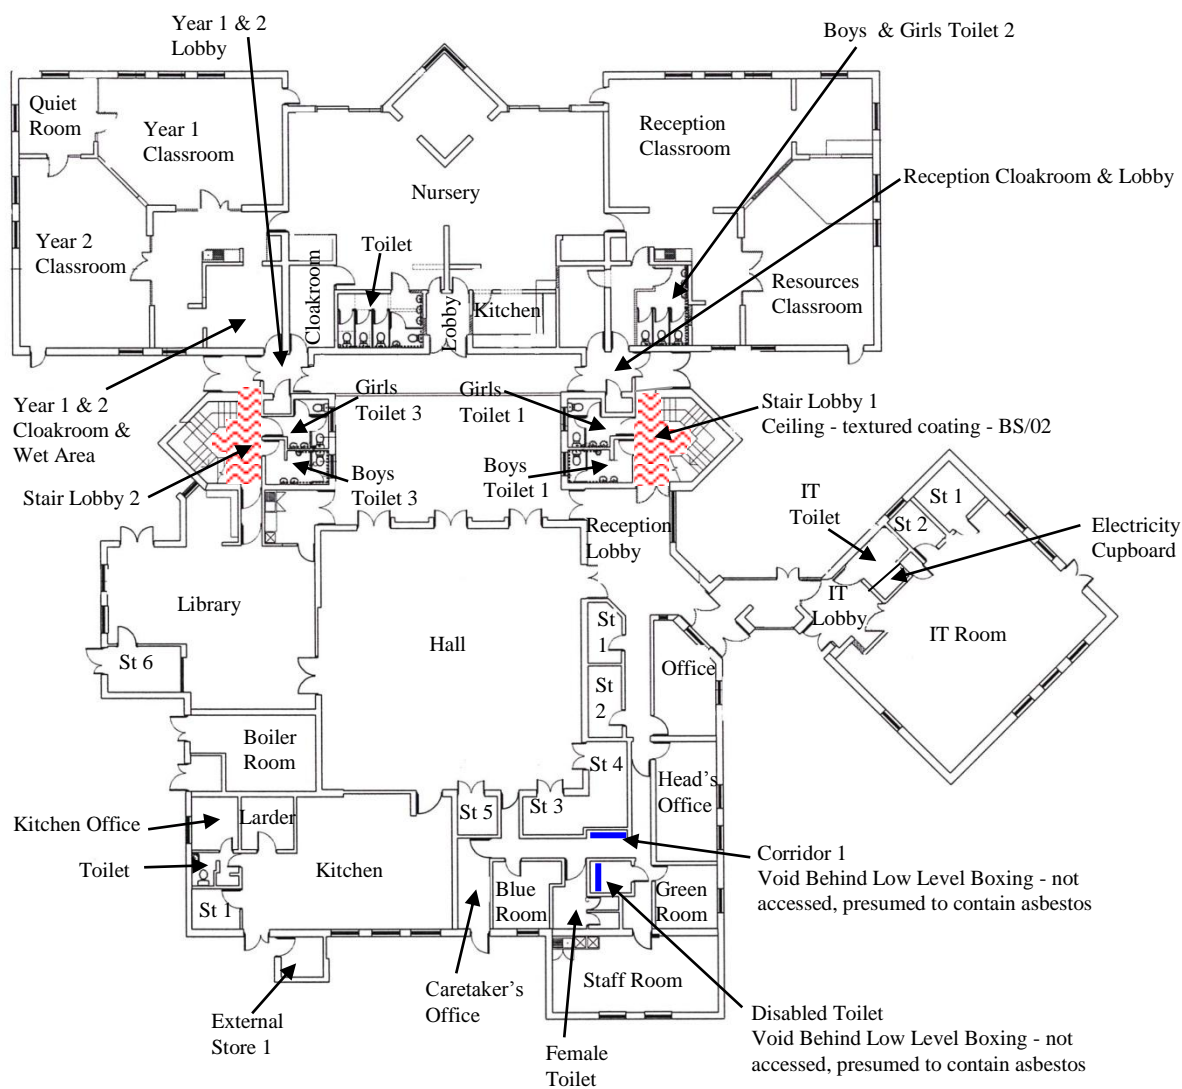
Ground Floor

Textured coating to ceiling - as BS/02

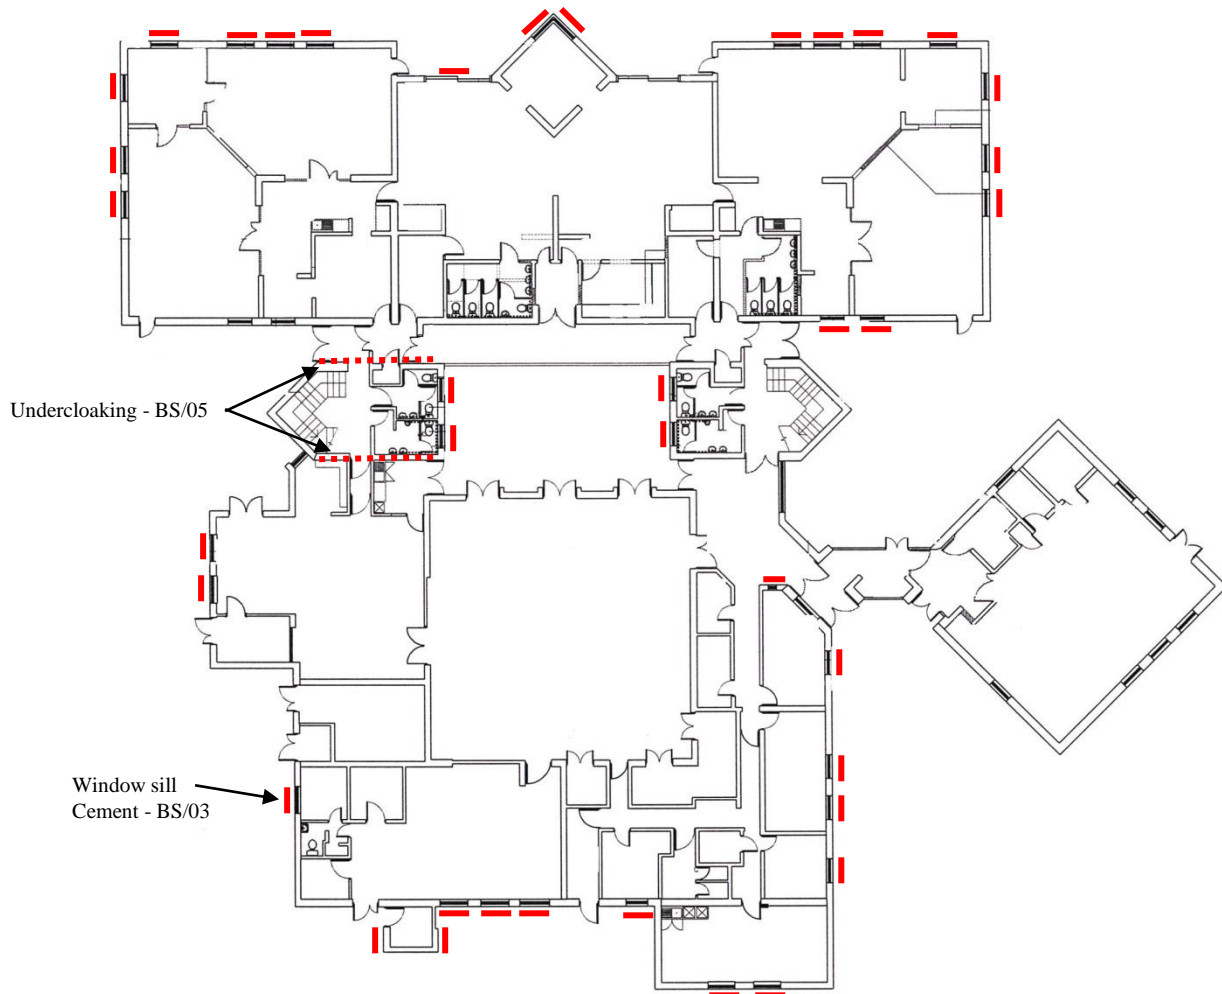
Exterior - Ground Floor

— Cement window sills - as BS/03

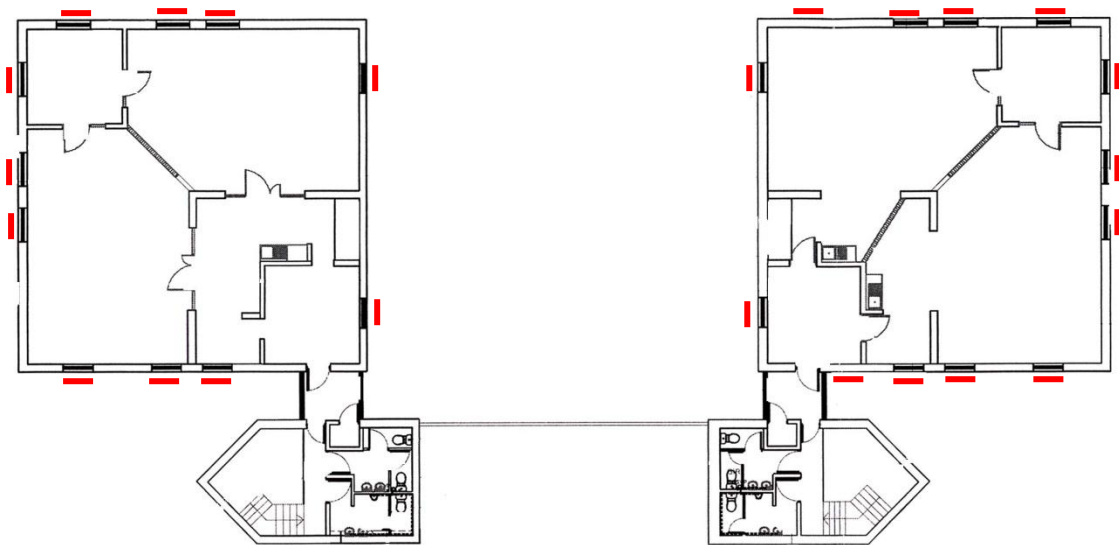
Exterior - First Floor

— Cement window sills - as BS/03
