BRE Client Report

Chalcots Estates, Camden

Prepared for: Astrid Kjellberg-Obst
Date: 8th June 2020
Report Number: P116025-1000 Issue: 6

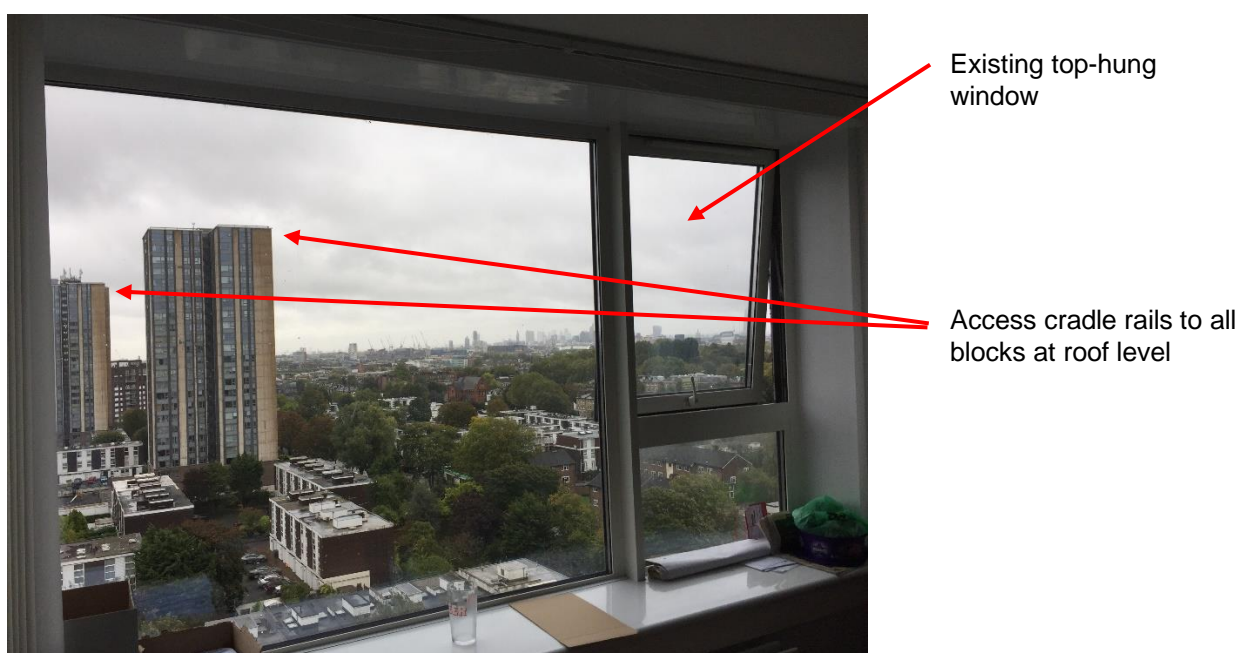
[1577] Window to living room, flat 85, Burnham block

- I.3 Camden explained that the top-hung windows were of the type that had previously detached. As a consequence, all windows to all blocks had been fitted externally with stainless steel cables to ensure any detachment would not result in units falling to the ground.
- I.4 Unlike the other rooms in the flat, the living room benefited from an additional window, however Camden stated that this was only the case for flats with external flank walls.

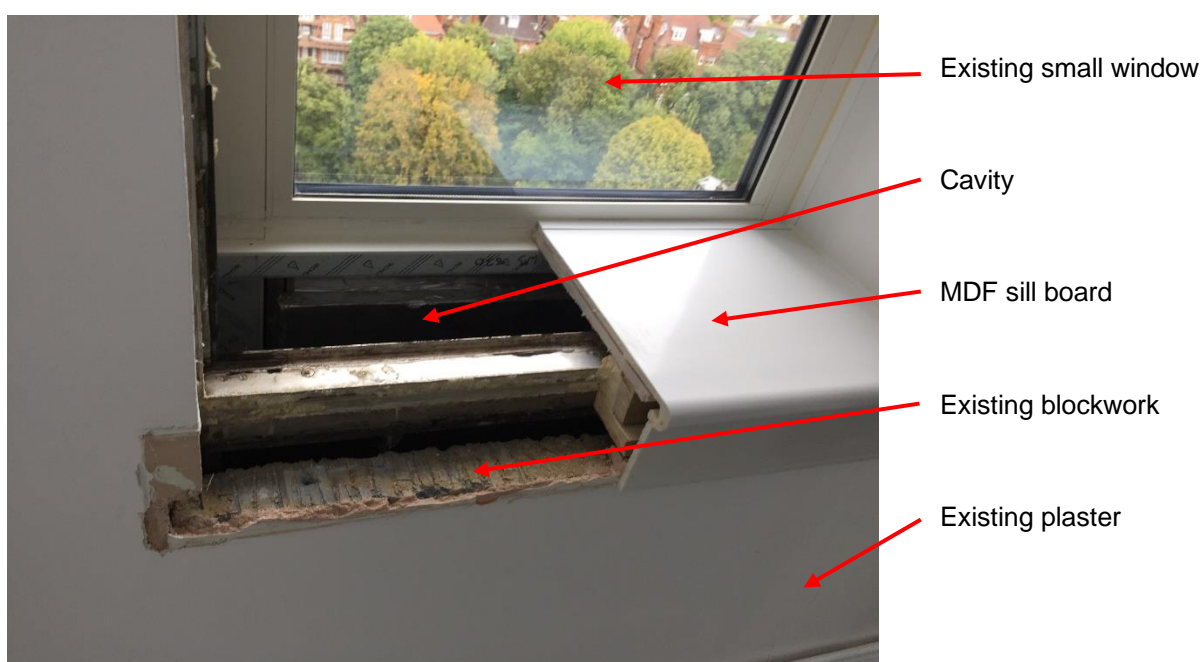
[1581] Flat 113, living room, small window.

- I.16 The smaller window of the living room was also partially finished for the purpose of inspection. This allowed the construction of the sill board, fire stopping and reveal construction to be examined.

- I.17 The construction followed the same principles as the large window.

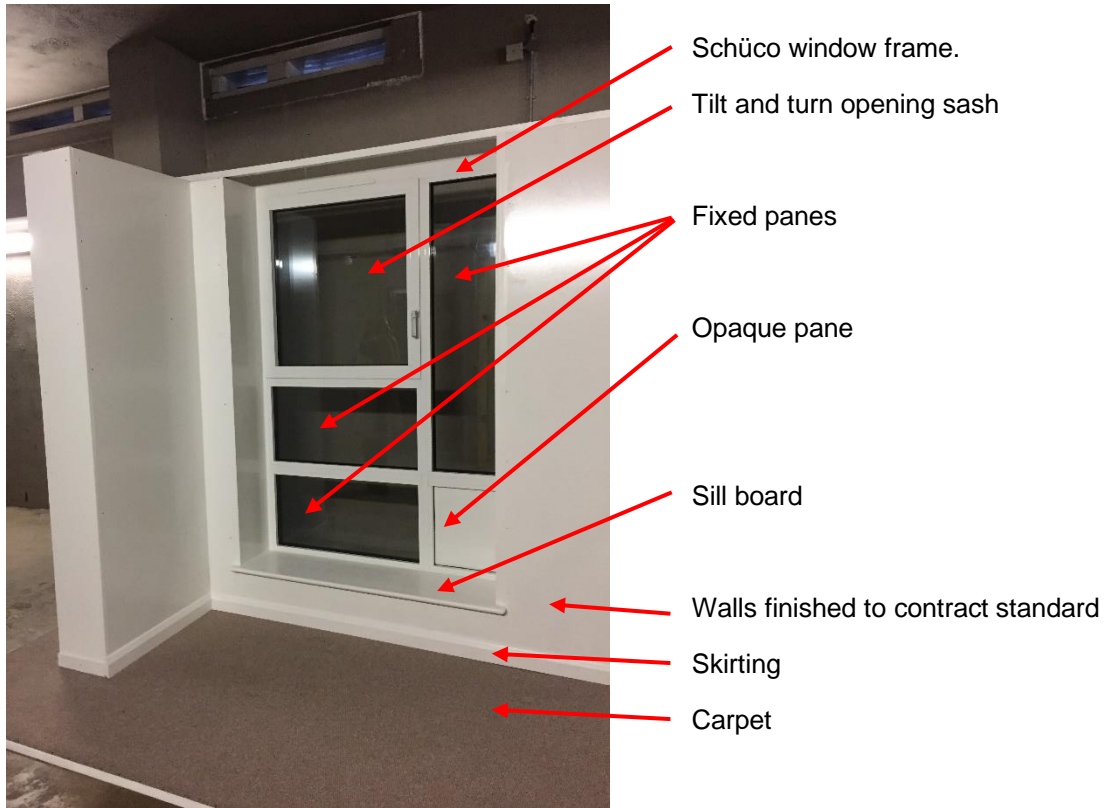
[1583] Sample large window in the basement of Burnham block.

- I.18 Subsequent to the visits to the flats, the team moved to the basement to examine constructed sample windows.
- I.19 The first sample to be examined was a large living room window. The sample was presented as a fully finished window set within the refurbished finishes, including painted walls, skirting and carpet.

- I.20 The external face of the window system, whilst complete, was not set in an arrangement which replicated the external façade, lacking, among other things, cladding materials and membranes. Drainage caps were present and were seen to be correctly created when viewed via the opening sash.

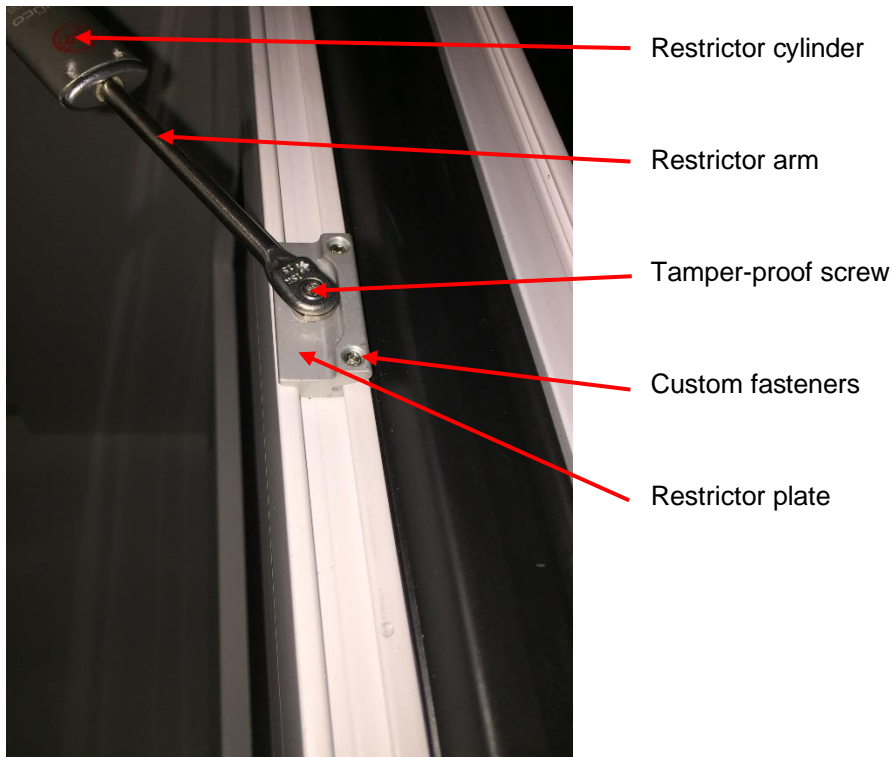
[1588] Restrictor arrangement

- I.23 In the 'turn' mode, the window is physically prevented from fully opening by a patented restrictor. The frame to sash dimension is approximately 390 mm at its widest point with an approximate dimension of 300 mm clear. In order to fully open the sash, the restrictor must be disabled with a special key/ tool, which we understand is to be supplied to the occupier. Please refer to the Frankham risk assessment sections within this BRE document for discussion on this subject.

- I.24 BRE dimensionally surveyed the window and then carried out a simple test by repeatedly pulling the sash away from the frame with the restrictor attached (turn mode). Whilst doing this, the restrictor plate (see above) exhibited considerable movement.
- I.25 We were not able to disengage the sash from the restrictor to examine the processes involved in cleaning the top left hand corner of the window when fully opened-in. The dimensions suggest that a chair or small step stool may be used by an occupier in order to reach this location.
- I.26 The small window sample was then examined and found to have been constructed in the same way as the large window sample, meaning that the internal finishes were complete (except for the ceiling) however the external finishes were incomplete.
- I.27 The small window is fitted as a 'tilt' only sash.

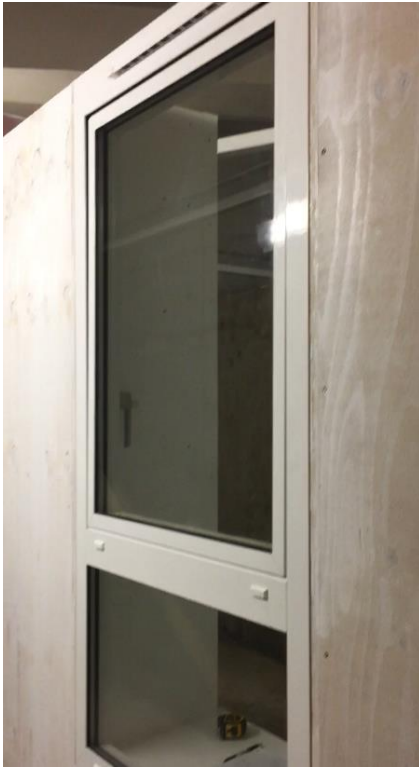
[IM1] External face of small window

- I.28 During the inspection of the small window sample, Camden stated that the tilt-only facility will not provide the correct amount of free air for purge ventilation and that discussions were being undertaken to develop an appropriate solution, including allowing the lower sash to open.
