Investigation into the accident on  
Cambridgeshire Guided Busway (near to  
Hills Road bridge) on 21<sup>st</sup> June 2017

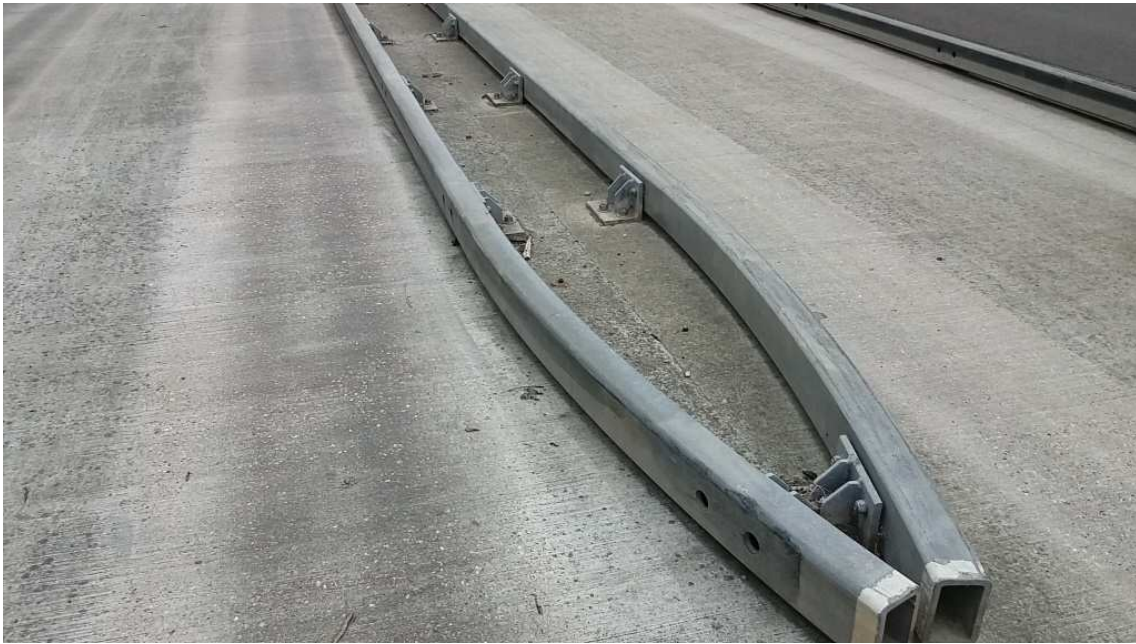
a: Right hand entry flare, showing evidence of tyre rubber deposit

- As a result of a misaligned entry into the guideway, the bus was deflected (first by the right hand flare and then by the left hand flare) into a trajectory which directed its travel across the guideway and adjacent maintenance track

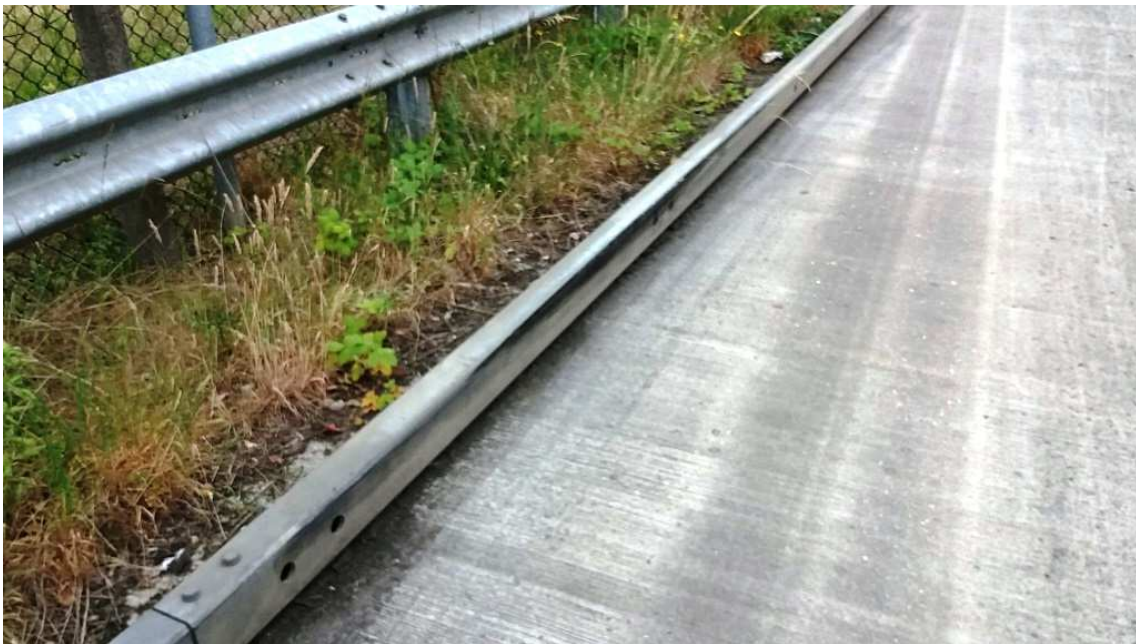
b: Left hand entry flare, showing evidence of tyre rubber deposits

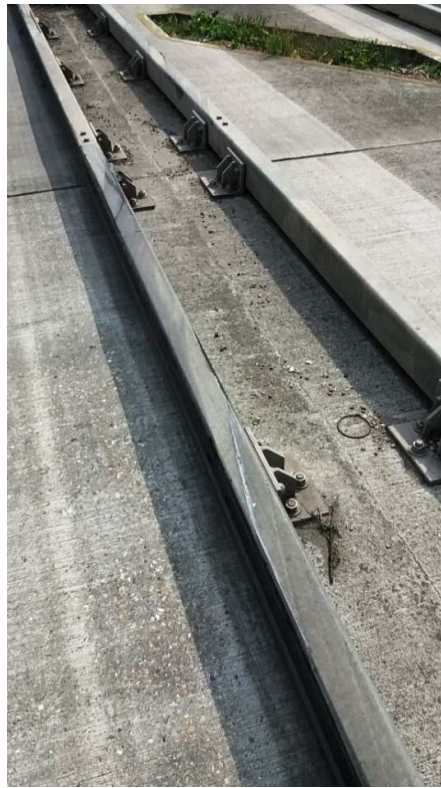
c: Right hand entry flare, showing evidence of damage further along from entry point

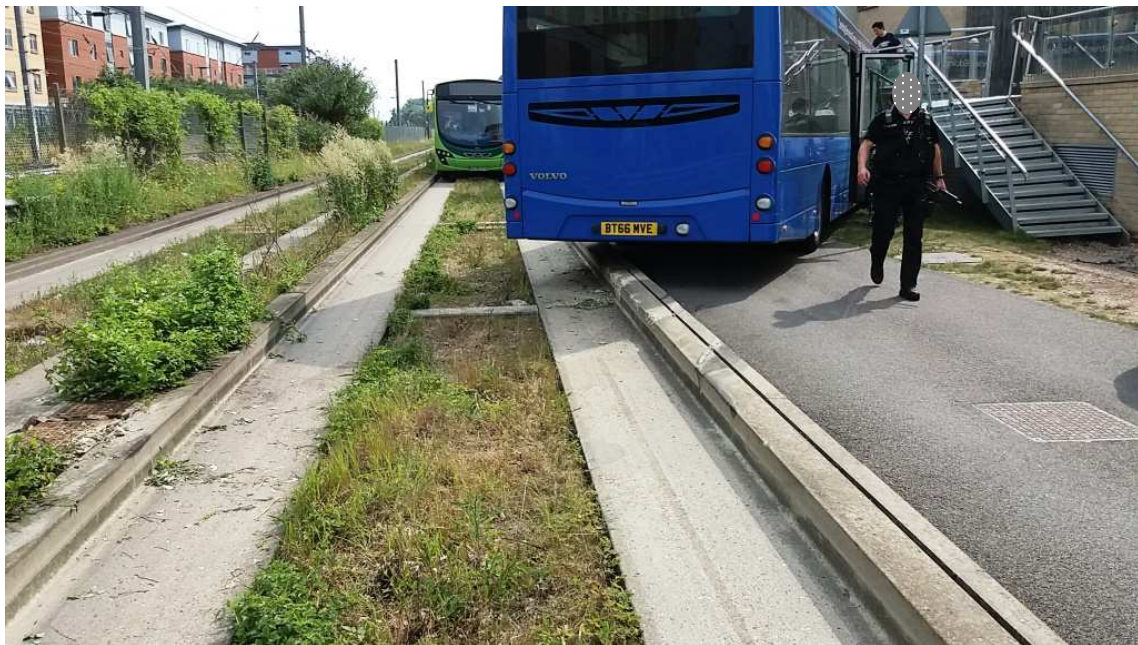
d: Final position of bus in relation to guideway and maintenance track
