<u>Feasibility Report For Borough wide</u> Boiler House refurbishments 2014/2015:

Connant House Heron House Helen Gladstone House Albert Wescott House Stanwood Gardens King Charles Court Lew Evans House

Date Ref 24th January 2014 K140023/001/KA/G06 Rev A

Description of Building and Services- CONANT HOUSE

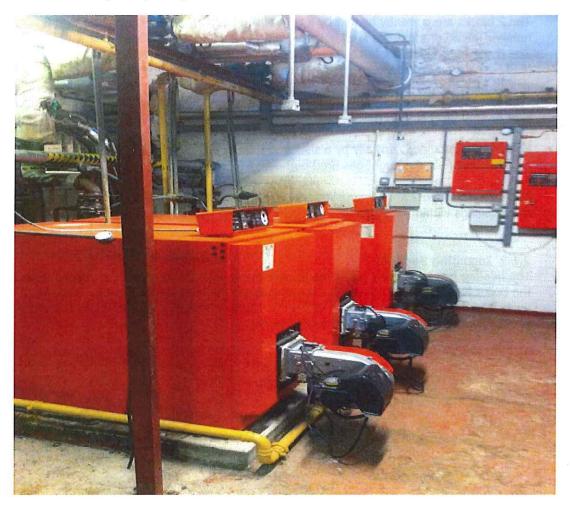
Boilers

Heating system is comprised of 3No. strebel E300 boilers each with a nominal heating output of 290.1kW, and each coupled onto an Ecoflam burner with 70kw min & 350kw maximum heating output. These are configured in series to supply compensated LTHW to all the dwellings for the purpose of space heating only. The boilers and the gas burners are in a good working condition and seem to have been installed not long ago. This will not require replacing within the scheme.

The boilers and the burners are in good condition and will not require replacement. In their present condition the boilers together with the burners should be capable of delivering at least 5 years of service under good maintenance regime. The individual flue ductwork serving the boilers should be renewed, re-installed/repaired to correct the defects that are visible on all the joints /connecting sections of the flue duct.

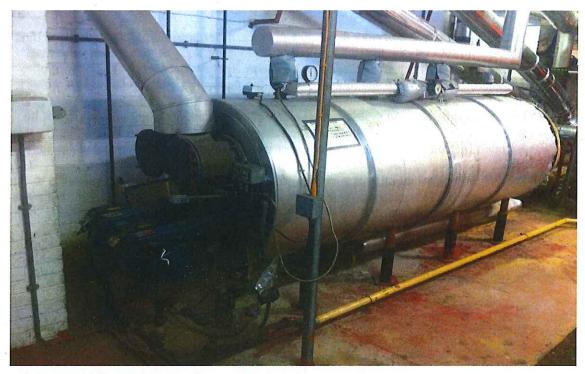
Beaumont bulk storage water heater

The unit is estimated to have been in operation for over 20 years and is in a very bad state. The lagging to the unit are loosened up and coming off, the controls for the unit seem obsolete so as the other ancillary parts/units aiding the operation of the water heater. The steel housing/shell based on local evidence is expected to be rusty and corroded. The water heater can be classed as an inefficient, end of life unit which will require urgent replacement

It is recommended that a new indirect calorifier be installed, with LTHW fed from the existing boilers, for the provision of hot water to all the dwellings within the two blocks.

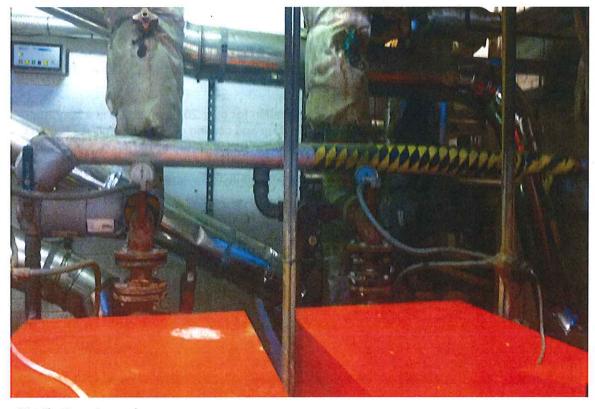
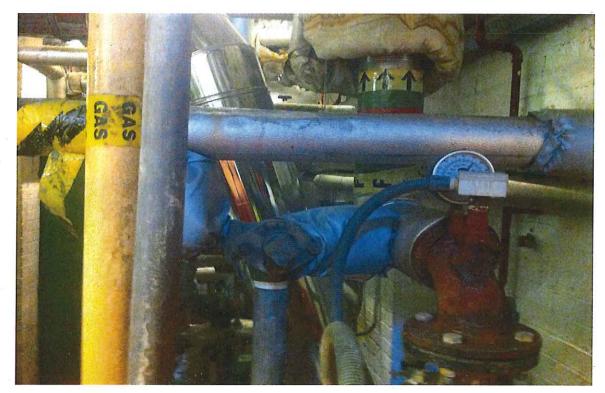
Distribution pipework

Generally, the entire pipework & valves within the boiler house, apart from sections that have been replaced due the replacement of failed items such as pumps and valves will require replacement due to its age and condition. There is overwhelming evidence of corrosion; rusting, & leakage, and the age of the pipework together with valves, make it susceptible to failure.

It will be necessary for the entire pipework and pumps, together with all associated distribution ancillary units be stripped out and replaced with new. This work should be carried out in conjunction with the removal of all remnant asbestos containing materials within the boiler house

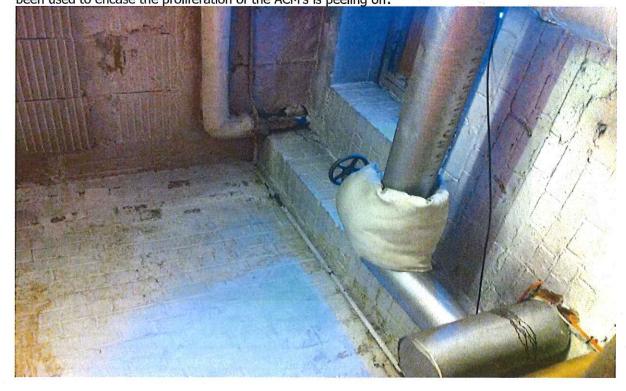
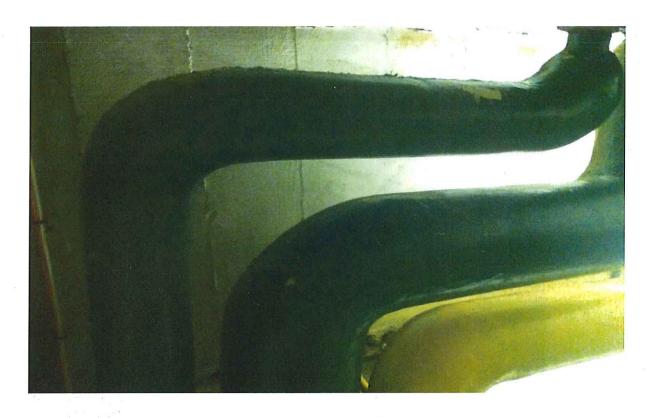
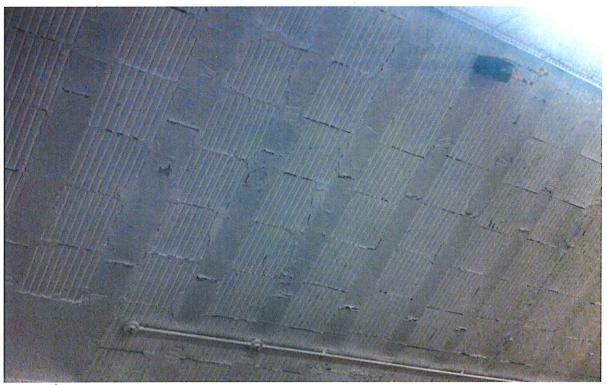
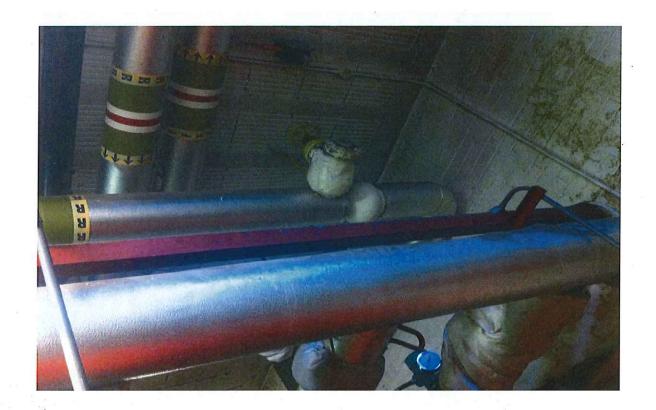
The lagging of the pipework in many parts, are of material suspected to be asbestos. The slabs that form part of the floor above the boiler house are also suspected to have been incorporated with asbestos containing materials (ACM'S). The paint which to have been used to encase the proliferation of the ACM's is peeling off.

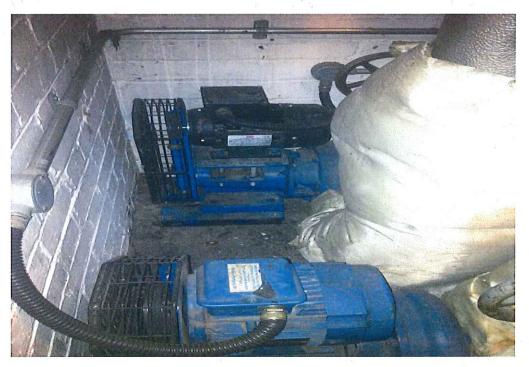
There are two belt-driven 'Pullen' pumps on each block's heating zone (Duty and Standby), for each of which an inverter (1 inverter per pump pair) has been installed. This is an unusual set-up and defeats the effect of the inverter on the operation of the pump. The entire pump set will require replacing due to its age condition and efficiency.

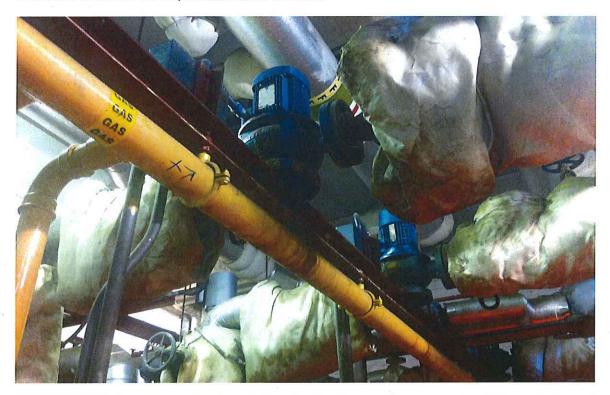
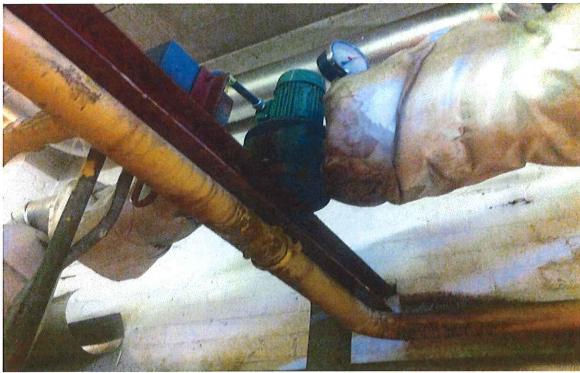
The boilers shunt pumps (3 No.) situated at high level on steel beam shows a lot of signs of leakage and corrosion, though they seem to have been replaced since the original installation. The lagging around the pipework within close proximity to the shunt pumps is in a bad state and will require immediate attention.

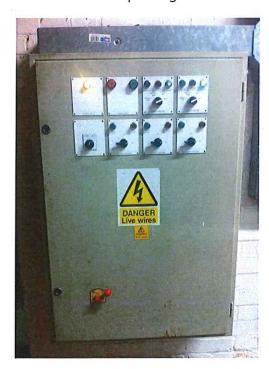
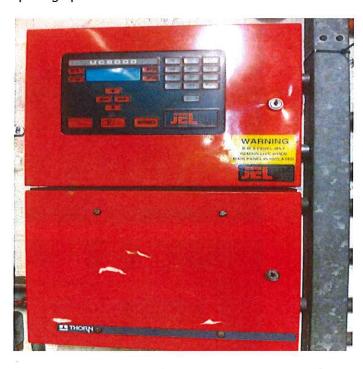
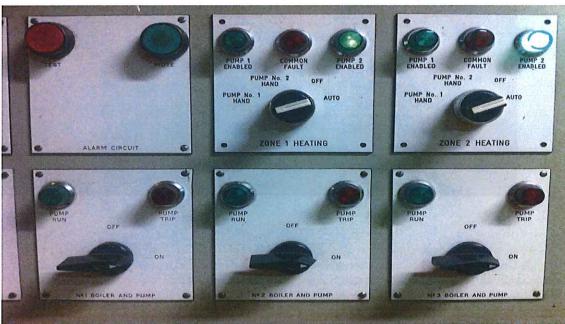
The controls would require replacing due to its age and condition. There were indicated faults displayed on the panel at the time of the site visit and could have been as result of a fault(s) on any of the control chain. This was a very common observation within all the boiler houses that were surveyed with this typical controller installed. There were also a few dead indicator panel lights as seen on the photograph.

The age and condition of the panel and of the Thorn JEL UC800 controller will require that they be renewed. This will allow for the other proposals to fall in line with the entire control strategy, for the provision of heating and hot water.

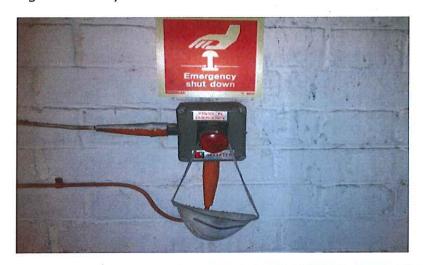
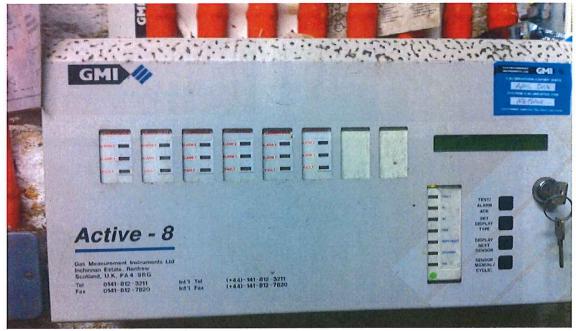
Gas safety within the boiler house is governed by a wall mounted emergency gas push button and a solenoid valve on the incoming mains. There is also installed, a GMI Active - 8 gas monitoring/measuring device which shuts off gas supply to the boiler house at the detection of gas escape. Fuse-able thermal links are also in place above the boilers. The operational status of these could not be verified. It will be recommended for renewal together with any associated works to be undertaken within the boiler house.

The boiler house gas safety arrangement should be upgraded as part of the improvement works within the boiler house. The existing system does not incorporate a fire alarm isolation provision and is proposed to be installed as part of the works A mention has already been made of the need to correct the defects on the boiler flues.

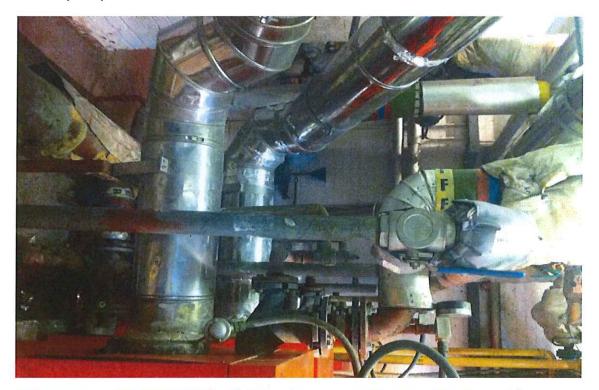
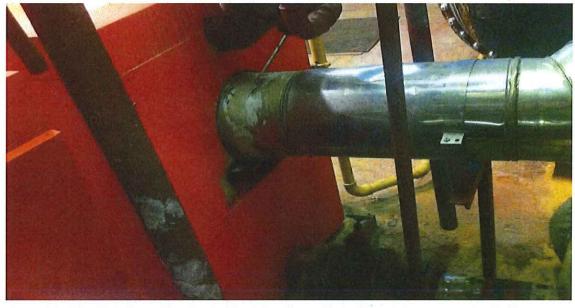
The fabric of the flue does not appear to be in a bad state, but all the seals (aluminium joining ring straps and aluminium foil faced sealants) are in a very bad state and require urgent replacement. The flue ducts have been connected to the boilers with cement sealant all of which appears cracked with parts fallen off, creating a potential avenue for the escape of products of combustion.

It is recommended that the existing boilers & burners be left as installed. The 3 no. dedicated flue ducts serving these boilers should be renewed with the consideration of a common flue duct header to link the 3 boilers.

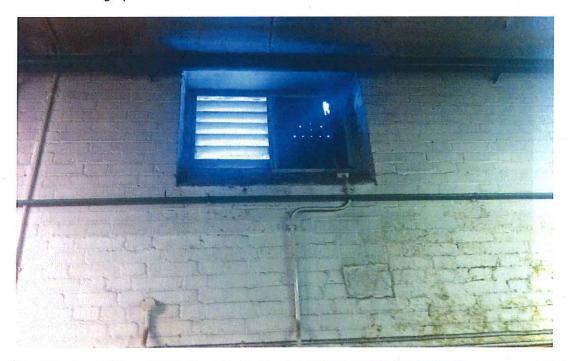
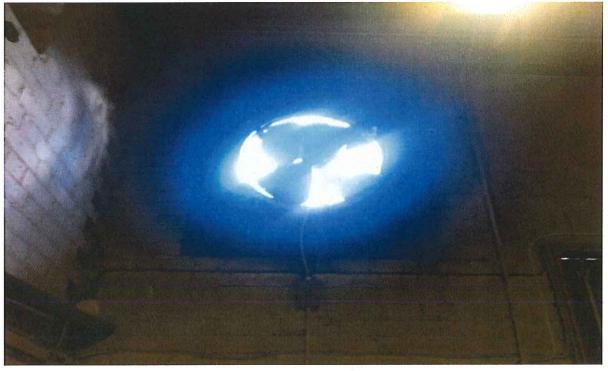
The boiler house ventilation has not been fully assessed at this stage, but there were some very concerning observations made about ventilation provisions which were; (a) the boarding up of ventilation grilles and (b) the non-operation of the fresh air intake fan which does not seem to be interlocked with the operation the gas fired units within the boiler house. At the time of the survey, the fan was not operational yet all the gas fired units were firing up.

The ventilation provision within the boiler house shall require upgrading to cater for the combustion & operational temperature requirements of all boiler house units. At present, the ventilation fan does not work in synchrony with the gas fired units within the boiler house. Every mechanically aided ventilation provision shall be interlocked with the supply of gas into the boiler house.
