Our Ref:
2469-L001-IJ-021211.doc

02 December 2011

Sidmouth Drill Hall: Pre-Demolition Inspection

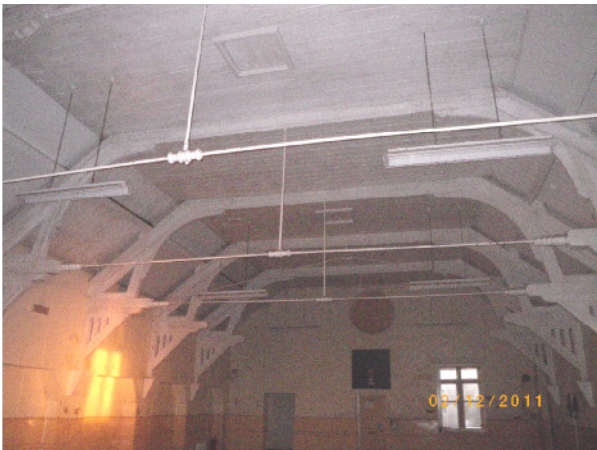
1

The main part of the building is an open assembly hall at ground floor level, which has external brick walls supporting a series of timber roof trusses (photos 1-3). The trusses are slightly unusual in that they have hammer-beam style ends and raised collar ties, but also have a horizontal steel tie bar, supported at midspan by a central vertical steel hanger rod. There is a timber boarded ceiling at collar beam level, with hatches to gain access to the triangular roof space above the ceiling. (These were inaccessible at the time of the inspection as scaffolding or a tower would be necessary.) The main pitched roof is slated.

In particular, it is unlikely that it will be practicable to lift off the main timber roof trusses in one piece, and they will need to be cut into manageable sections, using temporary scaffolding as propping. The ends of the trusses are carried directly on the external walls, and will be providing lateral support to these. Thus, removal of the trusses will potentially destabilise the side walls and the temporary propping system will need to take account of this until the walls can be safely brought down.

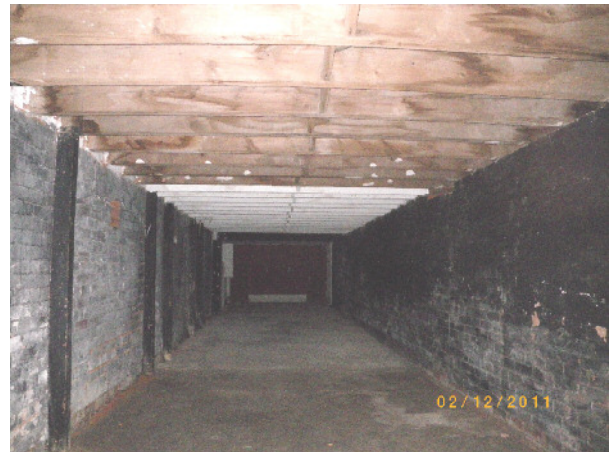
18

The ground floor of the main Hall, which is directly above the basement, has timber floorboards on timber joists. The joists span transversely between the external walls and an internal brick spine wall (photo 18), and a steel beam running from front to rear which is supported on concrete padstones on top of brick columns (photo 19). The basement wall next to the Sailing Club is formed of a series of elliptical arches between buttresses (photo 20).

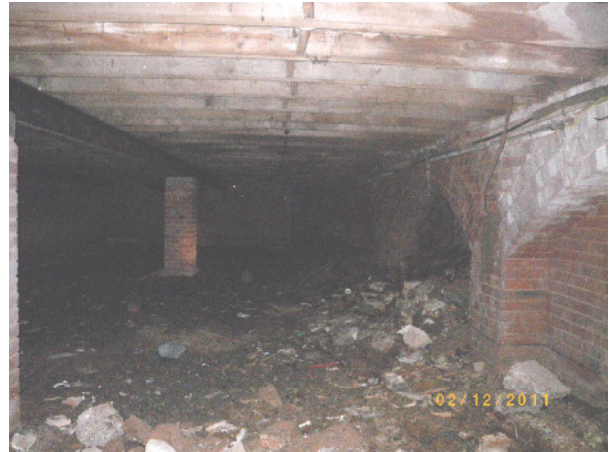
20

It is not possible to be certain of the structural action of the basement wall which forms the retaining wall alongside the Sailing Club. Whilst it is possible that the basement wall is structurally adequate as an independent retaining wall in its own right, it may - either intentionally or over time - be that the existing timber floor in the Hall is providing propping restraint at ground floor level. The vertical loads from the masonry superstructure and the roof above will certainly be providing additional assistance. In order to ensure stability of the retaining wall, it will therefore be prudent for infill material to be placed against the basement wall before the ground floor is removed in its entirety. The basement void immediately adjacent to the Sailing Club should therefore be progressively infilled to at least half its height, in advance of removal of the adjoining section of ground floor.
