Scheduled Monument Quinquennial Condition Assessment Surveys

**RM Sandhurst Training Area,
Berkshire**

July 2021

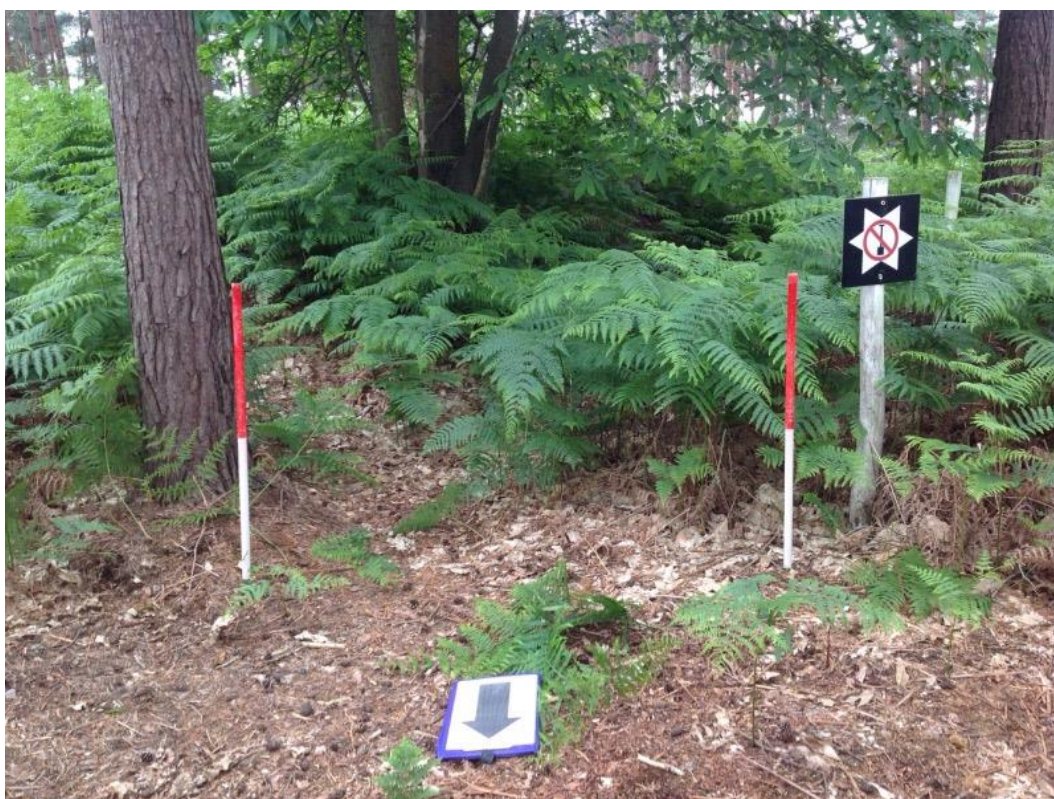
The redoubt is marked by a palisade of white posts and 'no digging' signs which are in good condition (Figure 1). The redoubt sits in an area of mixed woodland containing large trees and an undergrowth of thick bracken. Some of the trees growing on the redoubt had been felled, with the trunks left on the ground. A mountain bike track runs approximately 10m to the east of the redoubt.

The redoubt is very heavily overgrown with bracken which almost entirely obscures the view of the earthworks from outside (Figure 1). The interior of the monument is similarly covered in bracken, with dead vegetation covering the floor (Figure 2). It is recommended that bracken is cleared from the monument in the medium term to prevent the monument and its signage from being completely obscured from view, which could increase the risk of accidental damage. A large tree was also recorded growing within the earthworks of the monument. Removal of the tree is not recommended as this has the potential to cause further damage to the monument. However, its condition should be monitored and potentially felled if there is a risk of it collapsing onto the monument and causing damage.

Figure 1 - View looking south at monument showing 'no digging' sign, palisade post, bracken growth and trees

Overall, the monument is considered to be in fair condition and in gradual decline. This is primarily as a result of the large amount of bracken growth of the monument. The monument was also considered during the 2016 survey to be in fair condition and in gradual decline, showing no change in its condition. The clearance of bracken from the monument would do much to improve this and restore the monument to a more stable condition.

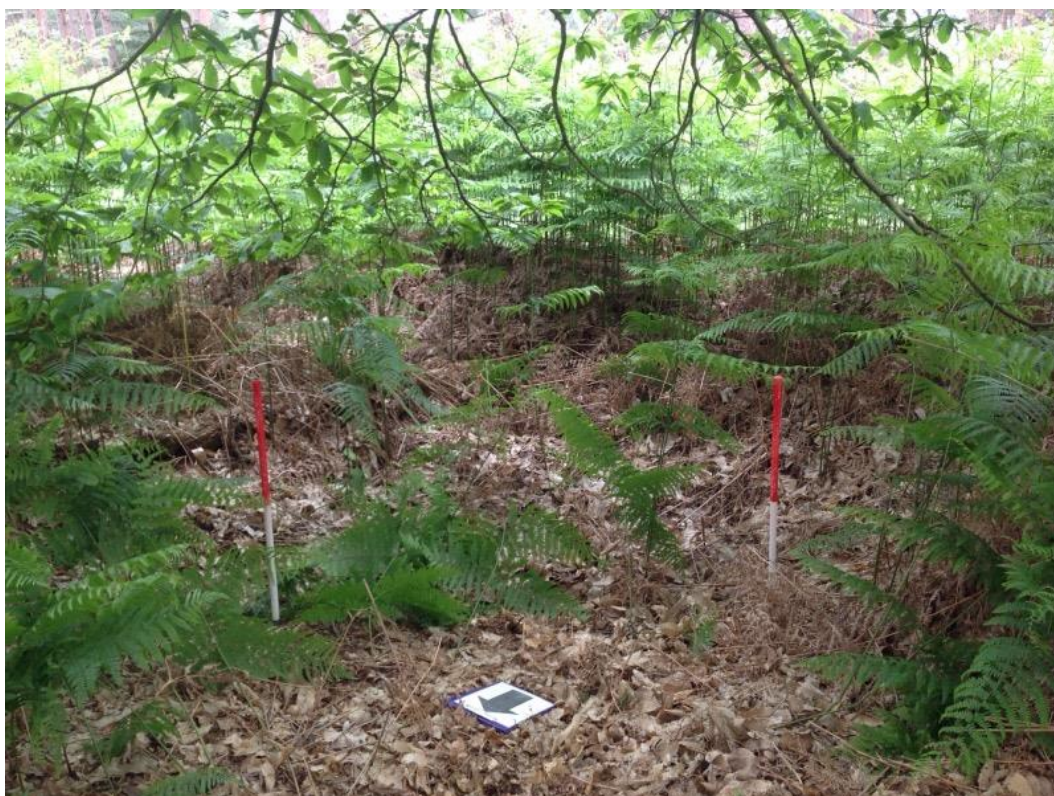
Figure 2 - View of interior of redoubt

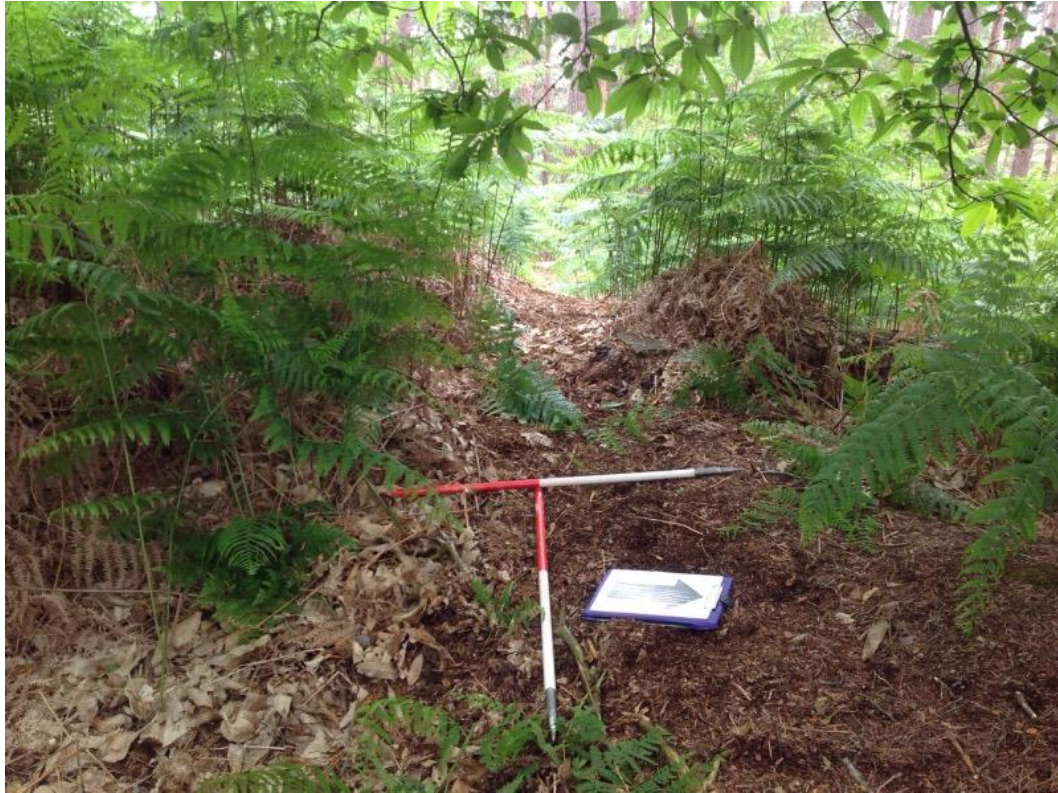
The west and north corners of the redoubt appear to be used as a track, potentially by animals such as deer (Figure 3). There is some risk that clearing bracken may increase the risk of the earthworks being damaged by mountain bikes, as a track runs close to the redoubt. This should be monitored and appropriate steps taken if such an event occurs, such as marking monument with additional signage identifying it as a Scheduled Monument.

Figure 3 - Potential animal track on the west corner of the redoubt

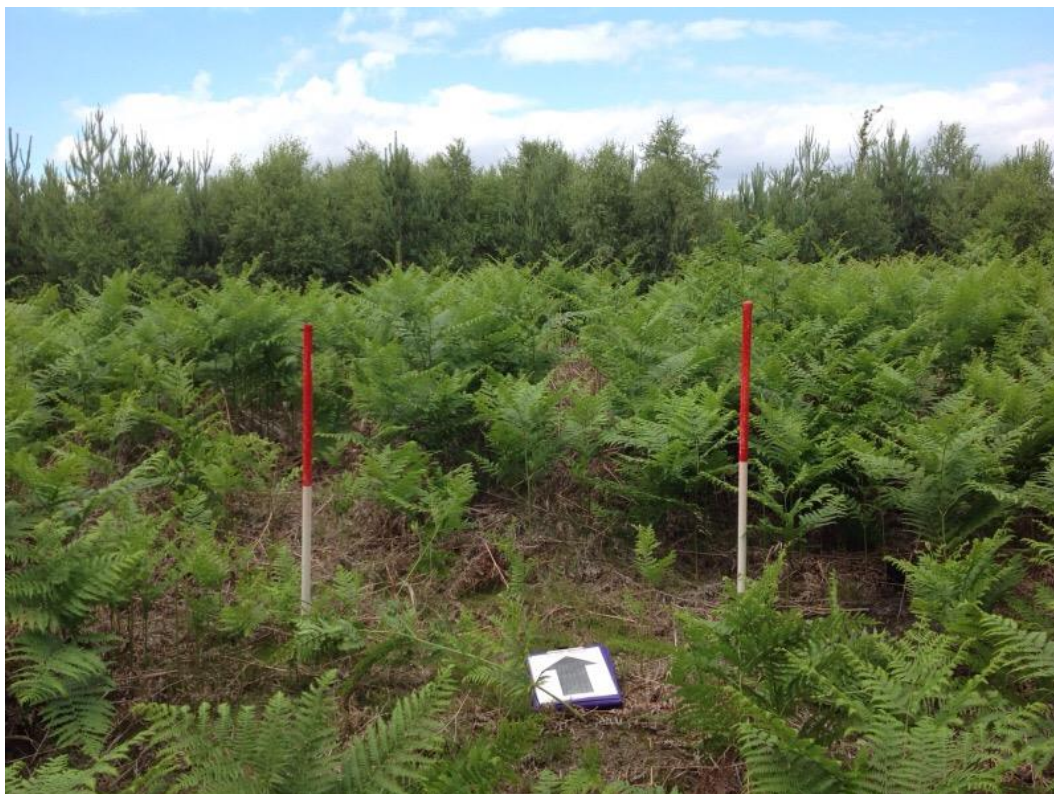
The mound is almost entirely covered in bracken (Figure 4), which is in contrast to the mixed coniferous and deciduous woodland surrounding it. The surrounding woodland almost entirely obscures the monument from wider views. Some tree sapling have started to take root atop the monument, though only in small numbers. It is recommended that bracken and trees are cleared from the monument in the medium term, to prevent it from being obscured from view which could result in accidental damage to the mound.

Overall, the monument is considered to be in fair condition and in gradual decline. The monument was previously considered to be in good condition and stable. The reduction in quality and stability is primarily as a result of the large amount of bracken growth on the

monument, and the growth of trees. As with the practice redoubts discussed previously, if vegetation is cleared then the monument could return to a more stable condition.

Figure 4 - View looking north showing bracken growth and trees in background

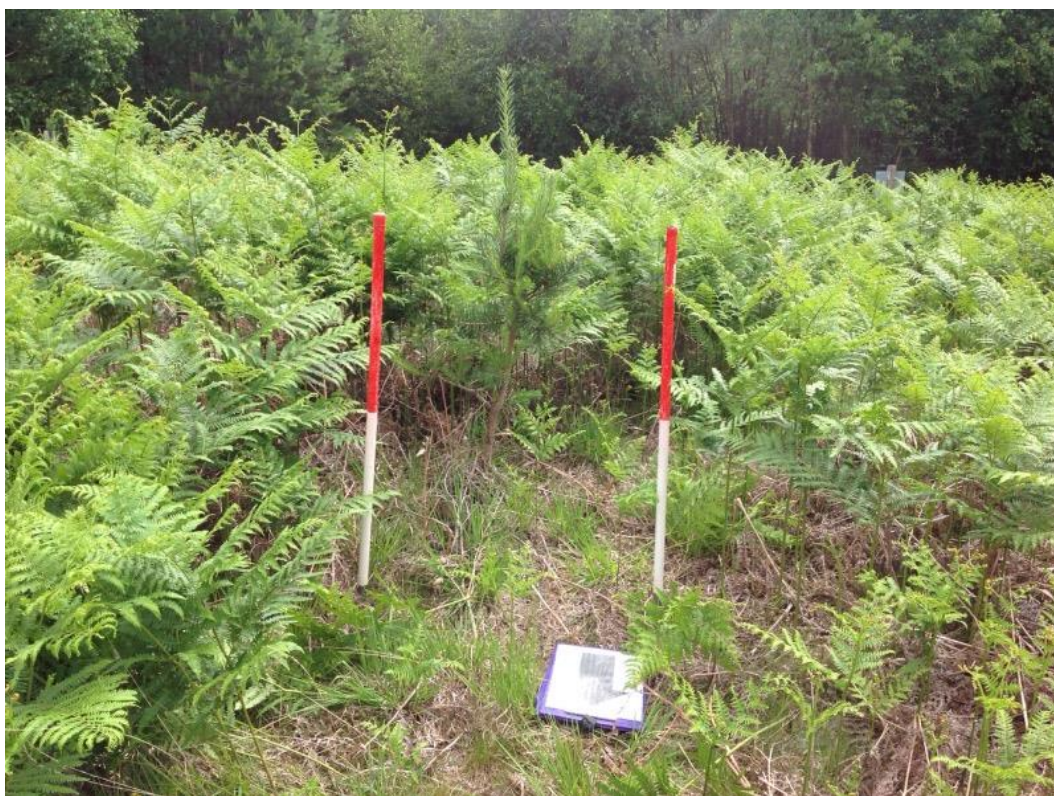
Figure 5- Tree sapling on top of mound

Windmill Stem mound (1017818) was found to be in fair condition and in gradual decline, due to being heavily overgrown by bracken. Tree sapling [REDACTED] noted growing atop of the mound. The monument was previously assessed as being in good condition and stable, due to having been cleared of bracken. It is recommended that bracken and trees are cleared from the monument.
