Scheduled Monument Quinquennial Condition Assessment Surveys

Aldershot Training Area, Hampshire

July 2021

Landmarc Support Services Ltd

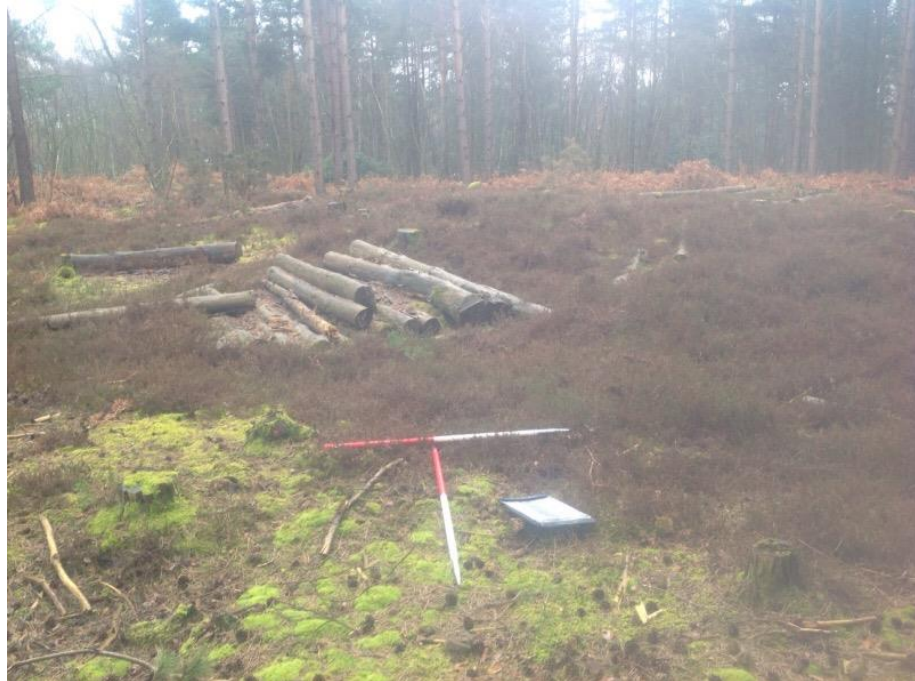
in the use of felled tree trunks laid over the barrow to discourage mountain bikers from riding over the barrows. These tree trunks are still in place over the monument and were interpreted as damage in this survey (Photograph 1). No evidence of mountain bike use was present within the vicinity of the barrows; it is suggested here that moving the logs to surround the barrows would, perhaps, be a better protection measure than laying them over the barrow mounds. There is also evidence of scrub encroachment on both barrows, in the form of bracken (Photograph 2). This scrub does appear to have increased since the previous survey of 2016.

Photograph 1- Logs lying on barrow mound

Logs are currently being used to deflect mountain bikers off two barrows at Heath Brow, it is recommended that these are moved to surround the barrow rather than being placed on the mound itself where they can damage the monument.

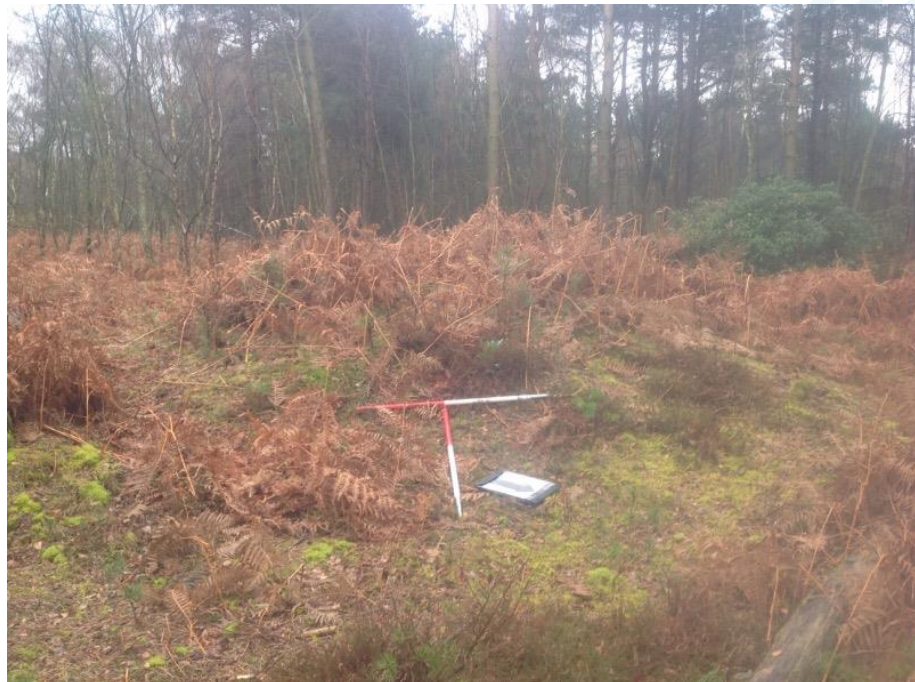
Photograph 2- Bracken growing on first area of protection

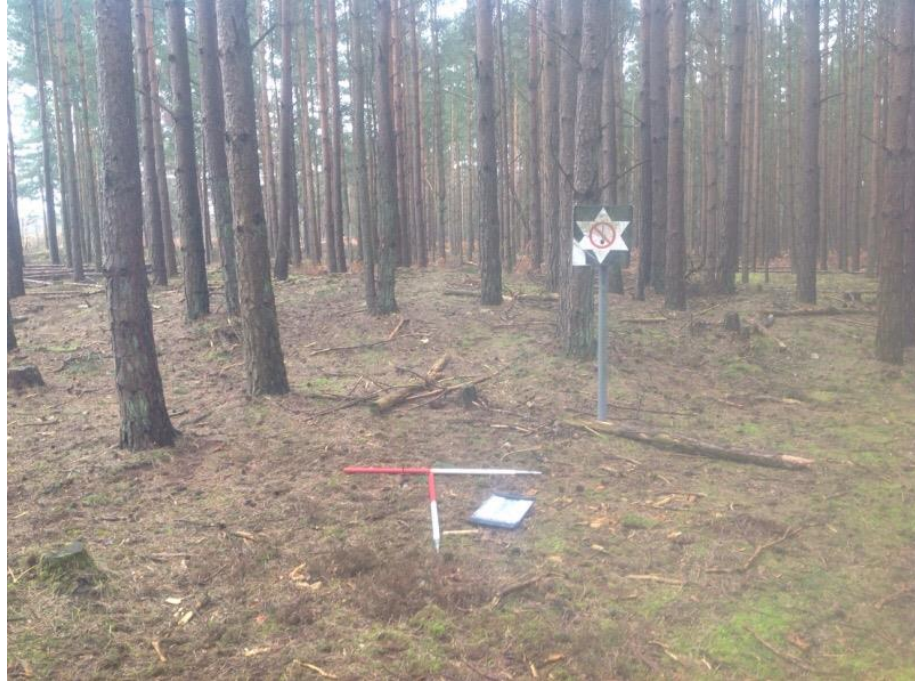
The second area of protection includes a single bowl barrow of approximately 15m in diameter and 0.6m in height (Photograph 3). The single barrow is within the woodland and has large conifers growing on the mound. These trees appeared to be in good condition and not at risk of wind damage or falling at the time of survey. Their clearance in the long term should be considered if the risk of damage increases.

Photograph 3- Single bowl barrow in second area of protection

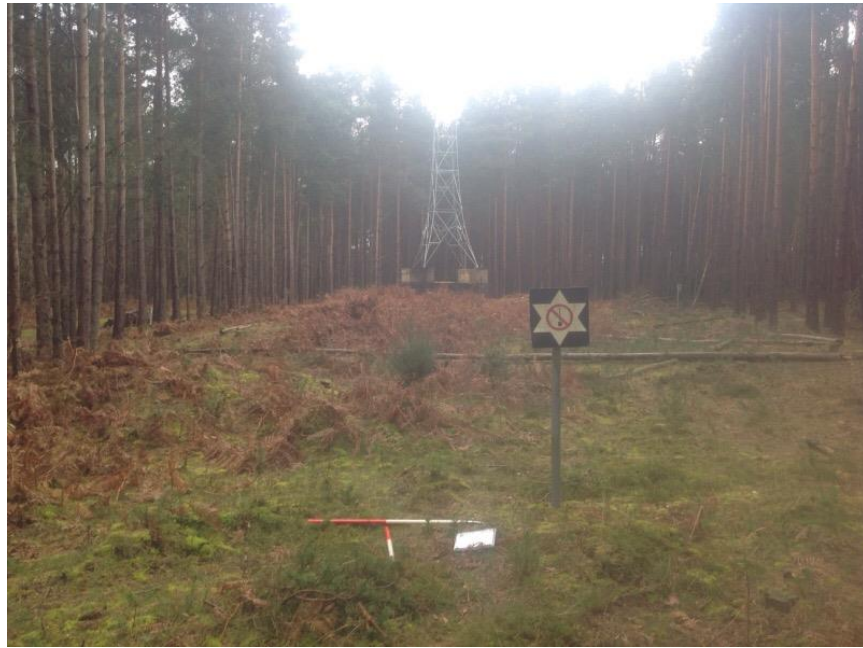
The most prominent of the two alignments is four closely spaced bowl barrows (Photograph 4), extending north-south for approximately 44m, parallel to the B3013 (Beaconhill Road) which lies 40m to the west. These barrows constitute the third area of protection. The northernmost barrow of this group is the largest and includes a circular mound, 17m in diameter and 1m in height. The remaining three barrows include circular mounds, ranging from 6.5m to 10m in diameter and 0.7m to 1m in height.

Photograph 4- Third area of protection showing four barrows and mast in background

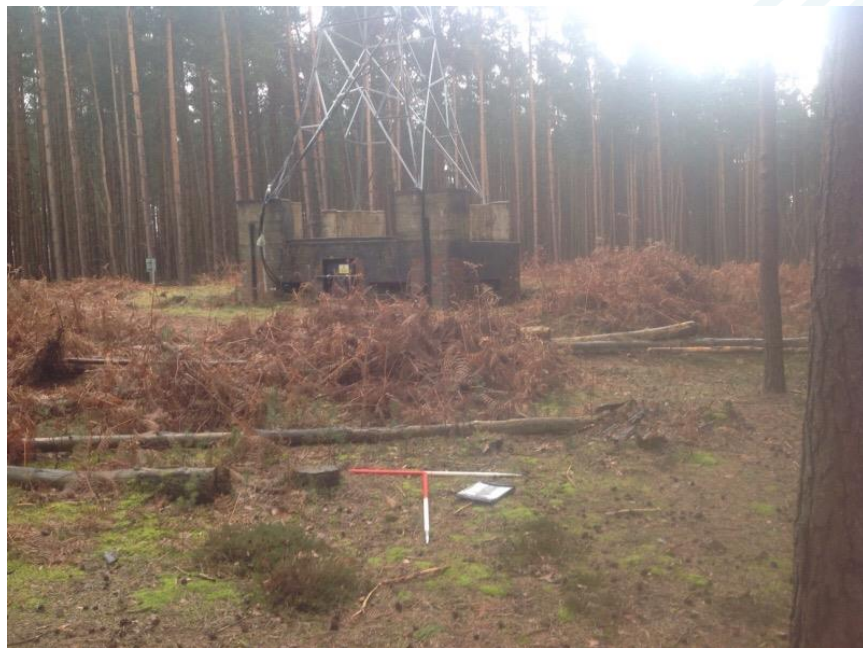
The northernmost barrow has a WWII pillbox constructed in a pit sunk 1.2m into the centre of the mound (Photograph 5). The pit was excavated to, roughly, the original ground surface and the spoil was spread around the sides of the mound, widening the diameter of the barrow by approximately 2m. The pillbox is a pentagonal brick and concrete structure with a steel door on the north side. A concrete drain projects down the south slope of the barrow mound. The pillbox is included within the Scheduled Monument; however, a radio mast erected on top of the pillbox is excluded from the Scheduling. The pillbox on the northern barrow remains in good condition and does not appear to be further affecting the stability of the barrow beneath.

Photograph 5- WWII pillbox on northern barrow

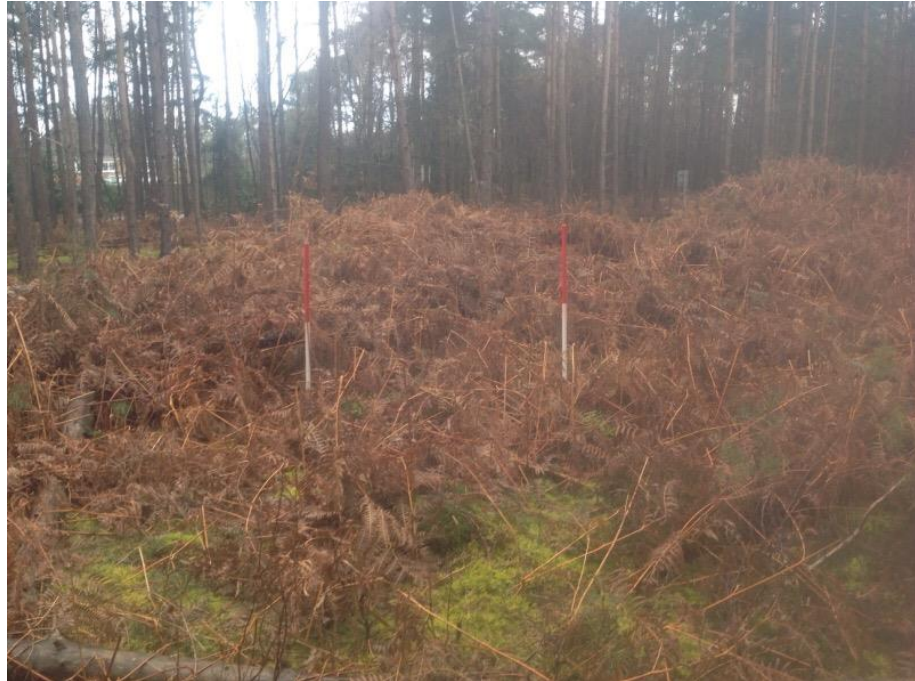
Photograph 6- Scrub encroachment on southern barrows of group of four

All four of these barrows currently show signs of scrub encroachment, though it is most significant on the southern three barrows (Photograph 6). This scrub, in the form of bracken, now almost entirely obscures the three barrows from view and, also, likely provides cover for burrowing animals; though no holes could be seen through the dense vegetation.

Overall, the monument was found to be in Fair condition and in Gradual Decline. This is the same result as in the previous survey in 2016. The amount of scrub encroachment appears to have increased since the previous survey, though smaller saplings mentioned in the report have been managed well over time. The scrub largely refers to bracken which requires more control in the summer months. As with the previous survey, the third area of protection, constituting four barrows, should be a priority for clearance as this area is most obscured by scrub.

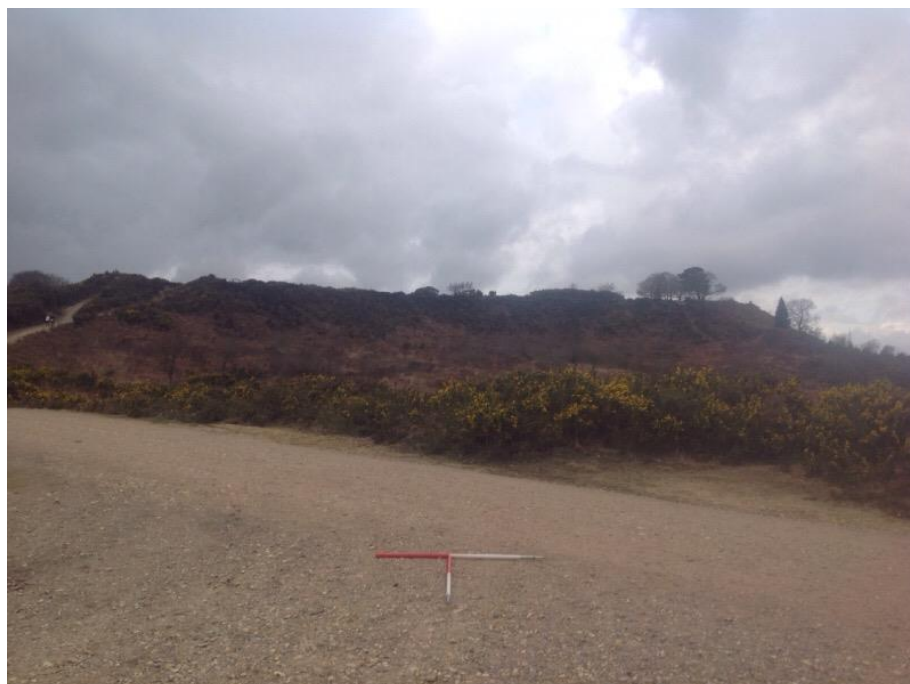
The monument includes a large multivallate hillfort of Iron Age date situated on an irregular promontory in an elevated location (Photograph 7). In the 11th century, the hillfort formed part of the Farnham estate of the Bishop of Winchester and by the 13th century, the area was part of one of three parks attached to Farnham Castle. The majority of the monument is heathland in character. However, the southern part of the fort, south of the track which runs from the south-west rampart to the eastern corner, is in mixed woodland cover. The monument is within a publicly accessible area and is heavily used by walkers, cyclists and runners.

Photograph 7- Overview of hillfort from the east

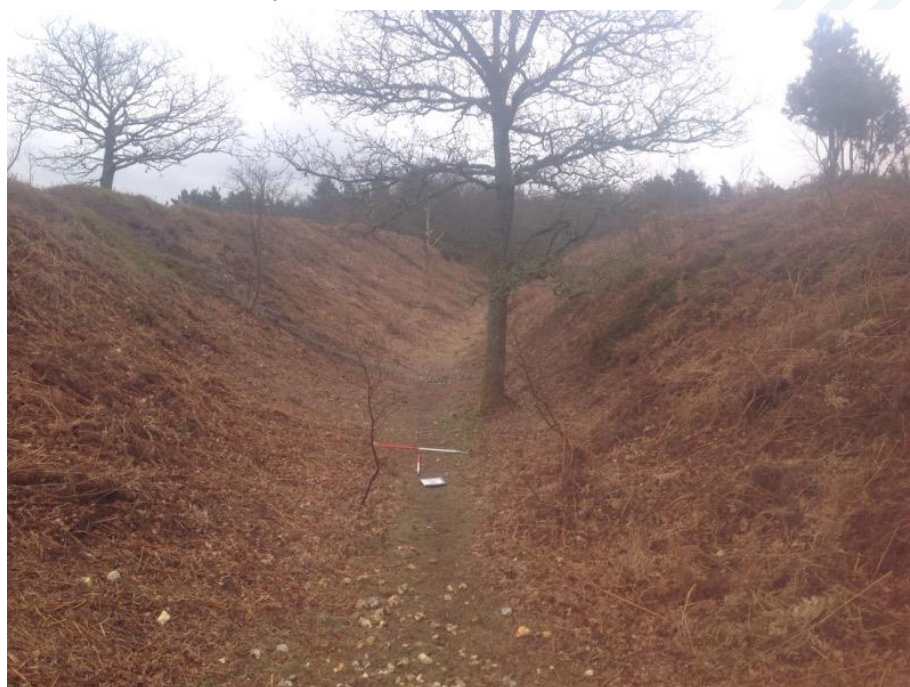
On the south and south-eastern side there is a double rampart (Photograph 8). The inner bank measures up to 10m wide and 3m high. The ditch between the inner and outer bank is up to 5m wide and 2m deep. The second bank is 2m high and 6m wide, and the final outer ditch is up to 1m deep. The south corner of the hillfort has three ramparts and traces of a counterscarp bank continuing around to the south-western side of the defences where it crosses the plateau. The defences are at their most pronounced where they cross the plateau. In 1970, a small trench was cut on the western side of the camp. Excavations demonstrated four phases of construction for the defences and that the outer bank and ditch represented a later development of the site from a univallate to a multivallate hillfort.

Photograph 8- Ramparts on south-east side

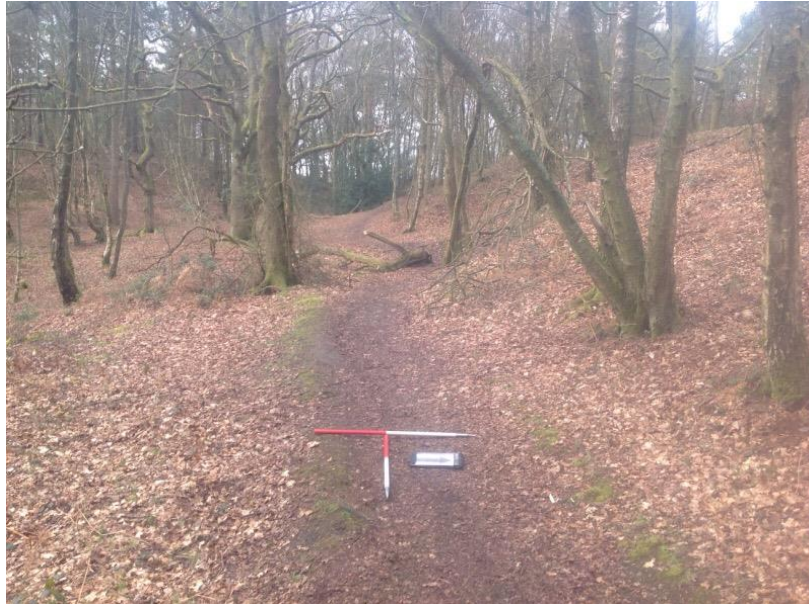
Photograph 9- Tracks created by mountain bikes in southern wooded area

A number of tracks and access points are spread across the scheduled area and are heavily used by both the public (on foot and bicycle) and maintenance vehicles. The widest of these tracks runs east to west across the scheduled area and in a loop around the west, north and north-east sides; it is well sealed and in good condition. Further tracks have been created by public users of the site. Whilst these are largely in good condition in the northern portion of the monument, many of the smaller tracks in the southern wooded area are now becoming more eroded by mountain bike use on the site (Photograph 9).

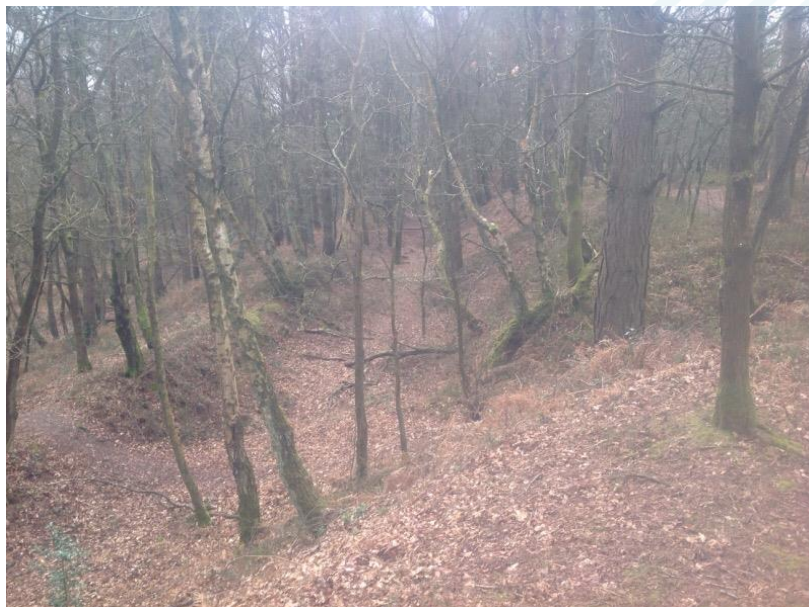
Photograph 10- Older and fallen trees on ramparts in woodland

The woodland itself is largely in good condition and shows signs of being managed well. In the long term, it will be necessary to monitor the older trees on the ramparts for signs of wind damage as they could cause damage if they fall (Photograph 10).

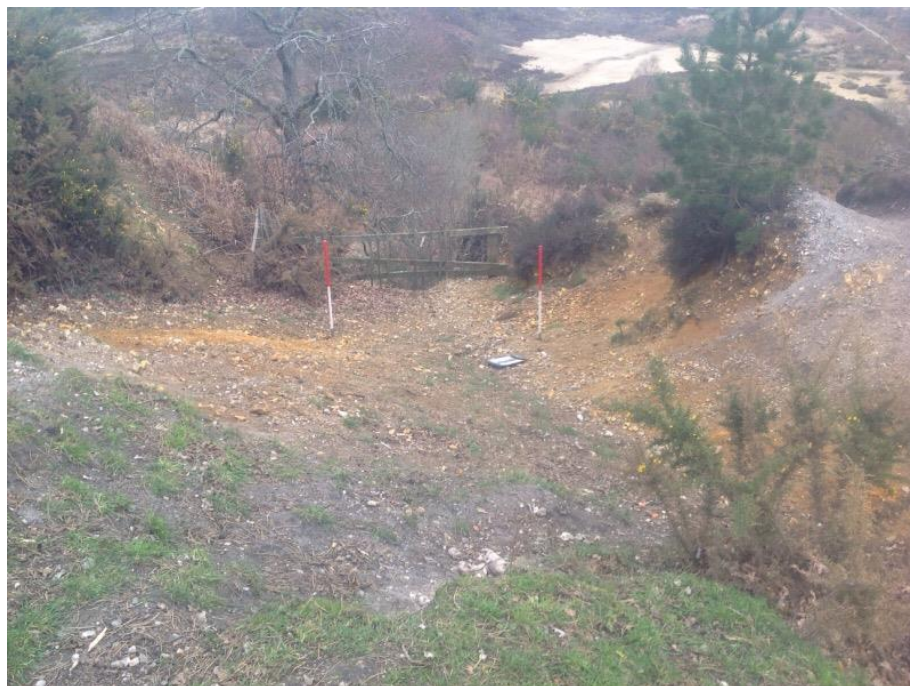
Photograph 11- Area of landslide on north-east side

The northern portion of the monument is much more open than the southern wooded section and is largely covered with gorse and areas of open grass. To the north-east, a small section of the scarp has suffered from landslide in the past and has been blocked with a wooden fence. This area now appears to be stable and grass is regrowing in places (Photograph 11).

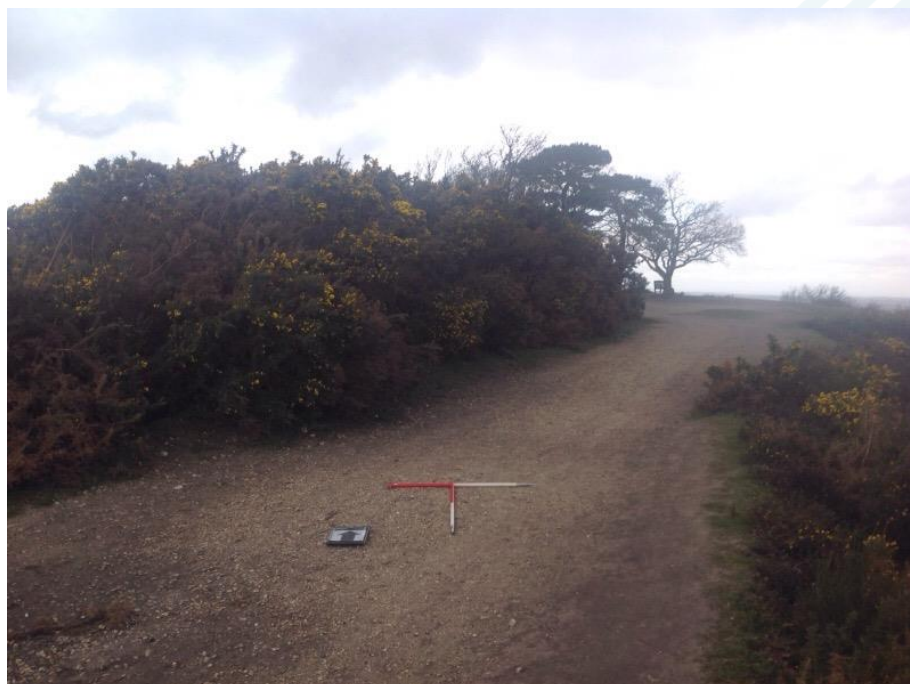
Photograph 12- Tall gorse to the east

The gorse covering large areas of the site is managed by a programme of vegetation management across the site; there was evidence of recently cleared areas at the time of survey. Whilst some of this gorse is becoming tall (Photograph 12), it is largely restricted to the central, flat area of the hillfort rather than covering the ramparts, so is less of an issue. This was a suggestion of the previous survey: to concentrate efforts to manage the vegetation on the areas of the hillfort which are more prominent, such as the ramparts, to make better use of resources. The strategy appears to have been largely successful.

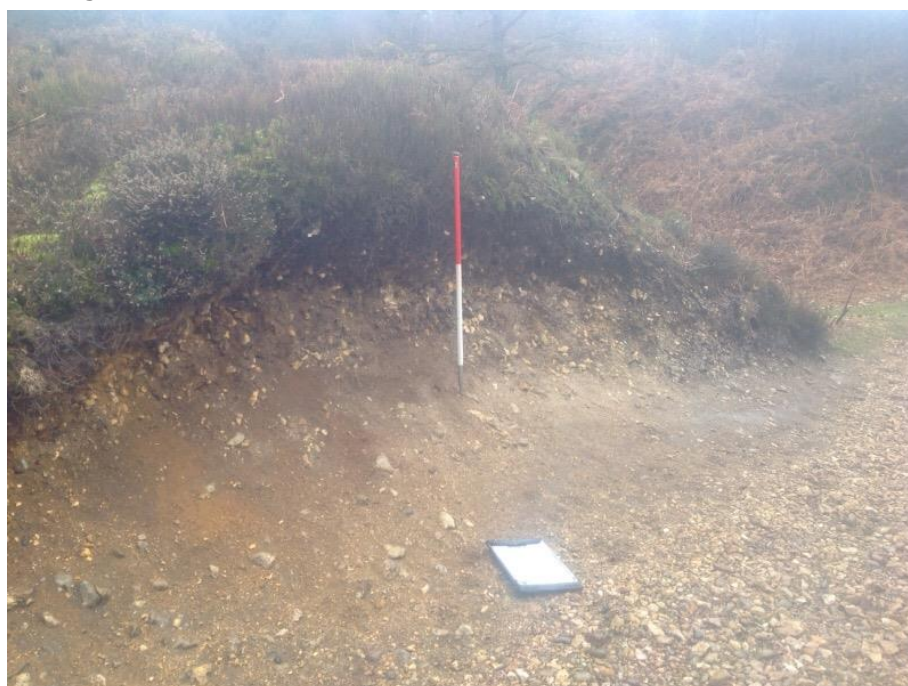
Photograph 13- Extensive erosion of ramparts to the west

Additionally, in this western area, there is further evidence of erosion by walkers and cyclists accessing the site. Some of the paths running through the ramparts have become heavily eroded and have worn away large sections of the ramparts, exposing bare earth, and increasing the likelihood of further erosion by water action (Photograph 13). This erosion, and other such areas in the south-east area where site users access the monument, should be targeted for repairs. This will likely require consent from Historic England and consultation should be sought prior to any works on the Scheduled Monument. Once repaired, the ground should be seeded with grass species in keeping with those currently on site to stabilise the bare ground.

Erosion by walkers and, more importantly, mountain bikers, appears to have worsened since the previous survey and accounts for the biggest threat to the ongoing stability of the monument. This erosion has become quite deep in places and should be targeted for repairs and reseeded followed by installation of signage to notify users of the sites importance and suggestions to stick to formal paths.

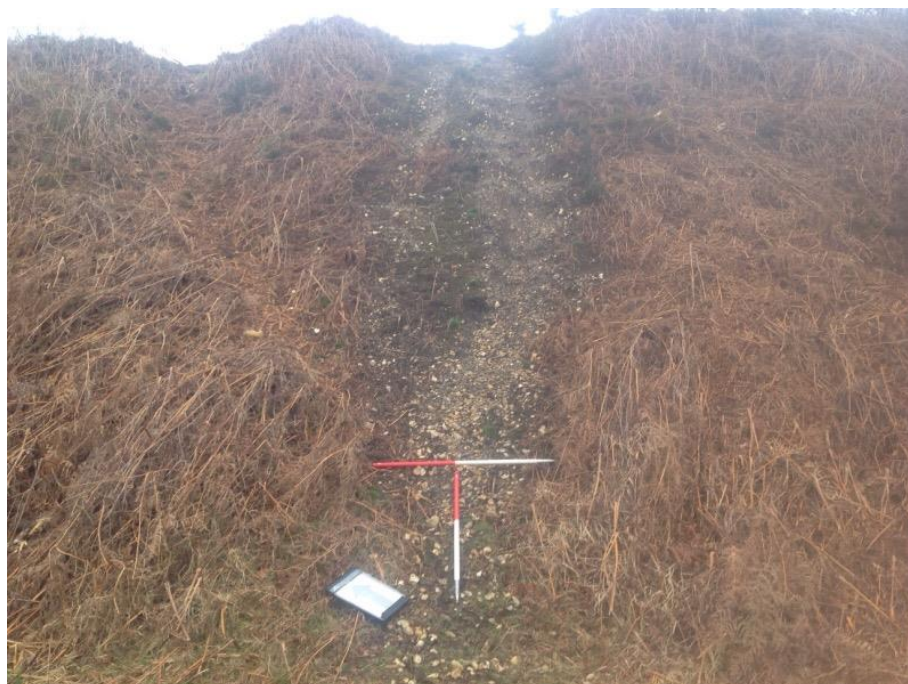
Photograph 14- Bike tracks over ramparts

Other tracks which do not follow the main walking routes appear to have been created by mountain bikers (Photograph 14). These tracks should also be repaired and reseeded to prevent further erosion.
