## Structural Engineer's Feedback Report

**Property Address:** 148 City Rd, Bristol, City of Bristol BS2 8YG

**Date of Inspection:** 09 December 2015

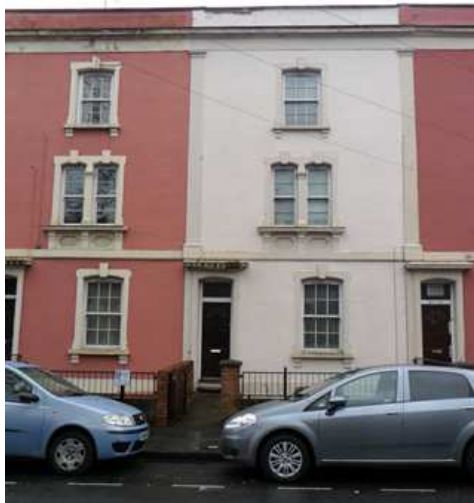
Photo: 1 Existing Front Elevation

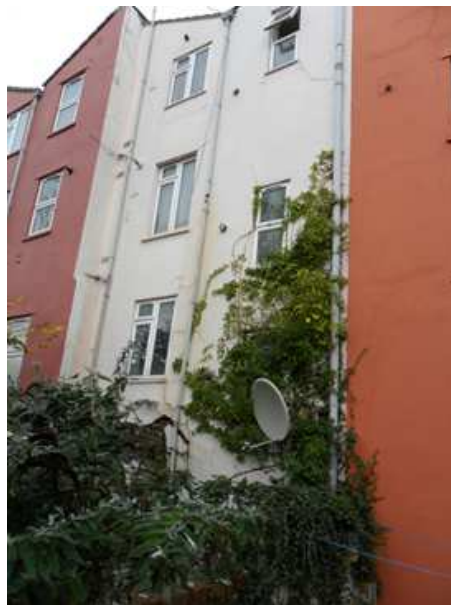
Photo: 2 Existing Rear Elevation

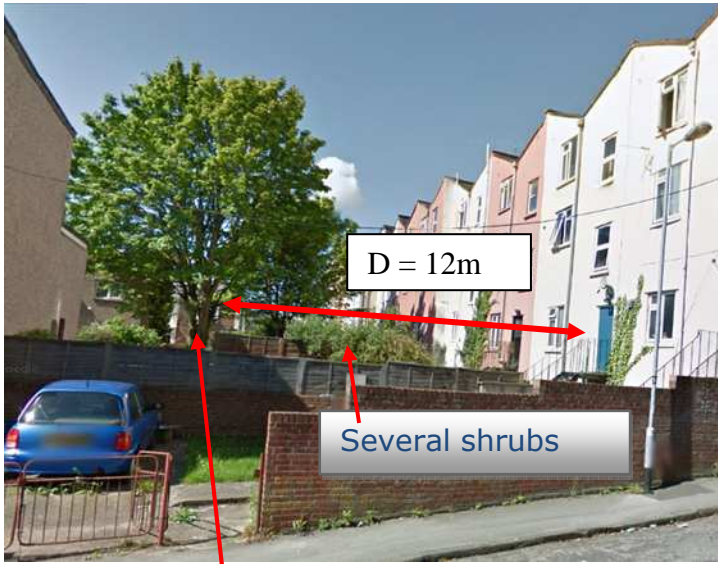
Photo: 4

Tree from the adjacent garden near the boundary line approx. 12m from the wall

See sketch. Tree roots can be troublesome in cohesive (clay) soils because they can induce volumetric change. They are rarely troublesome in non-cohesive soils (sand and gravels etc.) other than when they enter drains, in which case collapse and blockages can ensue. Both old and young trees are tolerant of quite heavy pruning and crown thinning. Broadleaf trees typically have wider spreading roots and higher water demands than coniferous species and many are better adapted to growing on heavy clay soils. Some are capable of sprouting from cut stumps or bare wood and most will tolerate pruning better than conifers. However heavy pruning of any tree should be avoided if possible, as it stimulates the formation of dense masses of weakly attached new branches which can become dangerous if not re-cut periodically to keep their weight down.

which are very close to the wall and the tree approximately 12m from the rear elevation wall. Because this tree has not reach maturity we would recommend that its growth is managed to ensure it does not affecting the integrity of the building in the future. This need to be communicated to the adjoining property owner working together to minimised the future impact of the tree roots to the property.

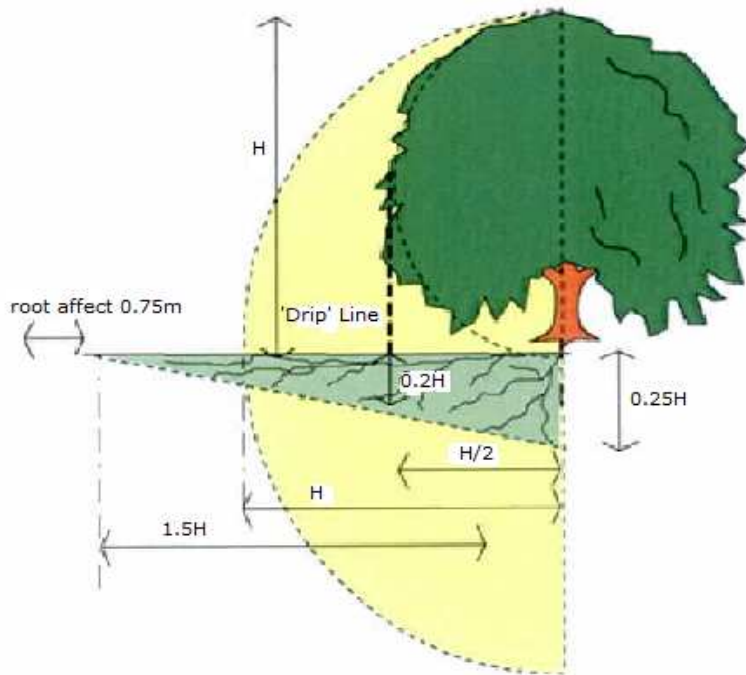
A visual examination of the South-East elevation shows signs of the tree and several shrubs

We believe that the `zone of influence of the shrubs removed from the front garden and the existing shrubs and the tree near the rear garden has caused failure within the foundation edges as the root system could have been encroaching on the drains. The movement could be a combination of the tree root encroaching in the drains causing blockages and cracks to the joints allowing water from the drains to discharge directly in to the base of the wall and soften the ground beneath the wall. Or the tree roots could have extended beneath the house’s foundations inducing volumetric changes. We refer you to our later comments in this regard in the main wall section in this report.

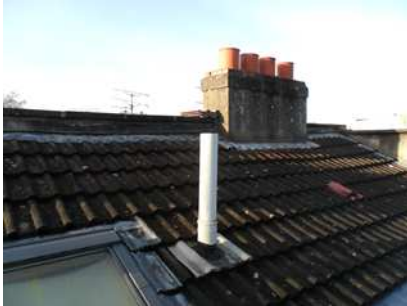
Photo: 5 Roof with Velux window

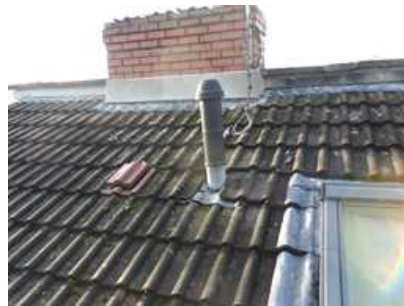
Photo: 6 Roof with new chimneystack

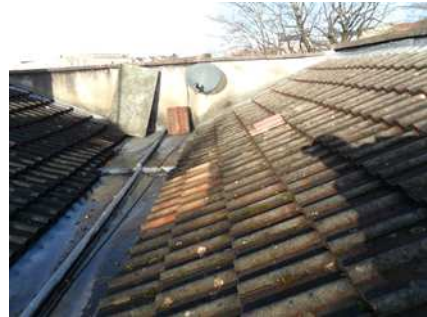
Photo: 7 Roof with Valley

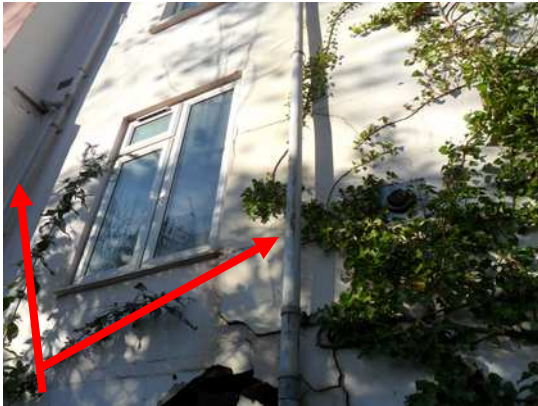
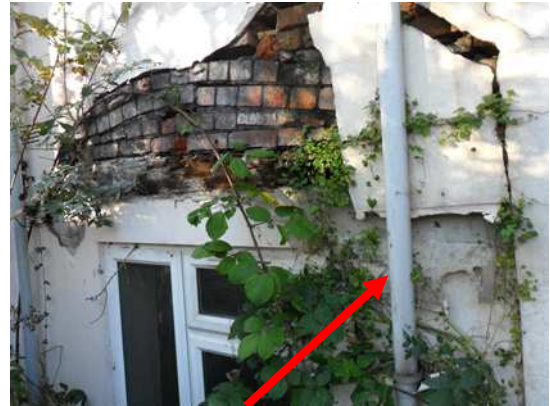
We notice the slabs holding the gullies directly below the rear elevation down pipes appear to be subsiding. We believe the water could be discharging directly to the ground rather than into the gullies. We refer you to our later comments in this regard in the drainage section in this report.

Photo: 8 Rainwater downpipe to the rear elevation Photo: 9 Rainwater downpipe to the rear elevation

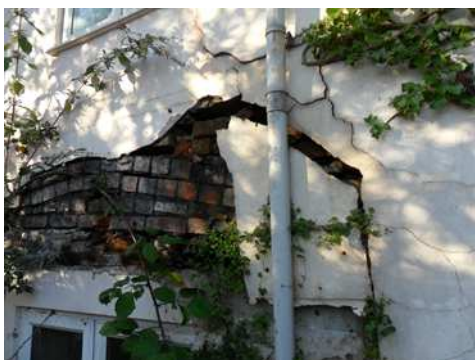
There is rotten timber lintel in urgent need of replacement, also, there is some minor past settlements, thermal and shrinkage movement cracks, on the entire elevation. The exact cause of the foundation movement or the likelihood of the degree of progressive movement we believe in this circumstance it is likely that there is an outside influence affecting the bearing capacity of the foundation sub stratum beneath the property.

Photo: 10 Lintel failure

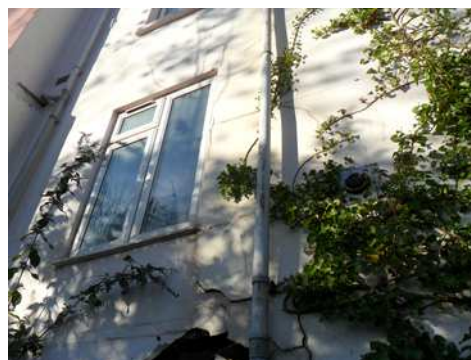
11 Render failure

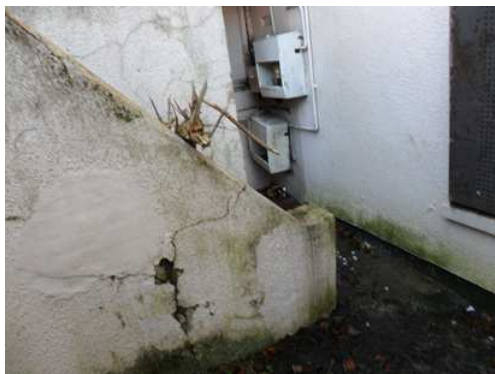
Photo: 12 Front garden wall failure

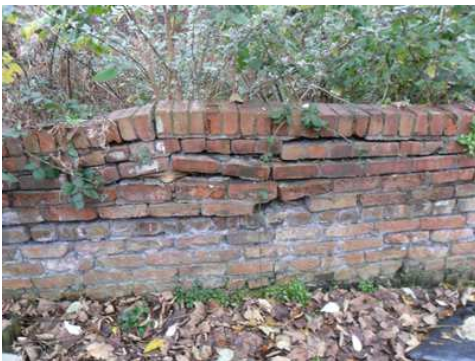
Photo: 13 Rear garden wall failure

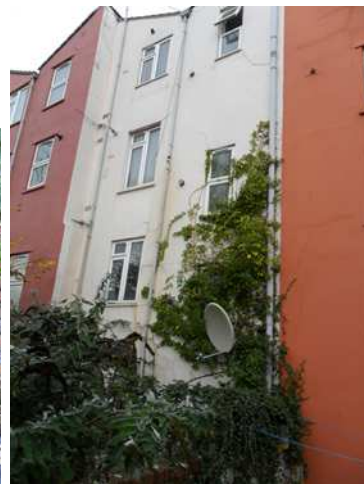
There is however cause for concern with regards to rear elevation wall. The wall is pulling away from the building, and will need to be tied back; to ensure structural stability. As discussed in this report the cracked masonry to this elevation is saturated from leakages from wind driven rain and the broken rain water downpipes discharging water directly into the wall, this water is tracking back into the floors and ceilings. There are several lintel failures on this elevation, this will need urgent attention.

Photo: 14 Rear elevation wall failure

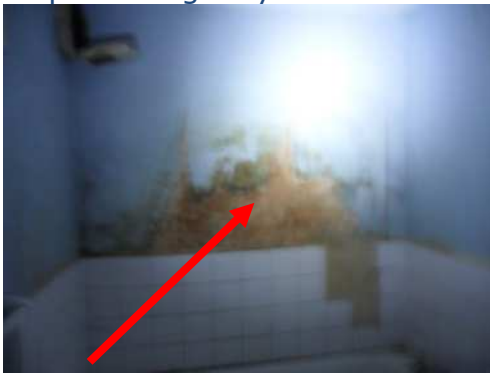
Photo: 16 Localise damp to the bathroom wall.

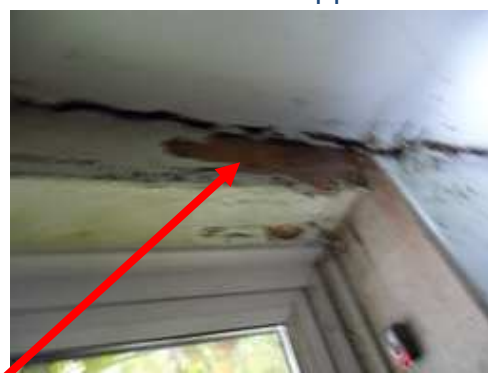
Photo: 17 Localise damp to the wall.

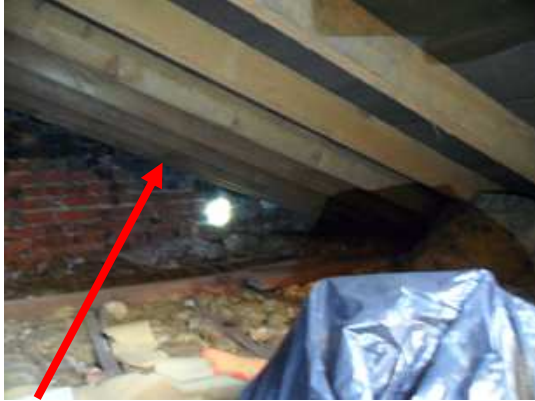
During our inspection we found the roof rafters, spanned from party wall to roof valley truck and the ceiling joists spanned from front to back of the property. This form of construction means the roof rafters are independent to the ceiling joists, in this form of construction the restraint to the roof rafters will depend on each rafter being tied back to the wall. Without an intrusive investigation, it was very difficult to establish if there was sufficient restraint to roof rafters and ties within the loft space to ensure structural integrity of the roof.

Photo: 18 Loft rafters

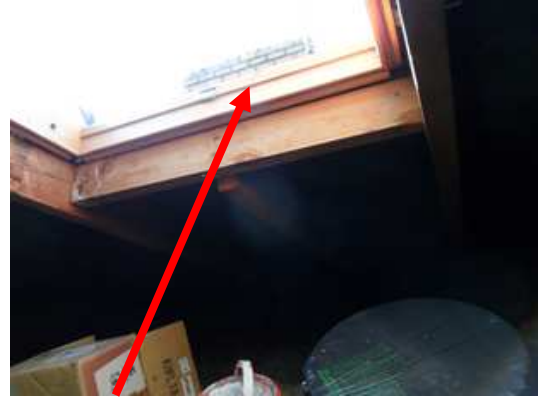
Photo: 19 Loft velux window

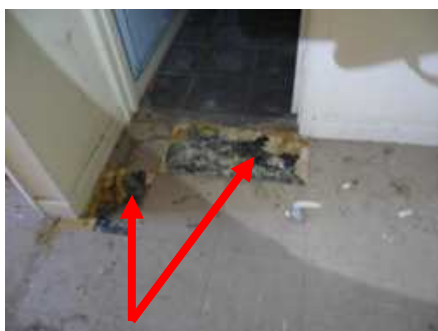
Photo: 20 Vinyl tiles removed

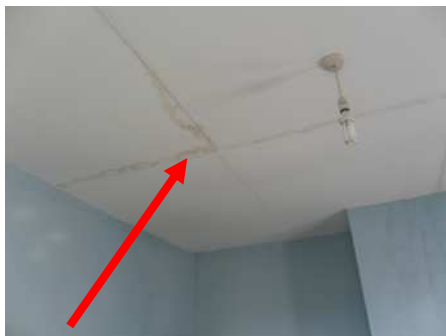
Photo: 21 Water tracking back to ceiling

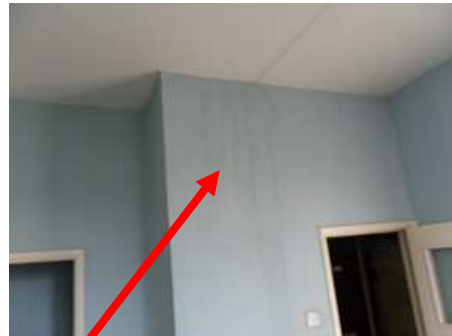
Photo: 22 Water tracking back to wall

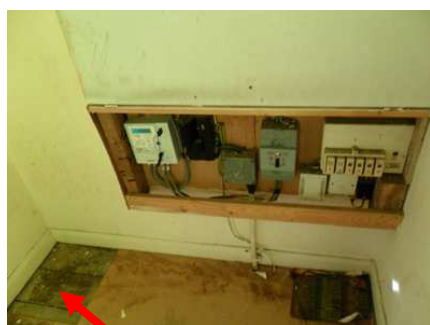
Photo: 23 water stained floor board

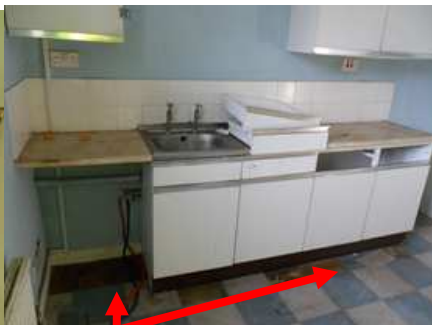
Photo: 24 Vinyl tiles removed

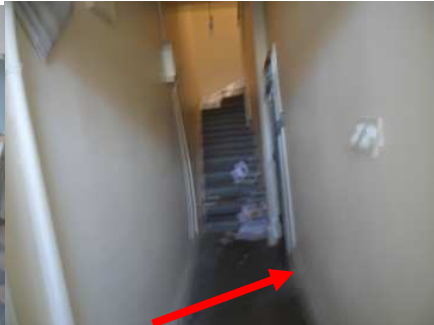
Photo: 25 slightly slanted floor

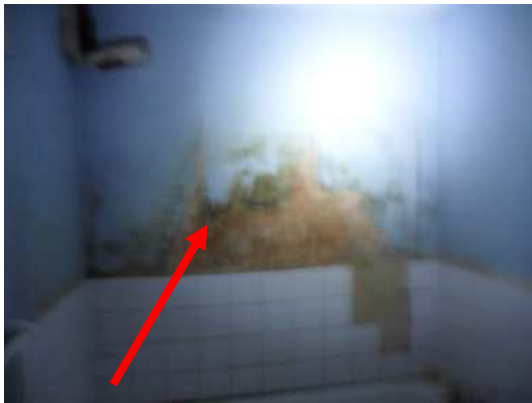
Penetrating dampness can occur when rain penetrates the external fabric of the building or as a result of some water leak. There are localised signs of damp in the bath room and in the cupboard area (See photo 26-29) evidence of recent work carried out to the kitchen floor. The floor repairs will need to be carried out again in some areas of the property. We believed the localised damp in the wall could be due to past water ingress, we did not find any evidence or sign of penetrating damp elsewhere in the building. We would recommend that the damp is treated.

Photo: 26 Damp in the bath room wall

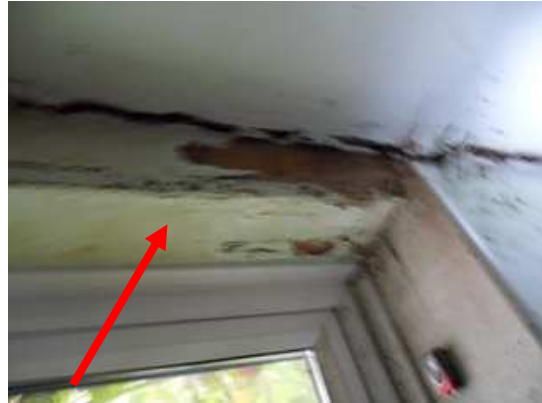
27 Damp in the wall

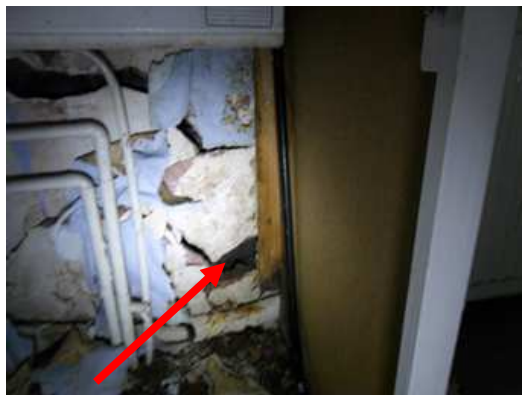
Photo: 28 Damp in the cupboard wall

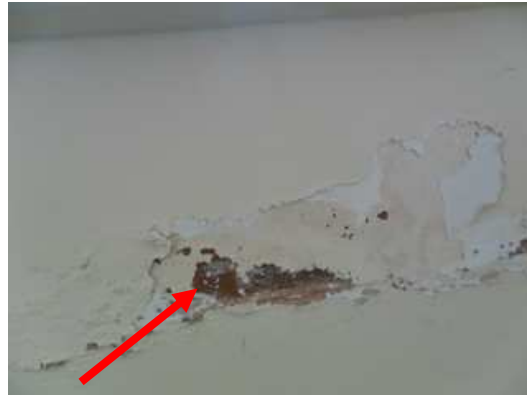
Photo: 29 Damp in the wall

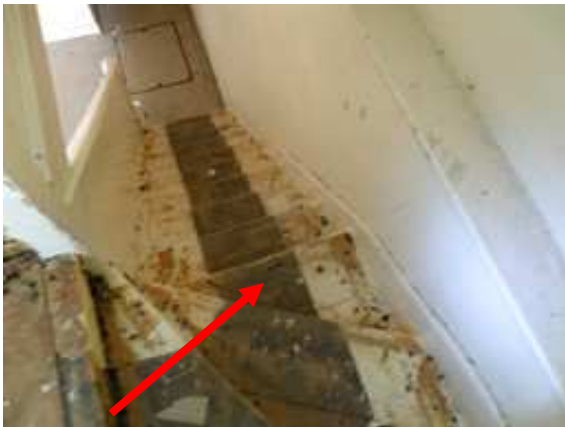
Photo: 30 staircase

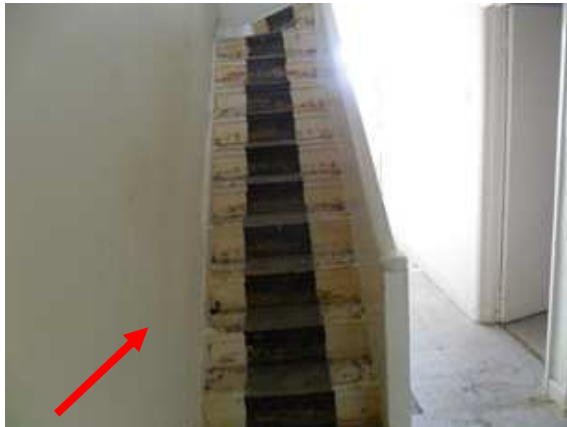
Photo: 31 staircase

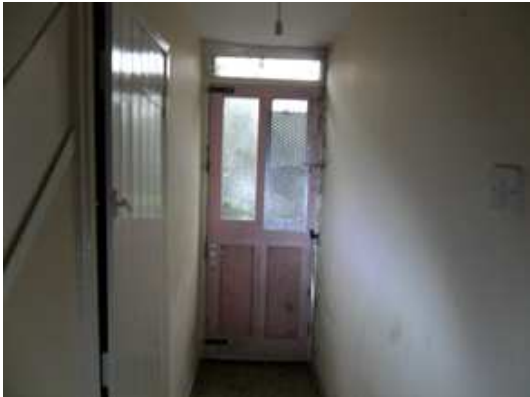
Photo: 32 Rear Door need replacing

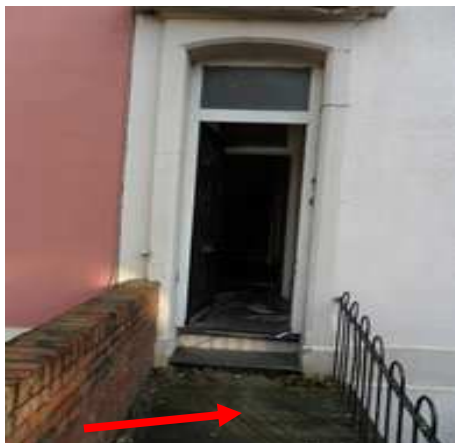
It is always sensible to assume the ownership of individual boundaries and Paths and drives will inevitably wear and become distorted with time. Although serviceable at present, some future maintenance and repair should be anticipated. We show evidence of significant defects. (See photos 27-28). The slab subsiding and cracking in some areas of the path driving water into the foundation line. We would recommend that the slab/path is re-instated.

Photo: 33 Defective areas of the slab

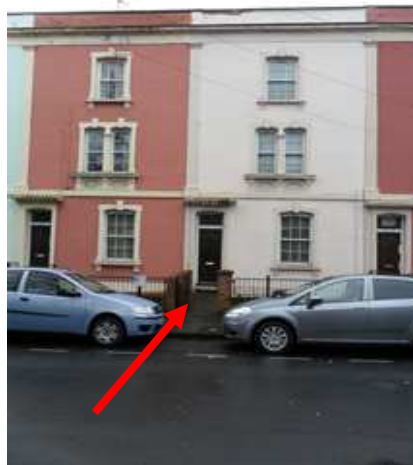
Photo: 34 Defective areas of the slab

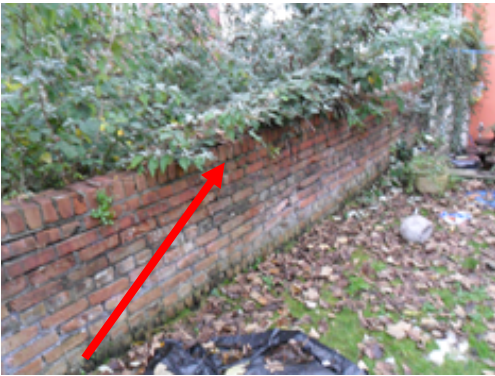
Photo: 35 Side boundary fence

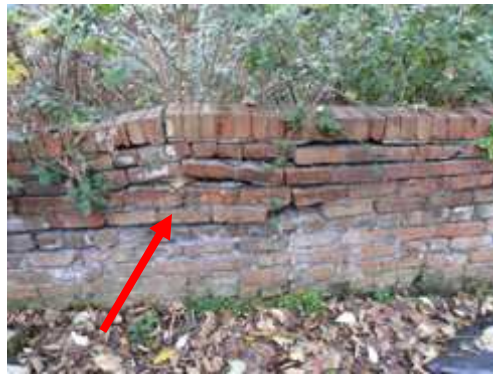
Photo: 36 side boundary fence
