Haringey Council

SUPERFICIAL BRIDGE INSPECTION REPORT 2014- 2015

Highgate Hill Retaining Wall HGY 132

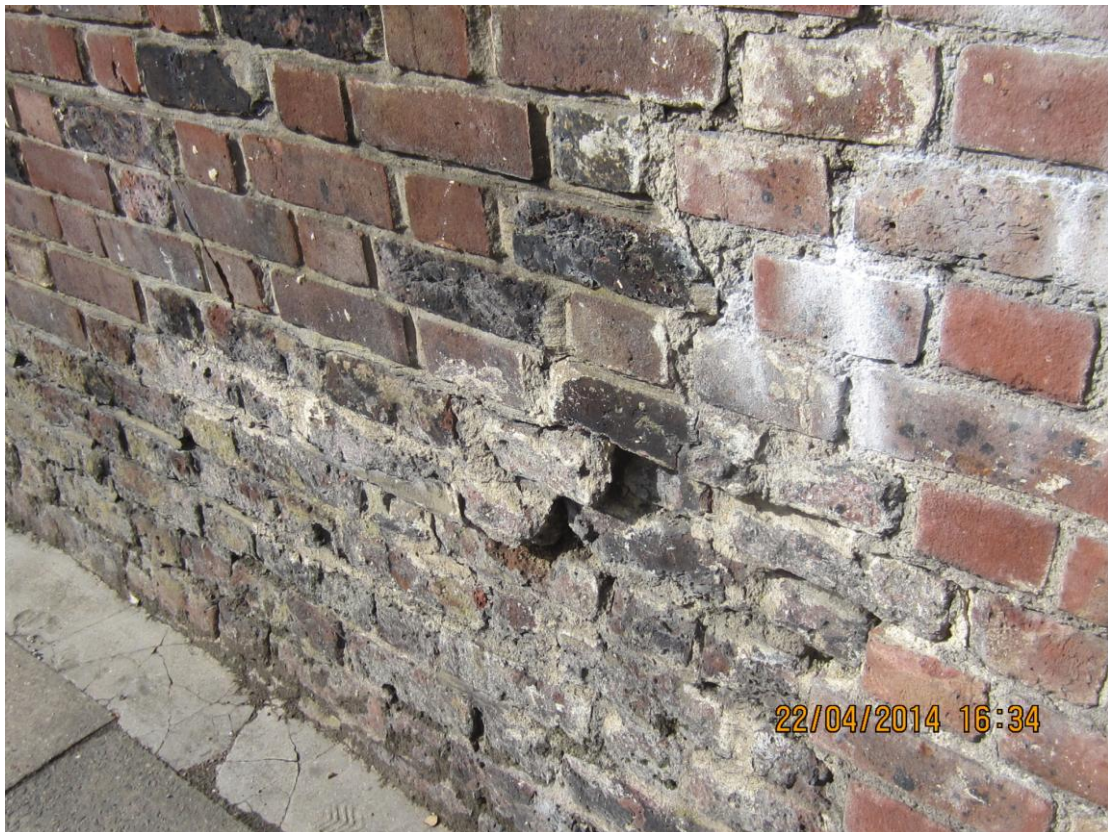
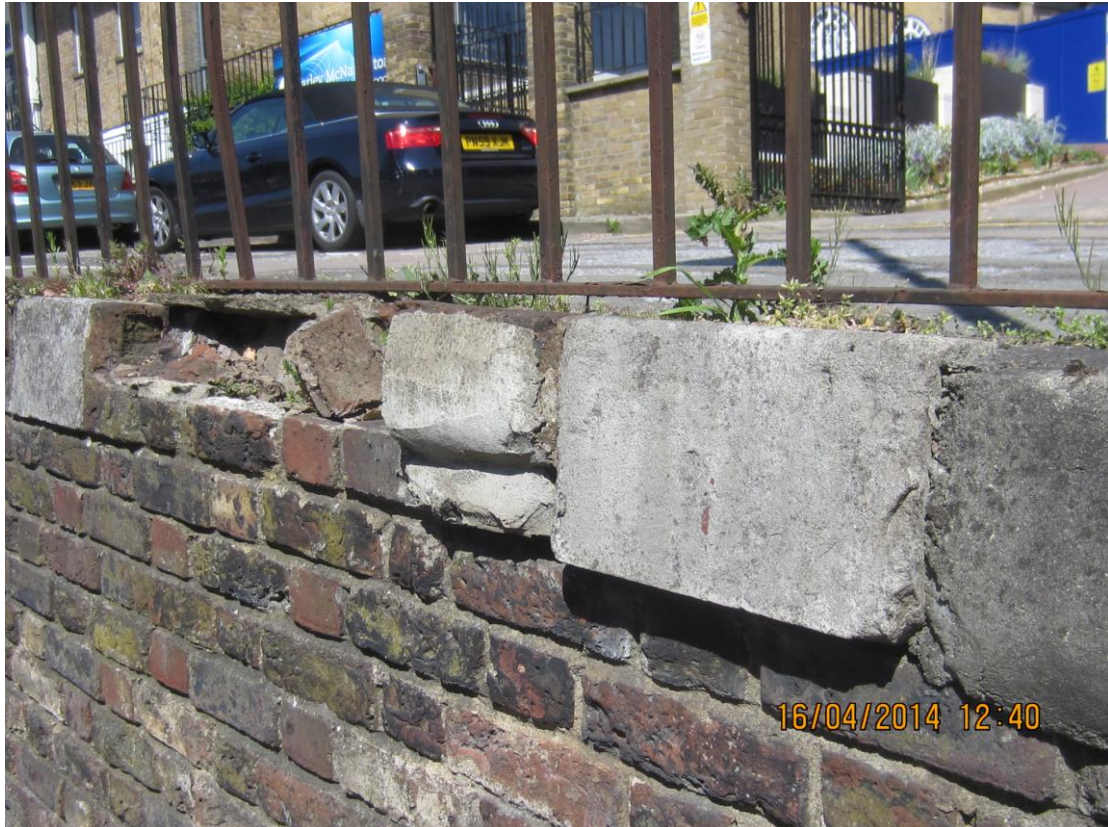
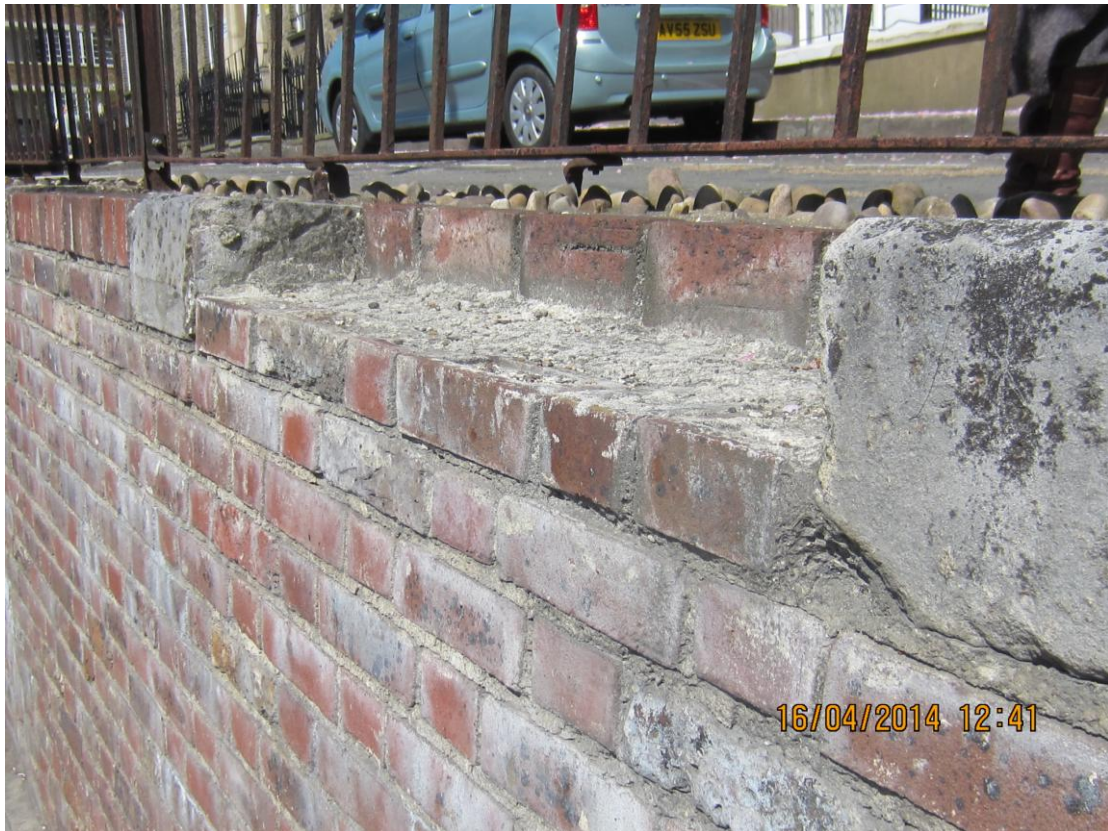
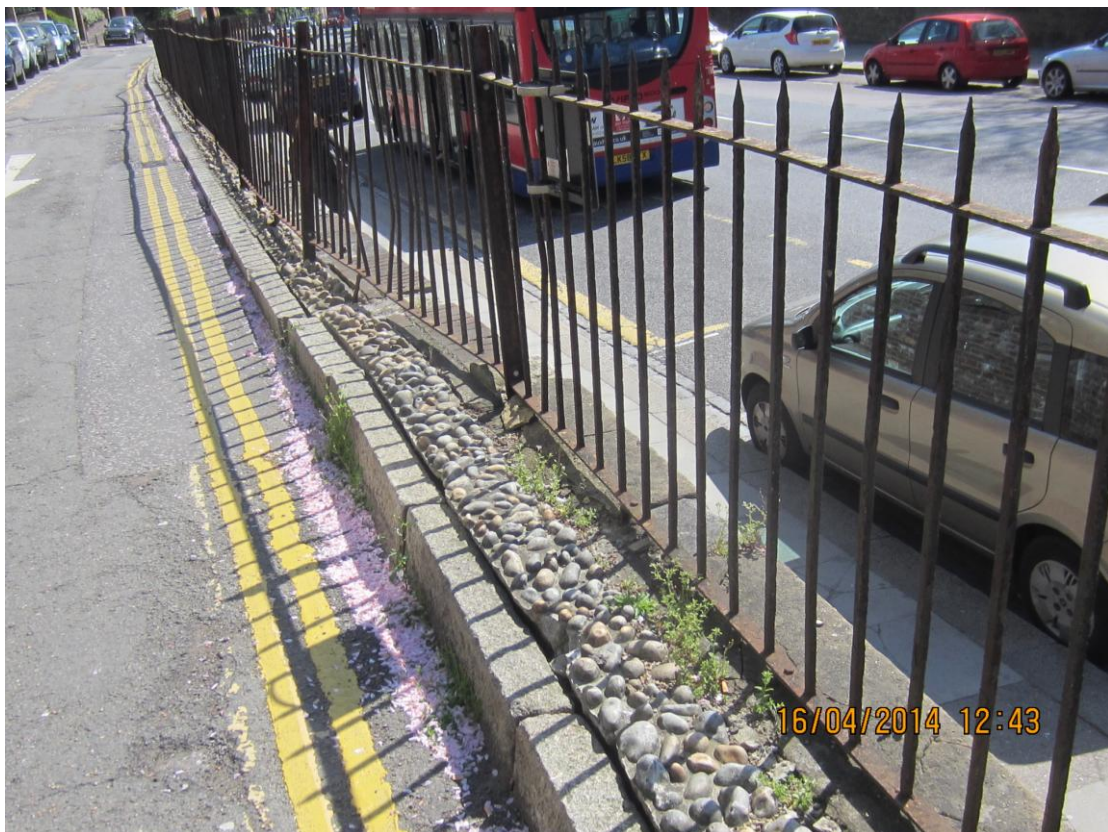
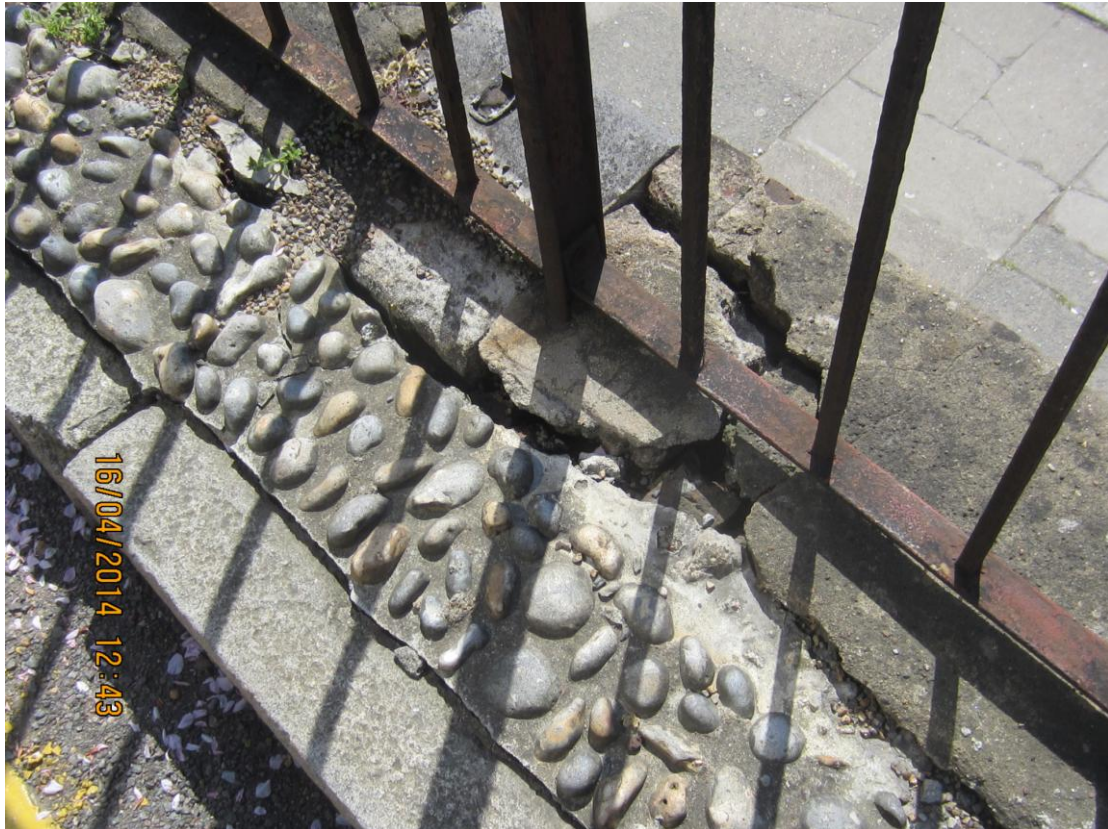
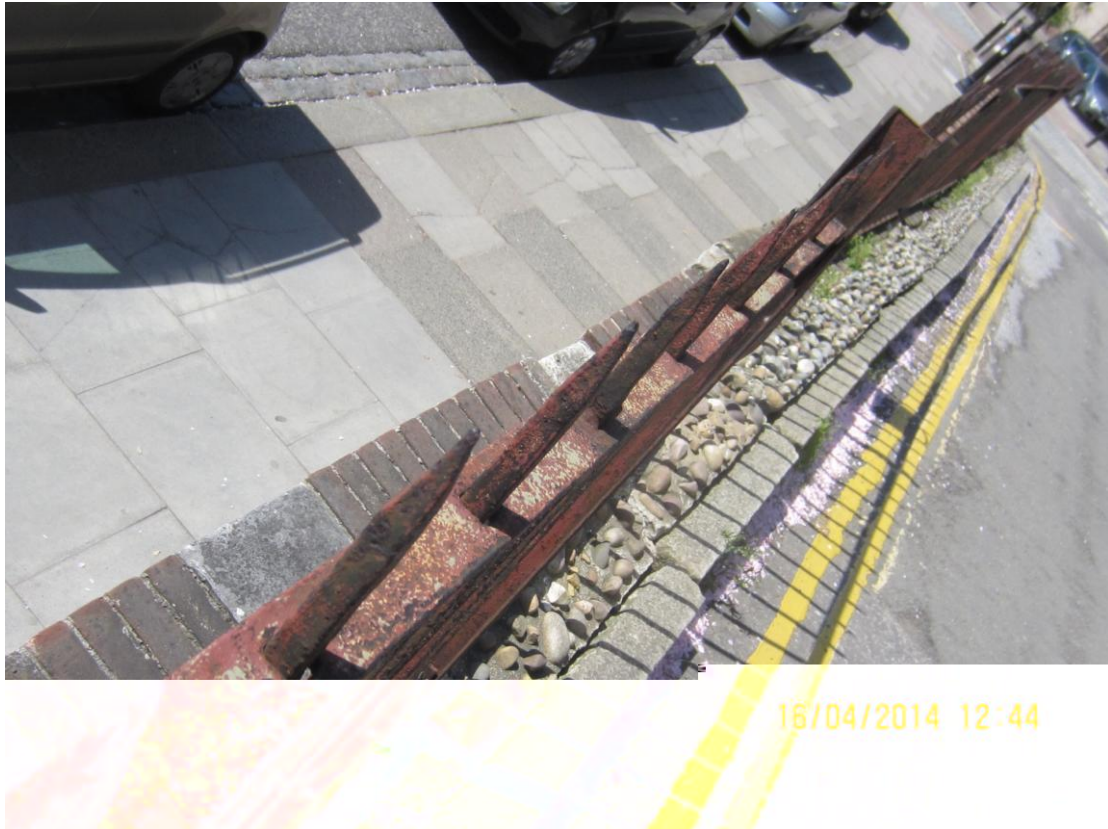
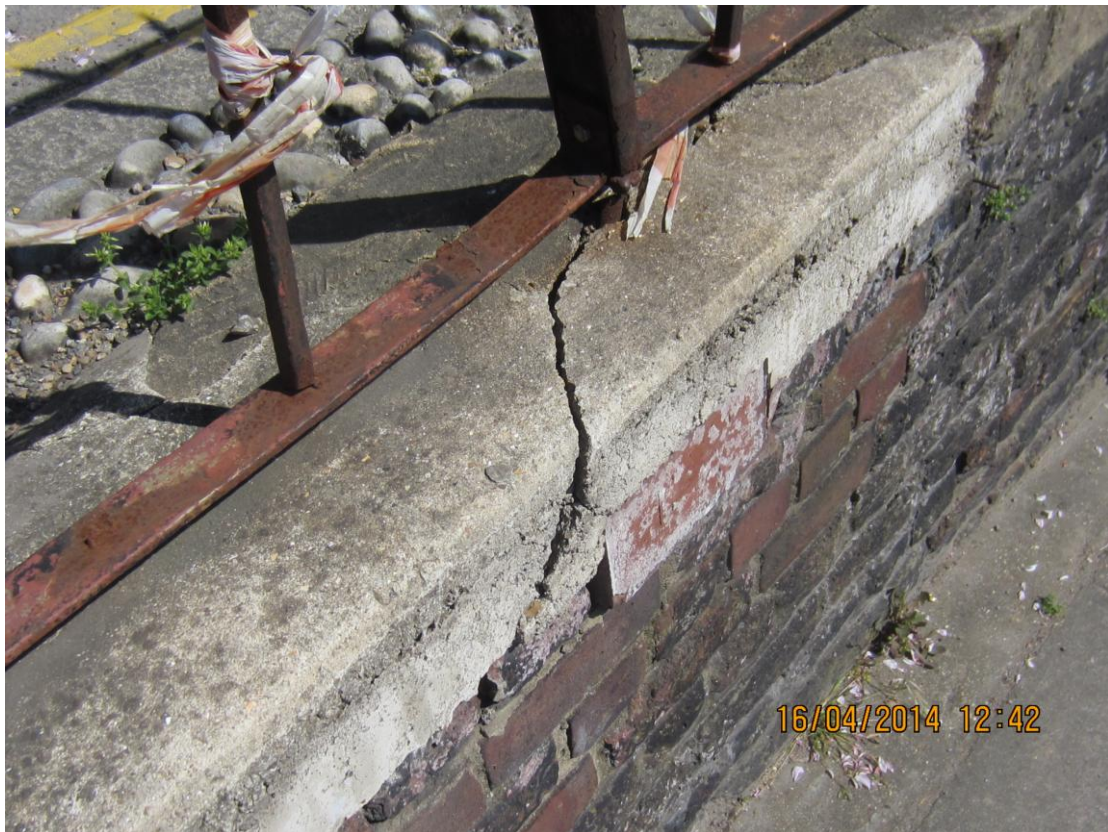
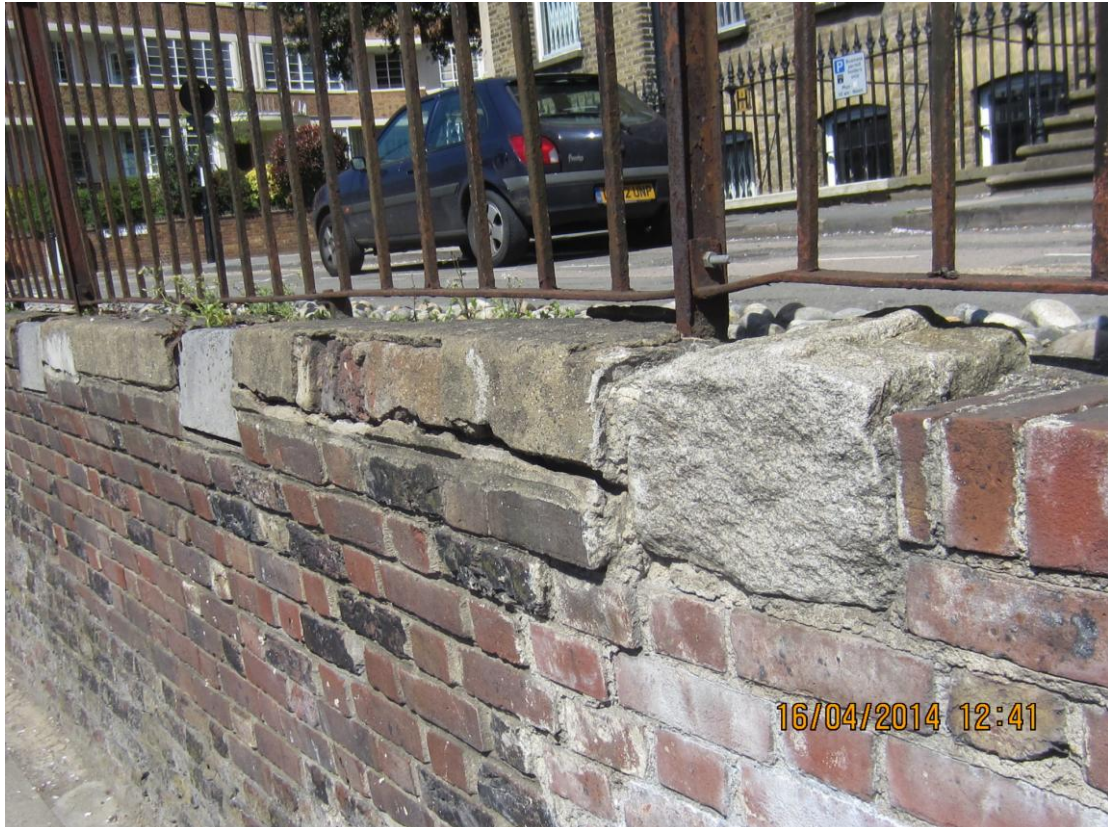
At a number of locations the brickwork was rebuilt, as can be seen by various bricks used for the construction. The section of wall near the bus stop was recently re built and some top course coping bricks are missing.

New movement is now noted close to bus stop and cracks along the kerb. The steel fence also has impact damage at this location. The top

level of a length of wall near the bus stop has leaned towards Highgate hill excessively, and is likely to collapse without warning. This movement is also indicated by long gaps along the kerb, and damaged steel fence.

As a matter of urgency please cordon off the area of footway around the moved wall. The section of this wall to be demolished and rebuilt, and the missing coping bricks are to be replaced.

All rebuilding works are to the agreed specification used previously.
