## Earth Structures Remediation

### Feasibility Report

Kingsbury to Wembley Park

Document No: TLL-B088-P954-EST-RPT-00001

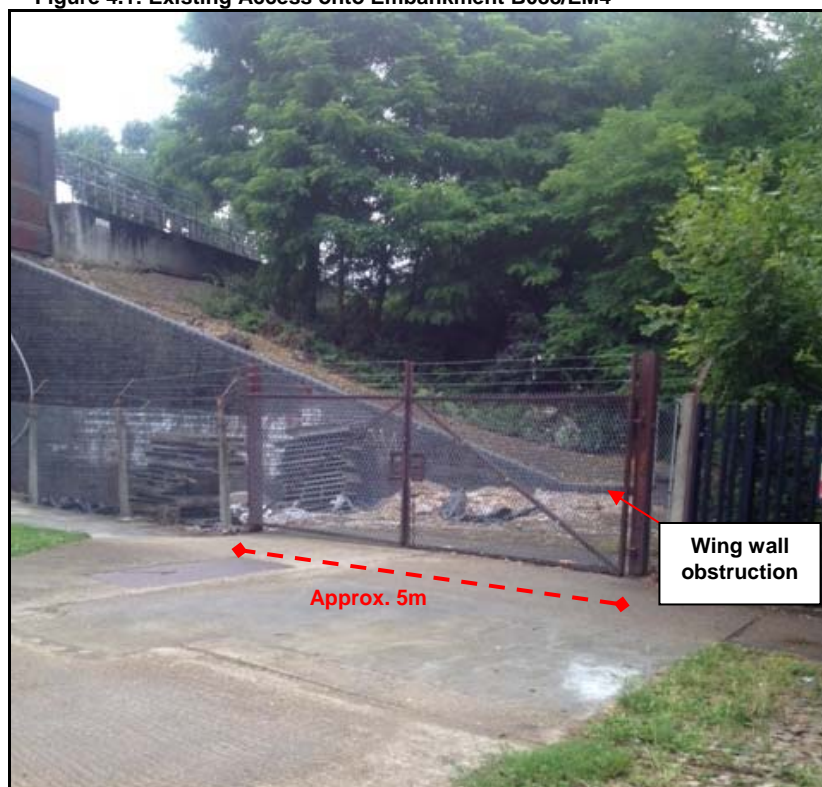
Figure 4.1: Existing Access onto Embankment B088/EM4

Beyond the access gate, the wing wall of bridge S2 runs perpendicular from the main bridge structure across the area in front of the gates (Figure 4.1), posing an obstruction to any onward access onto the embankment. Suitable temporary works will be required to ramp over this structure and protect it throughout any construction works.

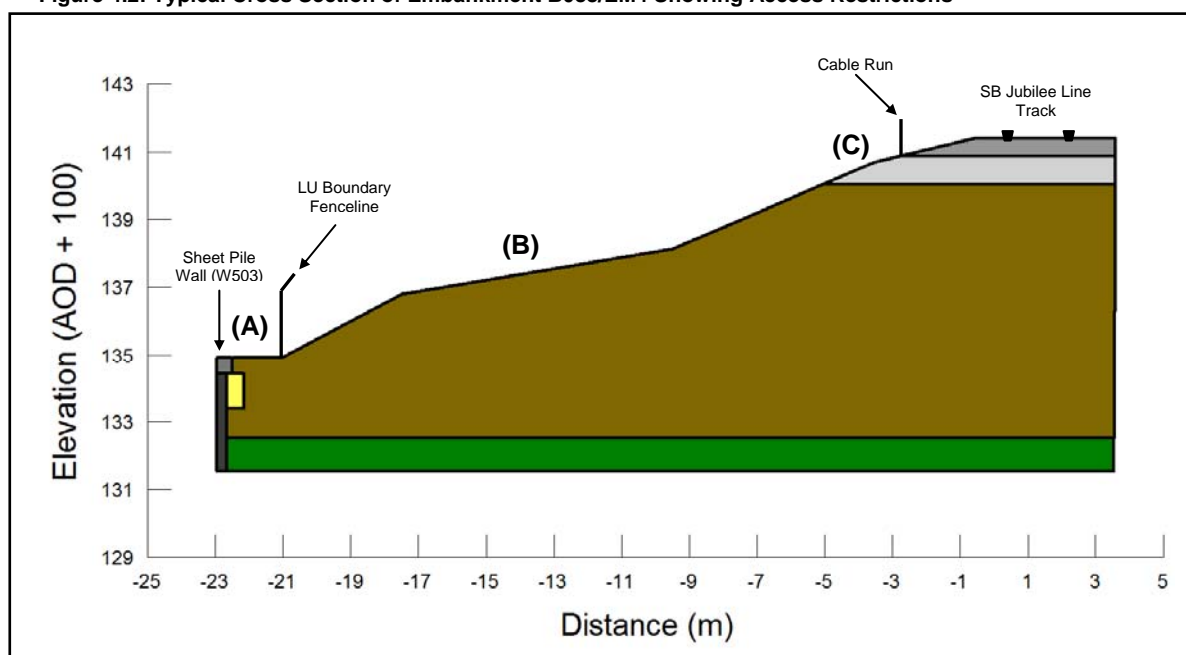
Figure 4.2: Typical Cross Section of Embankment B088/EM4 Showing Access Restrictions

- The proximity of the sheet piled wall (W503) restricts the movement of plant and machinery along the toe of the embankment. (A) - Figure 4.2
- An existing mid-slope terrace, representing the remnants of an access road constructed for previous remedial works, is not feasible to reuse, owing to its poor construction and the low strength of the embankment fill that supports it. (B) - Figure 4.2
- As discussed in Section 3, the embankment is currently densely vegetated with mature trees and shrubs.
- The crest is not of a sufficient width for plant to use to access along the embankment. (C) - Figure 4.2
- The presence of the reinforced concrete bridged culvert (S3) at approximate chainage JSB1300, will require suitably designed temporary works to bridge over it without the risk of overloading the structure.

To access the length of the embankment, suitably designed temporary access roads will need to be constructed, taking into consideration the low strength of the embankment fill, along with existing and historical instability of the embankment. Restricted access along the embankment is an issue for any potential remedial option considered.

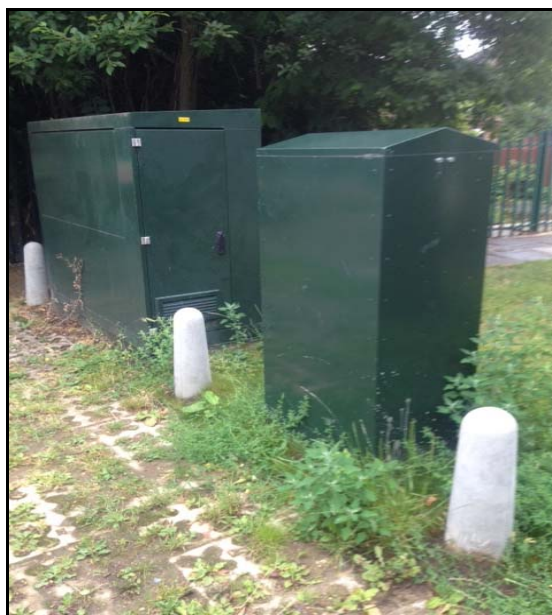
- Suitably designed third party asset protection will be required for a telephone mast and exchange box, located adjacent to access point (Plate 6 Appendix C).
- A full time lorry marshal/banksman will be required at the access point at all times, to ensure public and third parties are segregated from construction traffic attending the site.
- There is a potential to explore segregating an additional area in front of the existing gates, to create a larger space between the road and the embankment, see Section 5.2 for further discussion.
- Access negotiations with the Local Council, contact details are presented in Appendix D.

**Plate 6 – Telephone Mast and Exchange Box requiring Protection**
