Land at Plas Offa Farm, Whitchurch Pentre, Chirk

# **CPAT Report No 1224**

# Offa's Dyke De138, Chirk, Wrexham Survey, Excavation and Recording

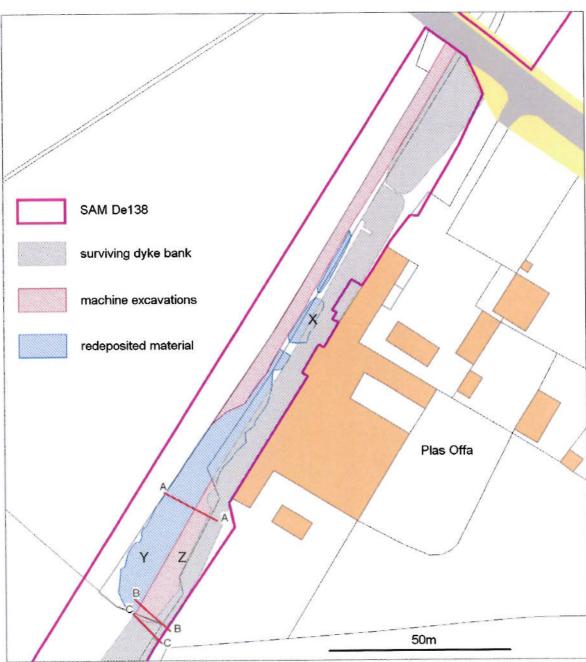
- 2.2 The survey revealed that the upper 0.1-0.2m of topsoil had been removed for about 140m across a width of 4m to 5m between the base of the bank and a new post and wire fence erected to the west of the dyke. The material was subsequently re-deposited along the west-facing base of the bank (Fig. 4). Removal of the topsoil exposed the uppermost fill of the ditch, while a stony clay spread along the central and eastern area of the newly created track represents material removed from the bank. 140m south-west of the A5 the track widened to form a levelled area that had been fashioned by the partial removal of the dyke bank for a further 40m; some stratigraphy was exposed within the truncated core of the bank (Figs 5 and 6).

- 2.3 It is estimated that the machine excavations have had a direct impact on 206m² of the bank, while a further 58m² of the bank has had material dumped against it. Material had also been redeposited across an area of 680m² of the ditch, while some limited ground disturbance has affected a further 445m². Based on the profiles surveyed across the damaged section of the bank (Figs 2 and 3) it is estimated that around 125m³ of material may have been removed, and then redeposited across the ditch.

Fig. 2 Survey showing the damaged section of Offa's Dyke. The letters X-Z indicate the positions from which text photographs (Figs 4-6) were taken.

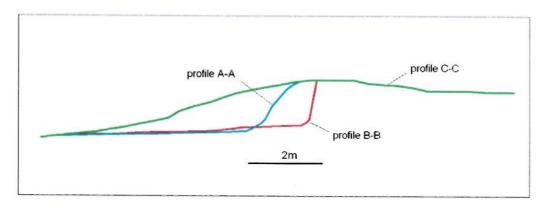
Fig. 3 Comparative profiles (A-A and B-B) through the damaged portion of the dyke and an adjacent undamaged portion (C-C) (see Fig. 2 for profile locations)

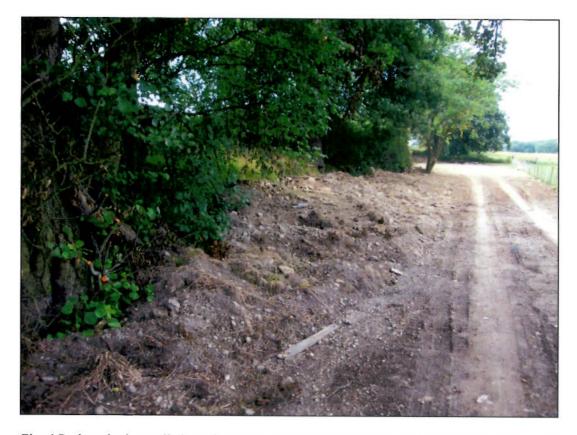
Fig. 4 Redeposited topsoil along the west-facing base of the dyke, viewed from the north-east. (X in Fig. 2). Photo CPAT 3677-0019

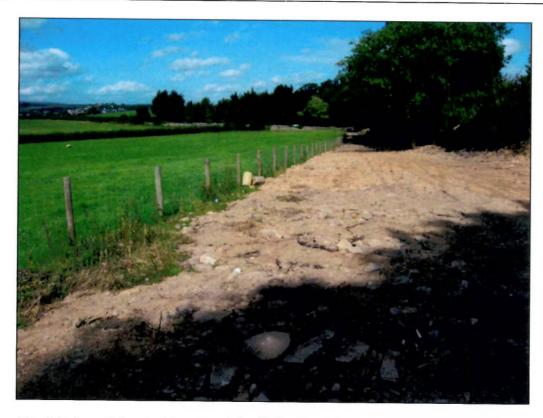
Fig. 5 Redeposited material on top of the ditch, viewed from the south-west (Y in Fig. 2). Photo CPAT 3677-0022

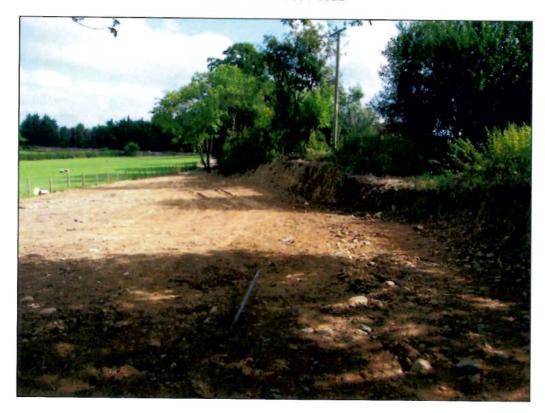
Fig. 6 The levelled area created by the partial removal of  $c.40\mathrm{m}$  of dyke bank, viewed from the south-west (Z in Fig. 2). Photo CPAT 3677-0008

Fig. 7 The exposed section of bank was protected by sheeting to prevent erosion prior to the commencement of the archaeological excavation (Z in Fig. 2). Photo CPAT 3677-0035

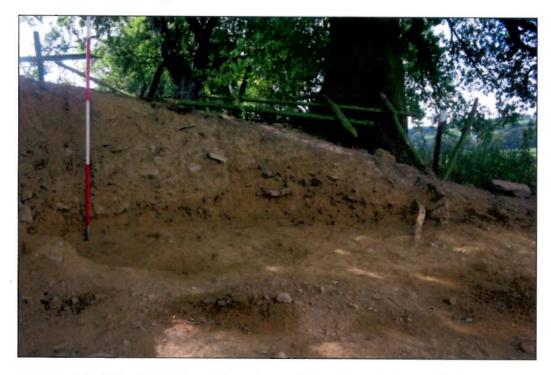
- 3.8 A sondage (A) exposed the inner edge of the infilled dyke ditch (22), lying approximately 5m to the west of the longitudinal section through the surviving bank. A modern drain (24) had been inserted along this edge and another modern drainage feature was evident in the centre of the damaged area where the earthwork had been breached by a former farm track. It is probable that some of the material removed from this breach had been dumped in the ditch to create a crossing point to adjacent fields. In addition a rough stone surface containing post-medieval artefacts lay on top of the upper ditch fill near the field entrances.

Fig. 9 Section A, viewed from the north-east. Photo CPAT 3697-0031.

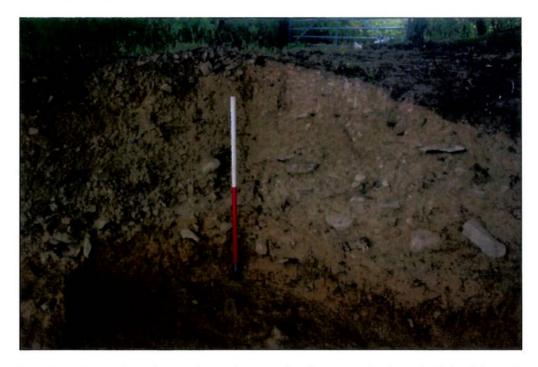
Fig. 10 Section B viewed from the north west. The drawn section is to the left of the scale. Photo CPAT 3697-0036.

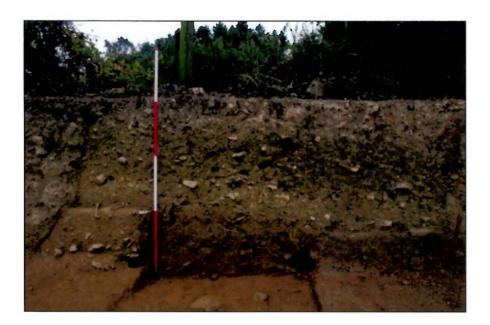
Fig. 12 Section C viewed from the north-west. Photo CPAT 3697-0095

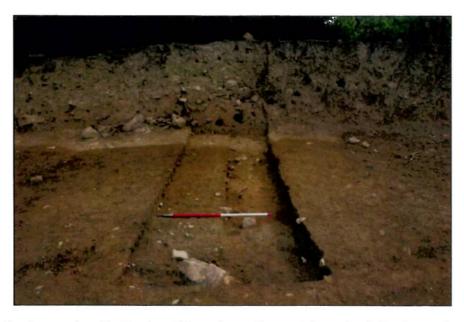
Fig 13. Sondage and section D viewed from the north-west. The scale within the sondage marks the inner edge of the ditch. Photo CPAT 3697-0081

3.10 The inner edge of the ditch was identified in sondages C and D, approximately 5m to the west of the face of the remaining bank (Figs 8 and 13). Both sondages revealed the uppermost ditch fill as a dark bluey grey silt (21) containing fragments of 19<sup>th</sup>-century brick and pottery, and part of an underlying layer of orange brown silt-clay (20).

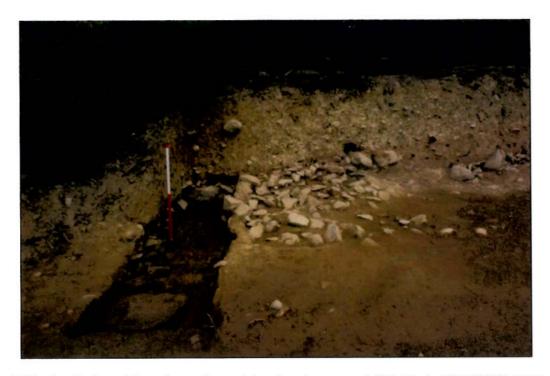
- 3.12 The ground surface in the vicinity of sondage E was strewn with rounded stones of varying sizes. Initially this was thought to be similar to the material encountered at the base of the bank in the south-western corner of the damaged area (see paragraph 3.6). However, further investigation exposed a spread of large stones (29) at least 0.3m thick lying beneath the base of the bank and spreading for approximately 2.5m within the excavated area, but obviously extending beyond it (see Figs 14 and 15). The stone clearly represented an earlier phase of activity, pre-dating the construction of the earthwork. Bulk soil samples were recovered from within the stone spread (Find nos 106-7), along with a sample from the base of the bank (28) (Find no. 105).

Fig. 15 Section E viewed from the north-west showing stone spread (29). Photo CPAT 3697-0104

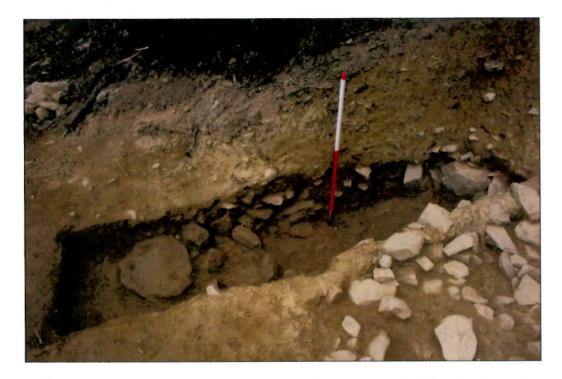
Fig. 16 Section E viewed from the south-west, showing stone deposit (29) within the sondage.
